VSR 3 - LOOKING EAST FROM KWONG MING YING LOI SCHOOL: EXISTING CONDITIONS AT THE DEVELOPMENT SITE.

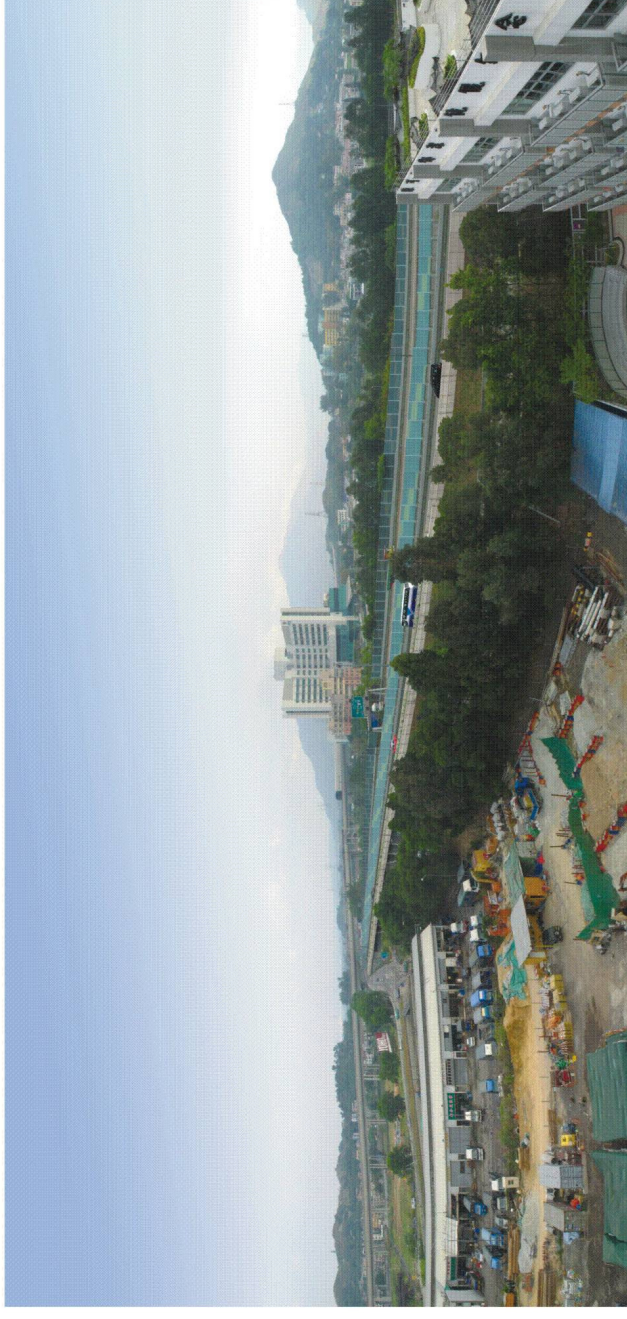
VIEW DISPLAYING THE 3D MODEL OF THE DEVELOPMENT SITE WITH LANDSCAPE AND VISUAL MITIGATION MEASURES AT DAY 1.

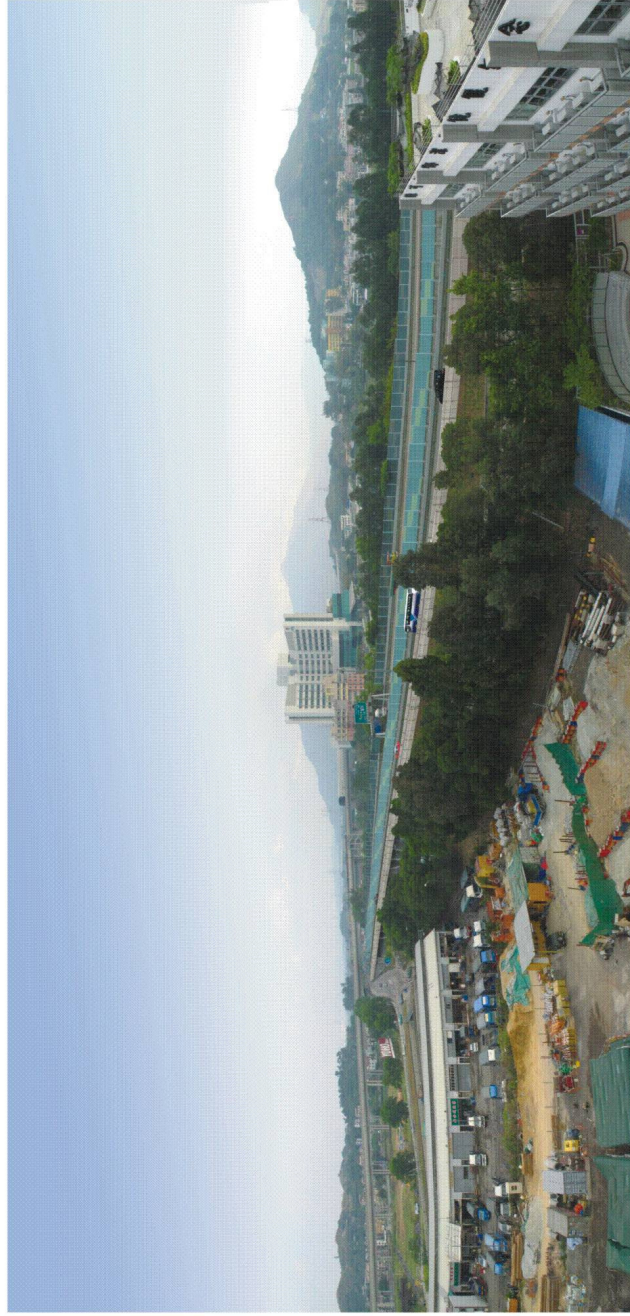
VIEW DISPLAYING THE 3D MODEL OF THE DEVELOPMENT SITE DAY 1 OF OPERATION WITHOUT LANDSCAPE AND VISUAL MITIGATION MEASURES

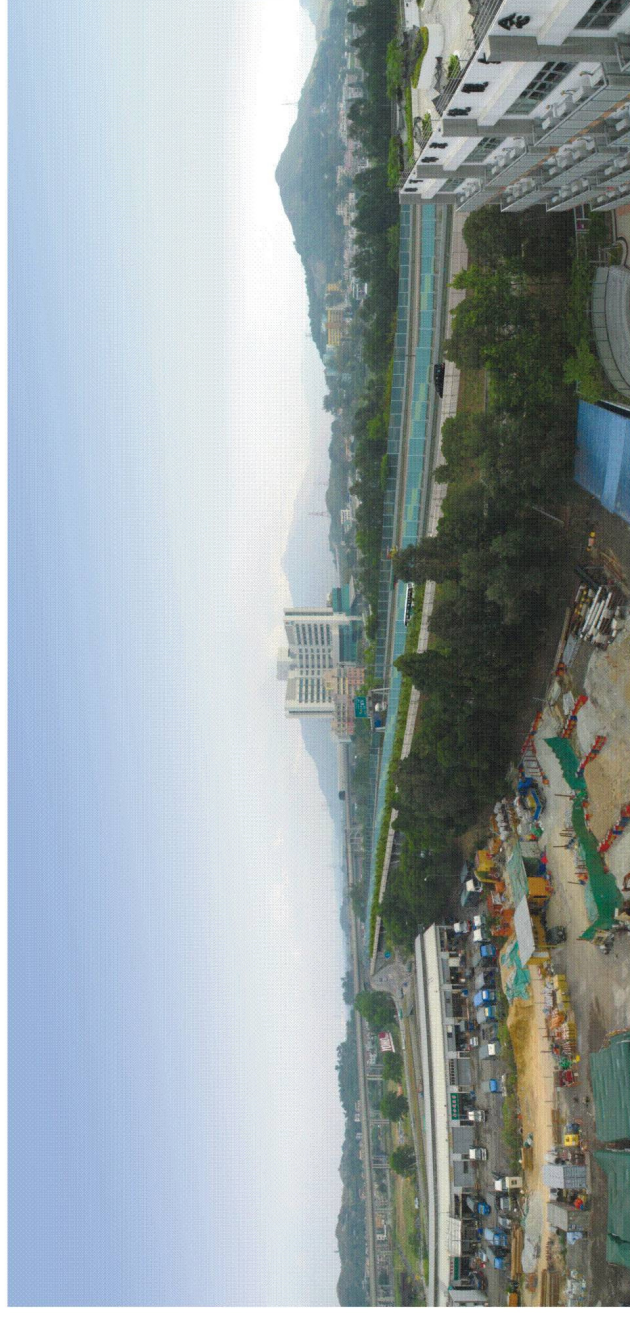
VIEW DISPLAYING THE 3D MODEL OF THE DEVELOPMENT SITE WITH LANDSCAPE AND VISUAL MITIGATION AT YEAR 10.
