Agreement No. CE 6/2019 (DS) Hung Shui Kiu Effluent Polishing Plant and Yuen Long South Effluent Polishing Plant – Investigation Timeseries Plots for Depth Averaged Dissolved Oxygen (mg/L) Blue: Normal Operation of YLSEPP (Scenario 1); Dashed Red: 2-hr Emergency Discharge from YLSEPP (Scenario 2)		Emergency	Dry Season
Appendix 5.6 – 01			
AECOM		/GPP/	emergency-d.ssn

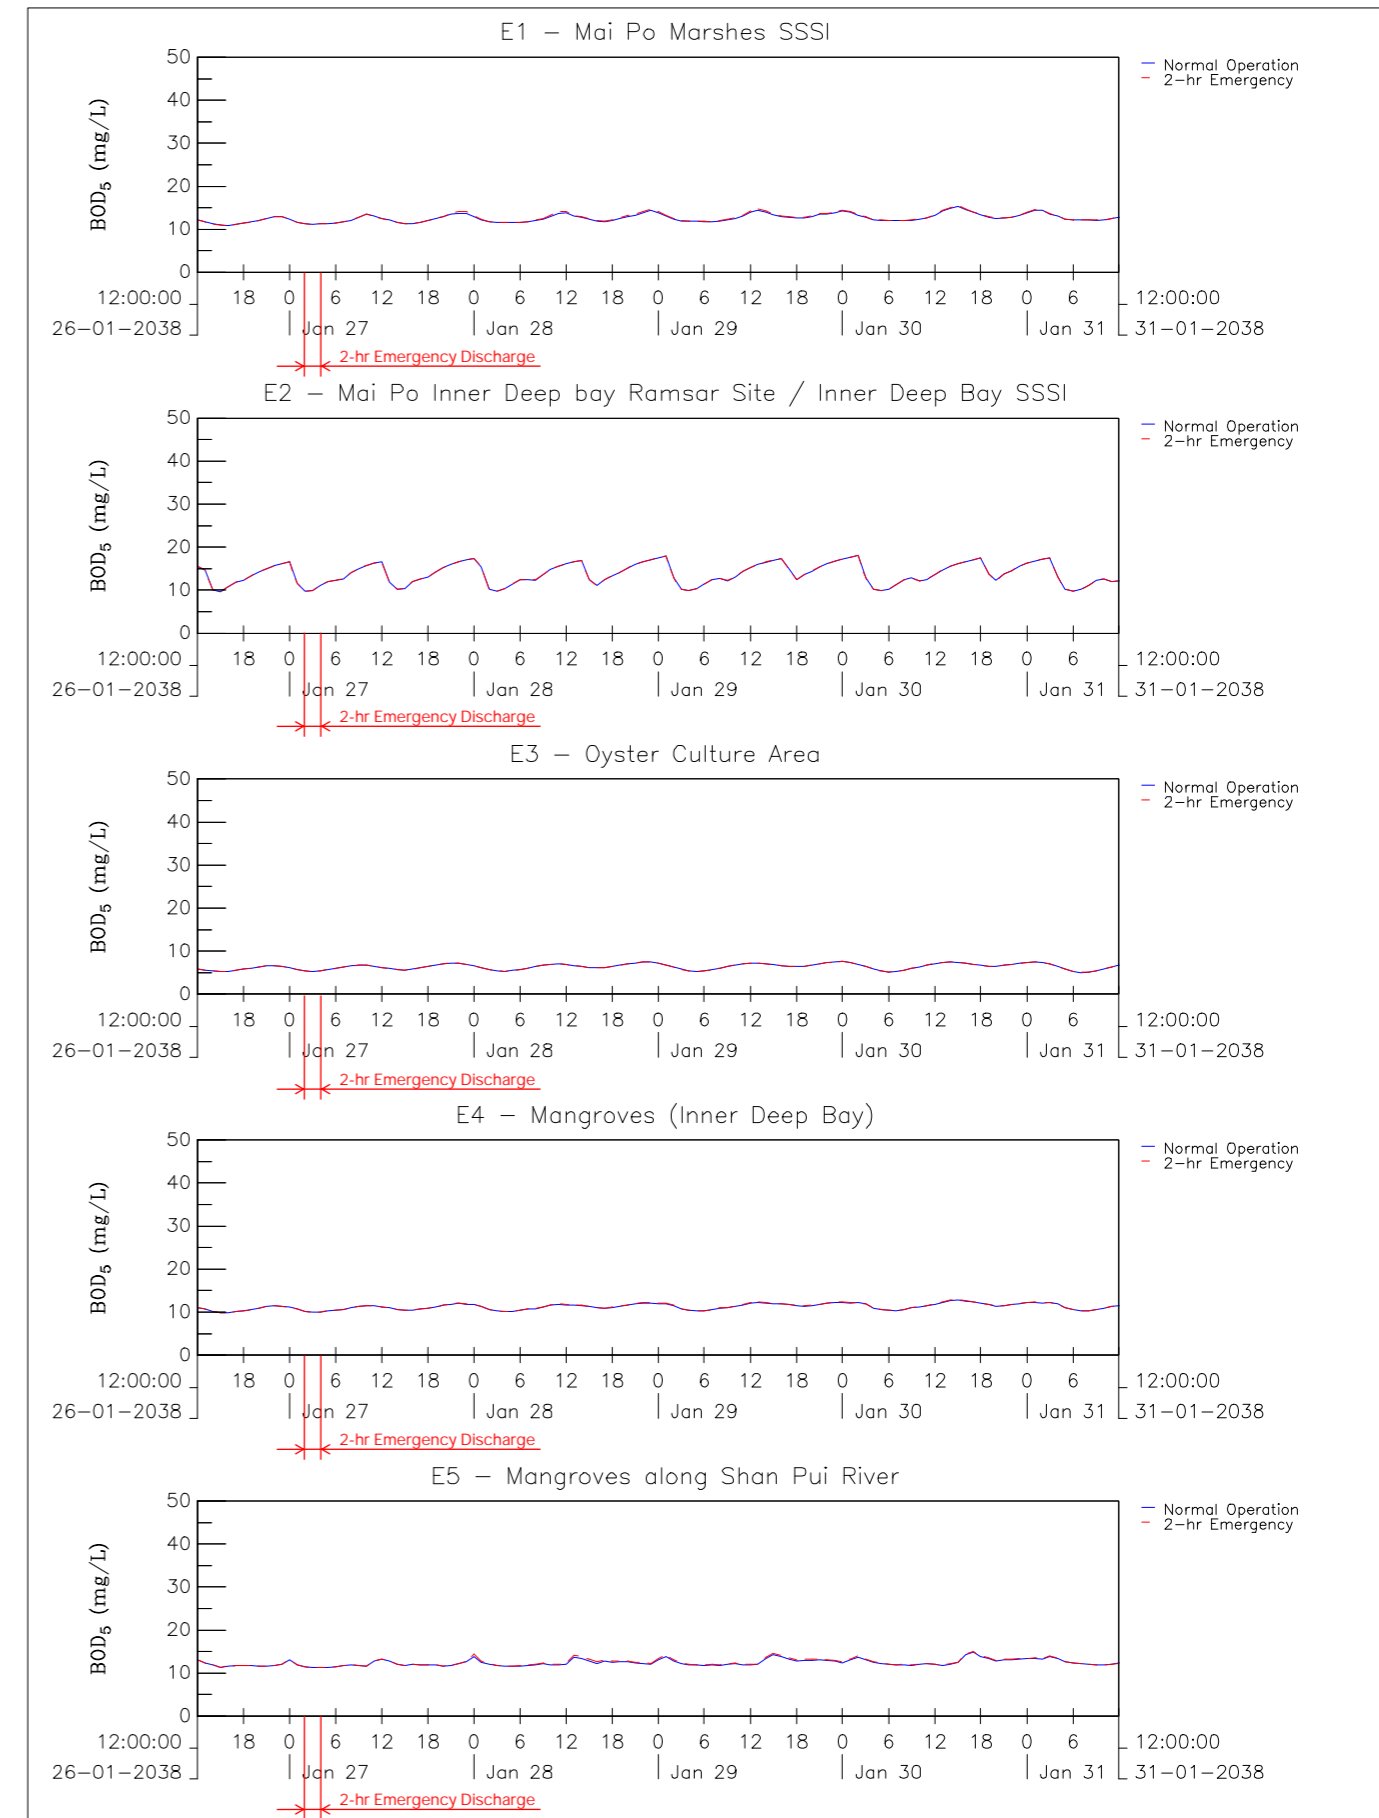
Agreement No. CE 6/2019 (DS) Hung Shui Kiu Effluent Polishing Plant and Yuen Long South Effluent Polishing Plant – Investigation Timeseries Plots for Depth Averaged 5-Day Biochemical Oxygen Demand (mg/L) Blue: Normal Operation of YLSEPP (Scenario 1); Dashed Red: 2-hr Emergency Discharge from YLSEPP (Scenario 2)		Emergency	Dry Season
Appendix 5.6 – 02			
AECOM		/GPP/	emergency-d.ssn

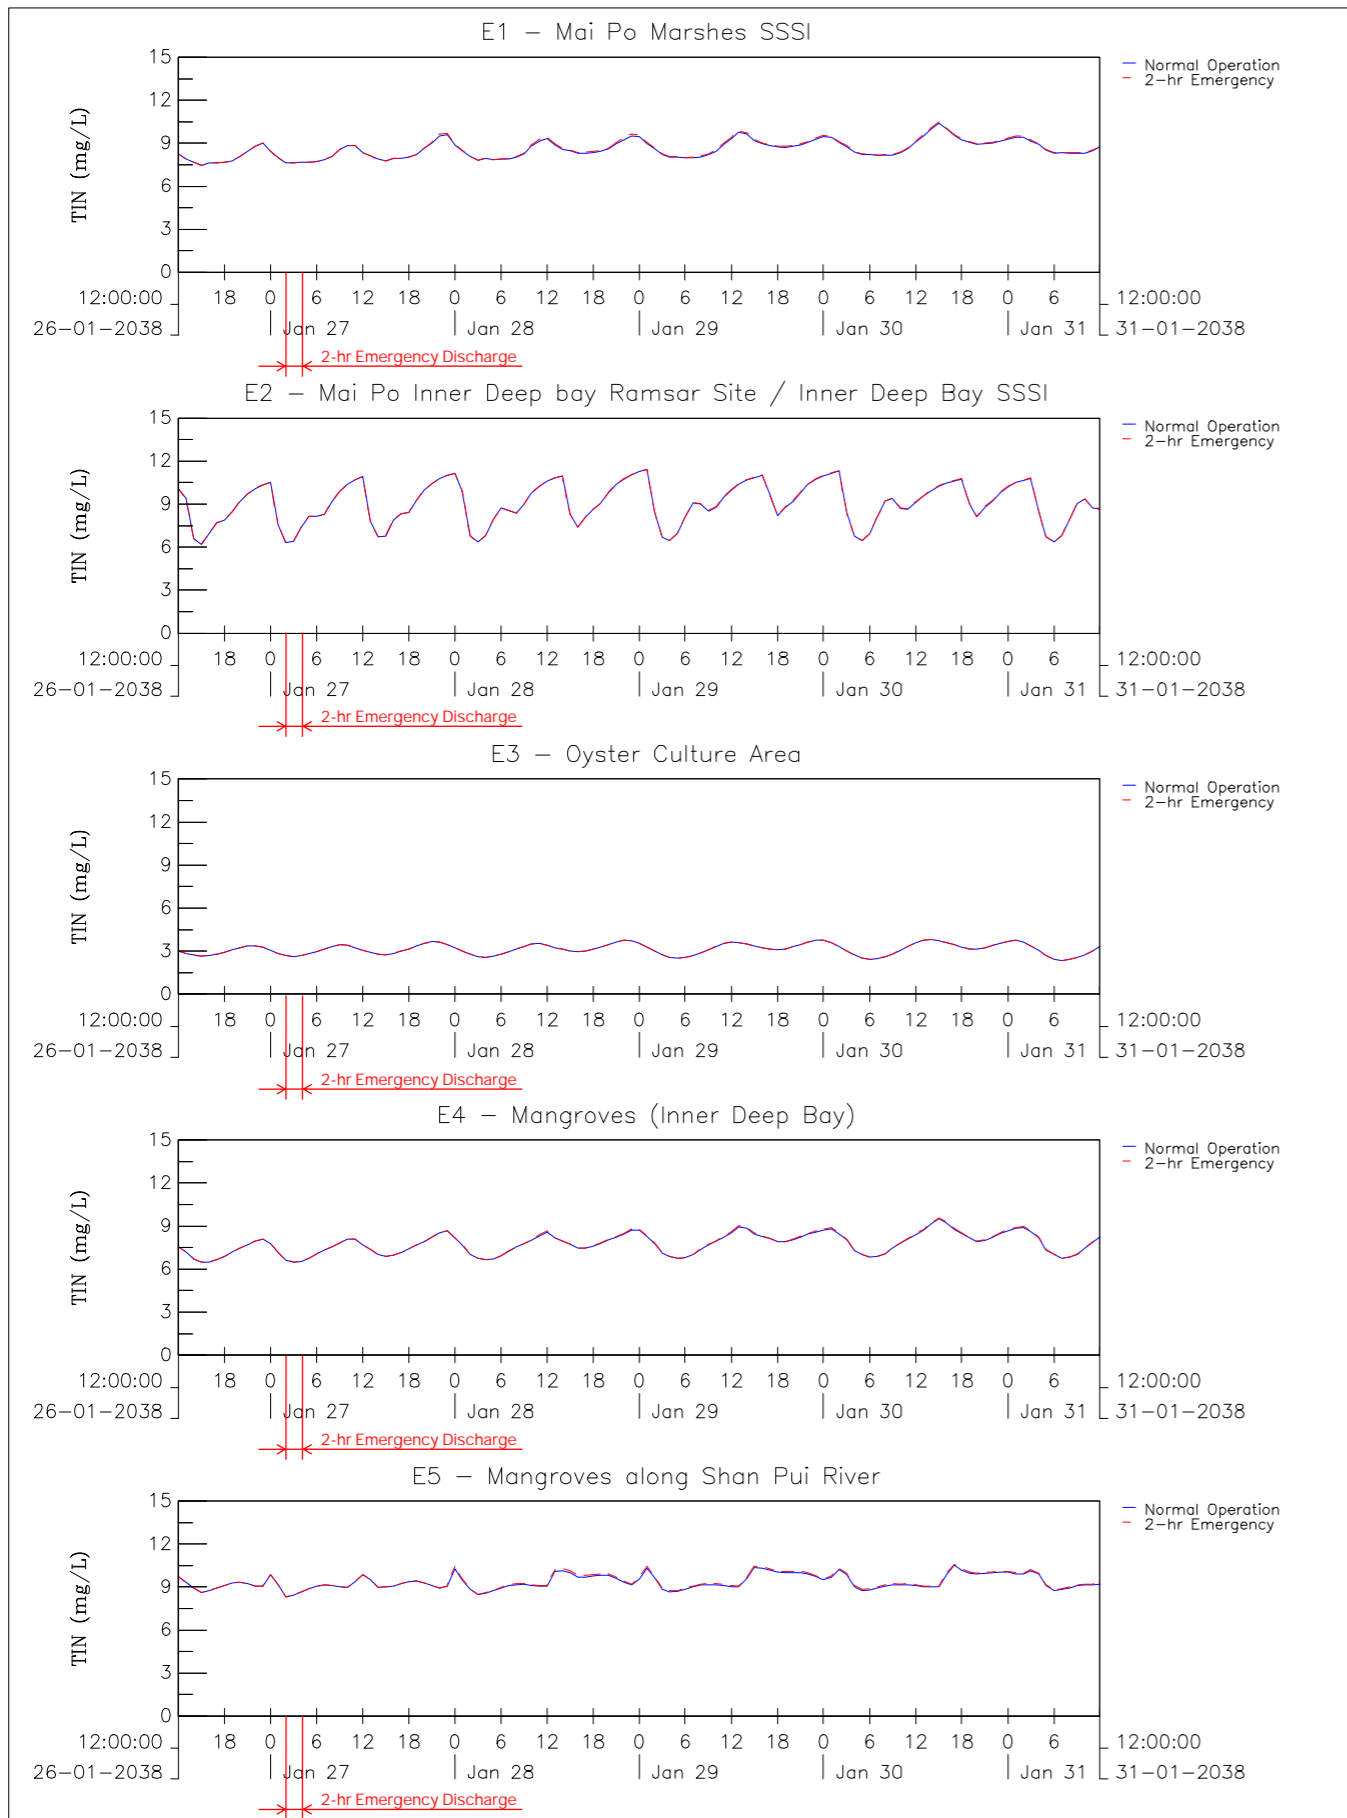
Agreement No. CE 6/2019 (DS) Hung Shui Kiu Effluent Polishing Plant and Yuen Long South Effluent Polishing Plant – Investigation Timeseries Plots for Depth Averaged Total Inorganic Nitrogen (mg/L) Blue: Normal Operation of YLSEPP (Scenario 1); Dashed Red: 2-hr Emergency Discharge from YLSEPP (Scenario 2)	Emergency	Dry Season
	Appendix 5.6 – 03	
AECOM	/GPP/	emergency-d.ssn

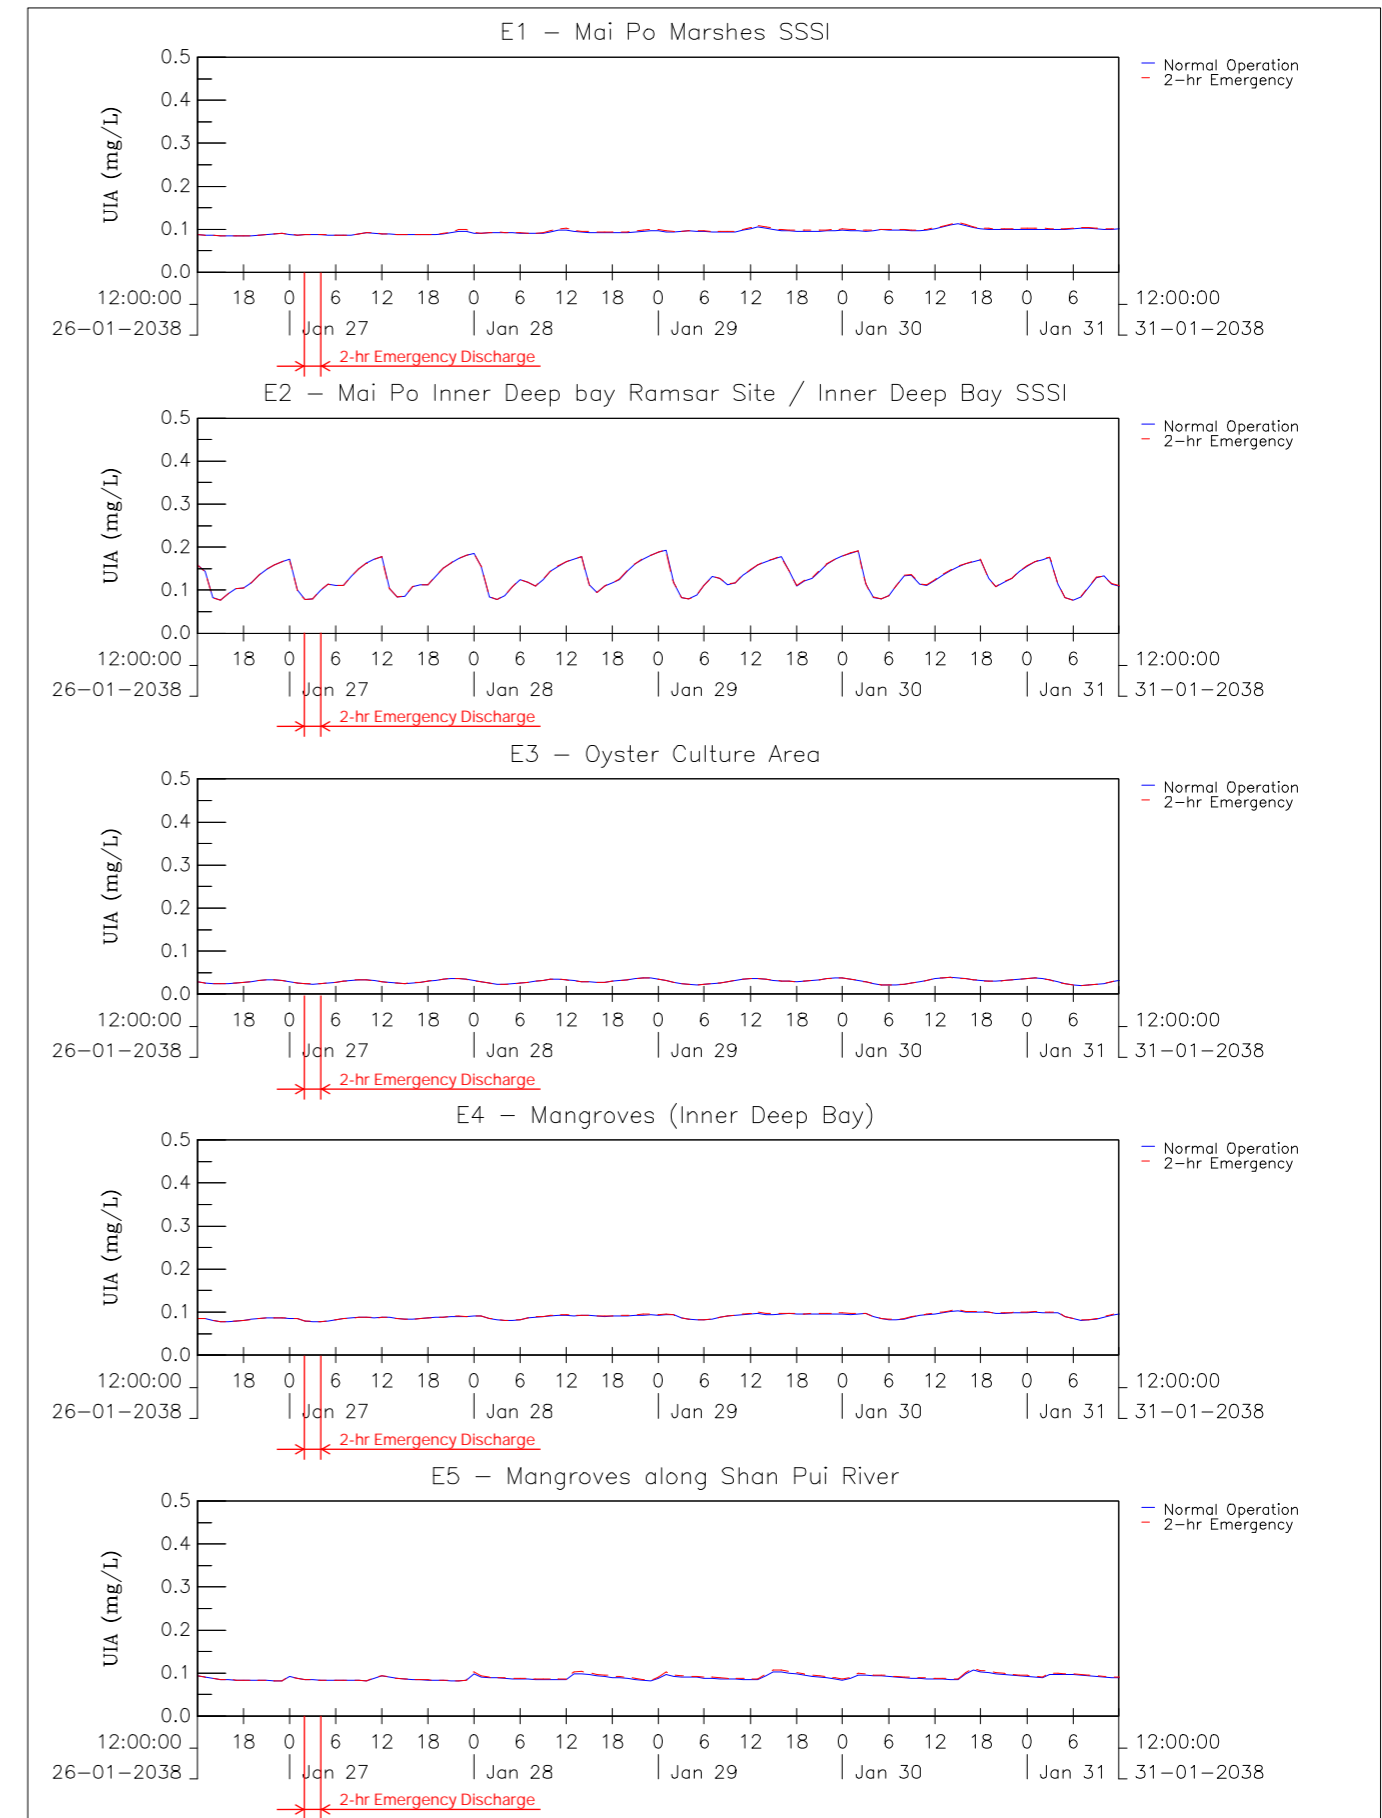
Agreement No. CE 6/2019 (DS) Hung Shui Kiu Effluent Polishing Plant and Yuen Long South Effluent Polishing Plant – Investigation Timeseries Plots for Depth Averaged Unionised Ammonia (mg/L) Blue: Normal Operation of YLSEPP (Scenario 1); Dashed Red: 2-hr Emergency Discharge from YLSEPP (Scenario 2)	Emergency	Dry Season
	Appendix 5.6 – 04	
AECOM	/GPP/	emergency-d.ssn

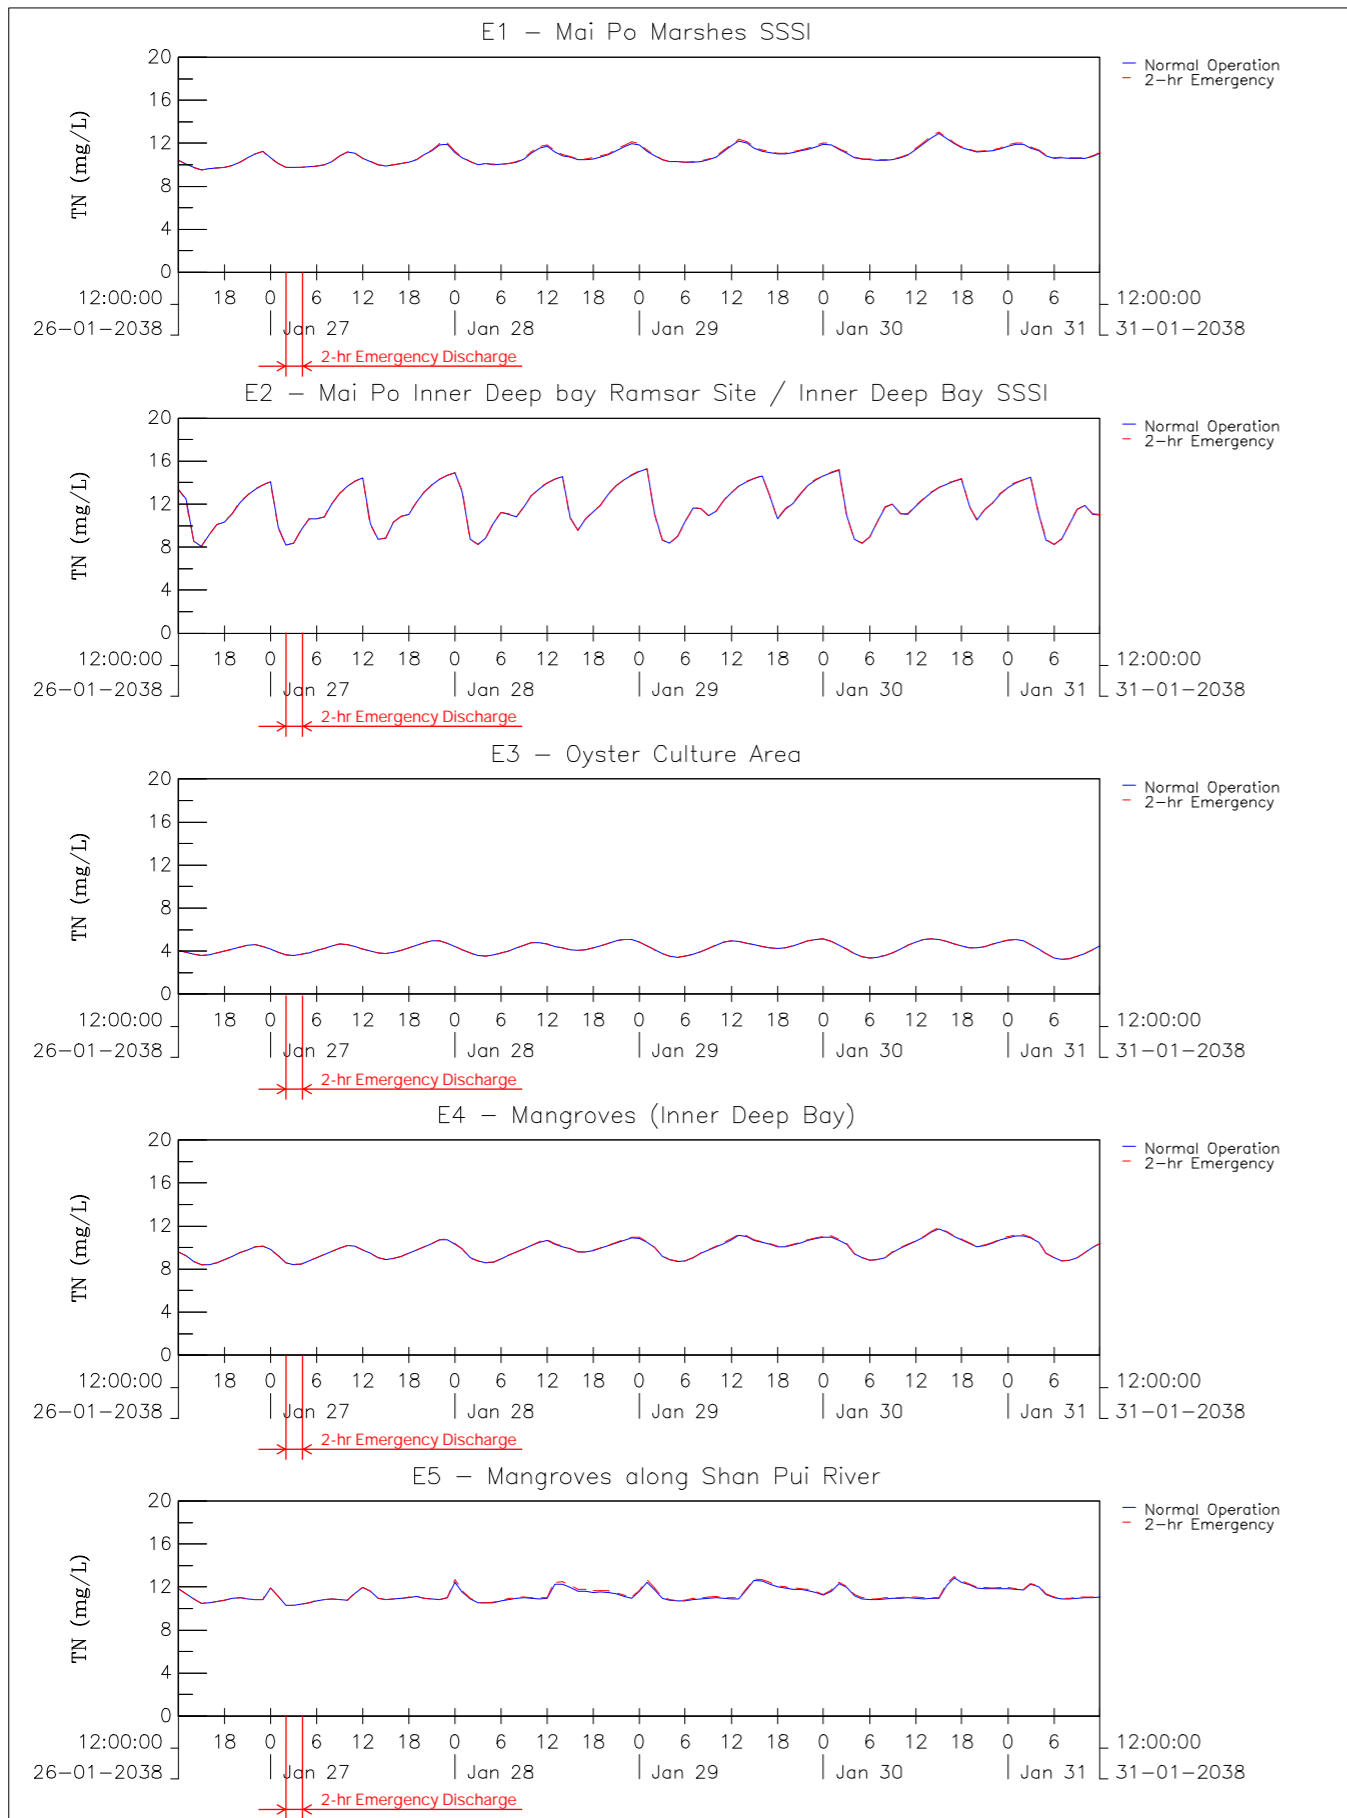
Agreement No. CE 6/2019 (DS) Hung Shui Kiu Effluent Polishing Plant and Yuen Long South Effluent Polishing Plant – Investigation Timeseries Plots for Depth Averaged Total Nitrogen (mg/L) Blue: Normal Operation of YLSEPP (Scenario 1); Dashed Red: 2-hr Emergency Discharge from YLSEPP (Scenario 2)	Emergency	Dry Season
	Appendix 5.6 – 05	
AECOM	/GPP/	emergency-d.ssn

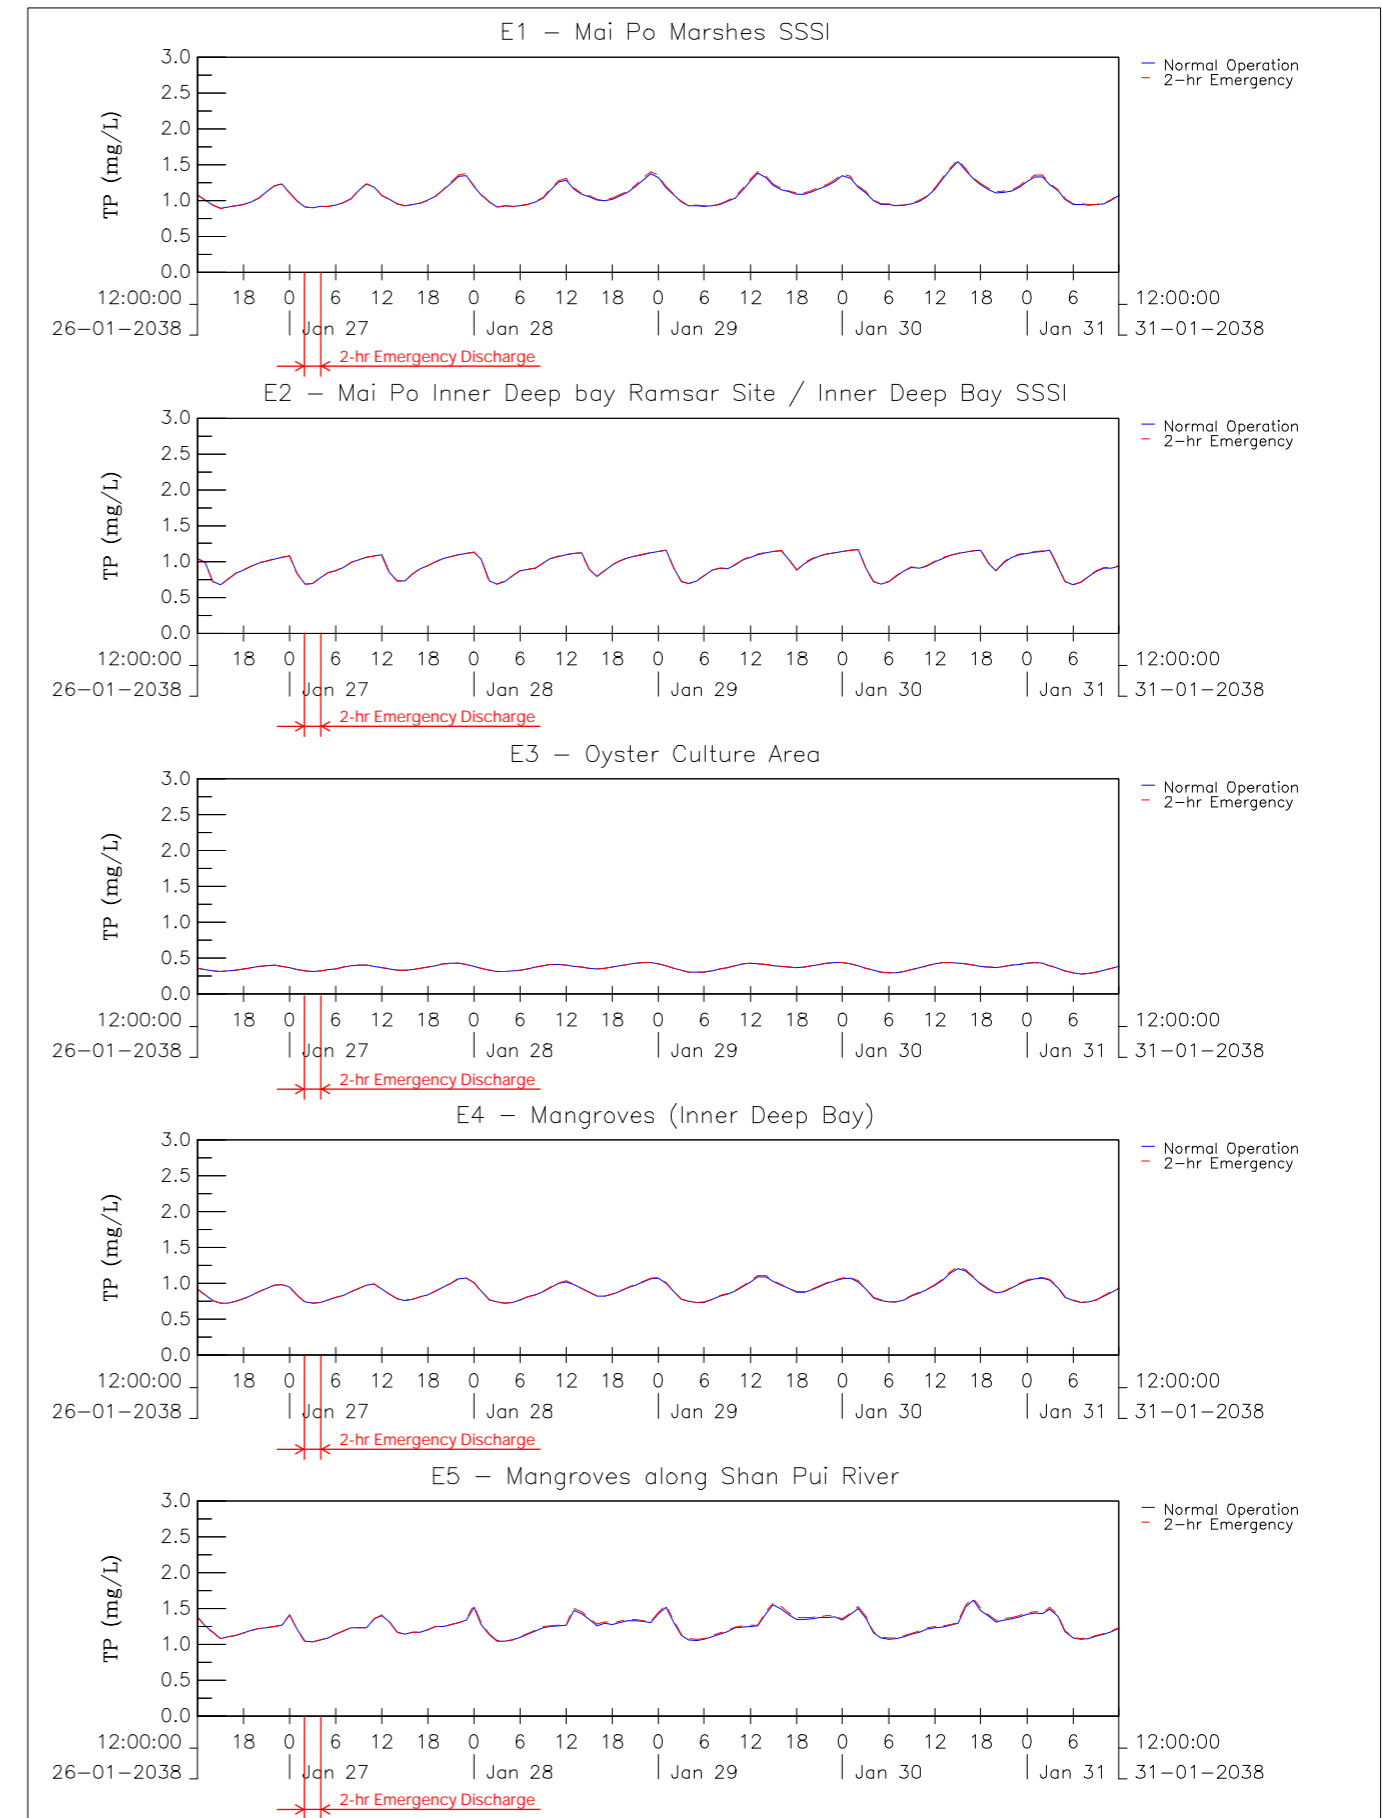
Agreement No. CE 6/2019 (DS) Hung Shui Kiu Effluent Polishing Plant and Yuen Long South Effluent Polishing Plant – Investigation Timeseries Plots for Depth Averaged Total Phosphorus (mg/L) Blue: Normal Operation of YLSEPP (Scenario 1); Dashed Red: 2-hr Emergency Discharge from YLSEPP (Scenario 2)	Emergency	Dry Season
	Appendix 5.6 – 06	
AECOM	/GPP/	emergency-d.ssn

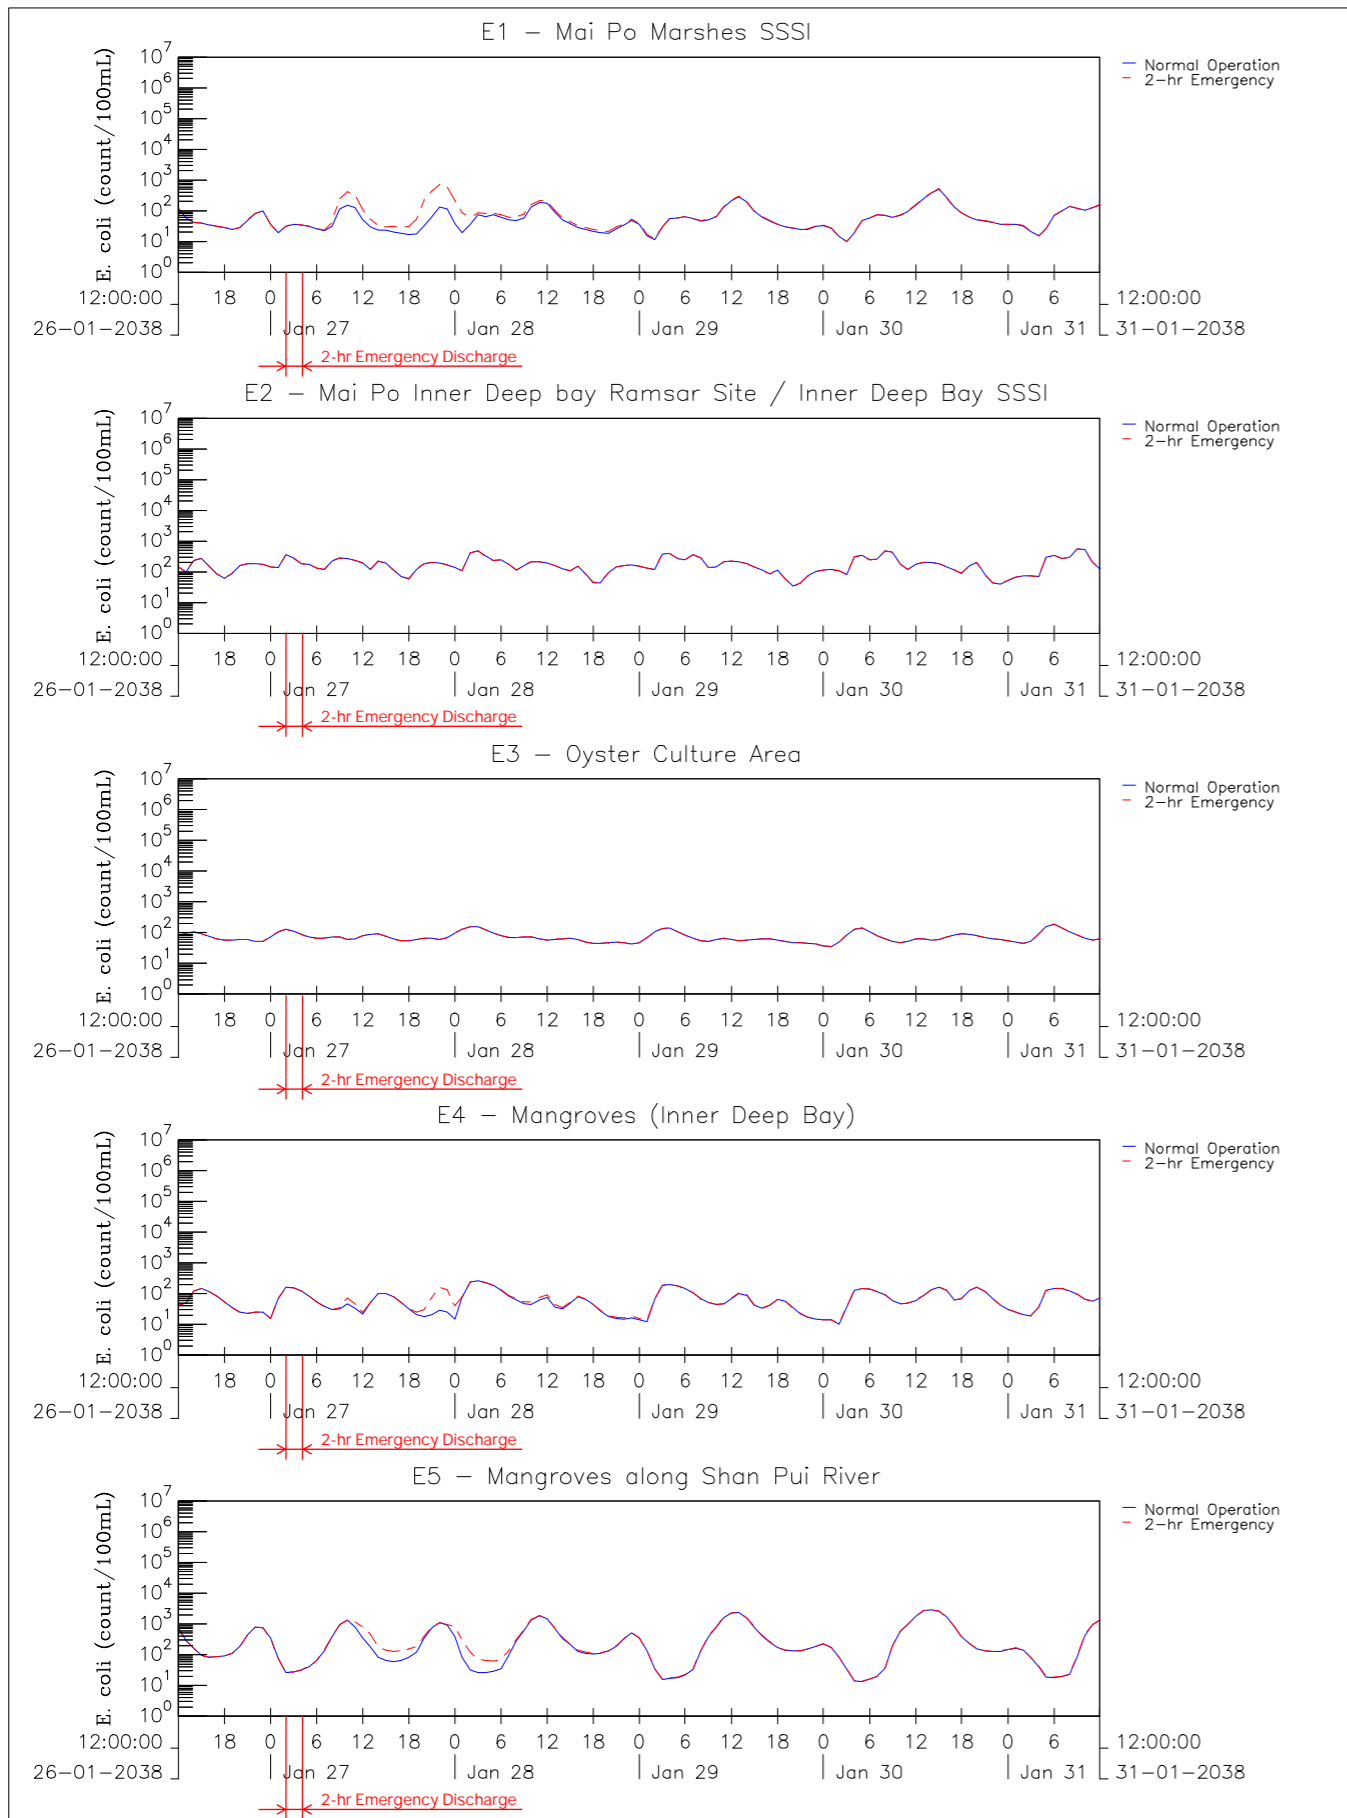
Agreement No. CE 6/2019 (DS) Hung Shui Kiu Effluent Polishing Plant and Yuen Long South Effluent Polishing Plant – Investigation Timeseries Plots for Depth Averaged E.coli (count/100mL) Blue: Normal Operation of YLSEPP (Scenario 1); Dashed Red: 2-hr Emergency Discharge from YLSEPP (Scenario 2)	Emergency	Dry Season
	Appendix 5.6 – 07	
AECOM	/GPP/	emergency-d.ssn

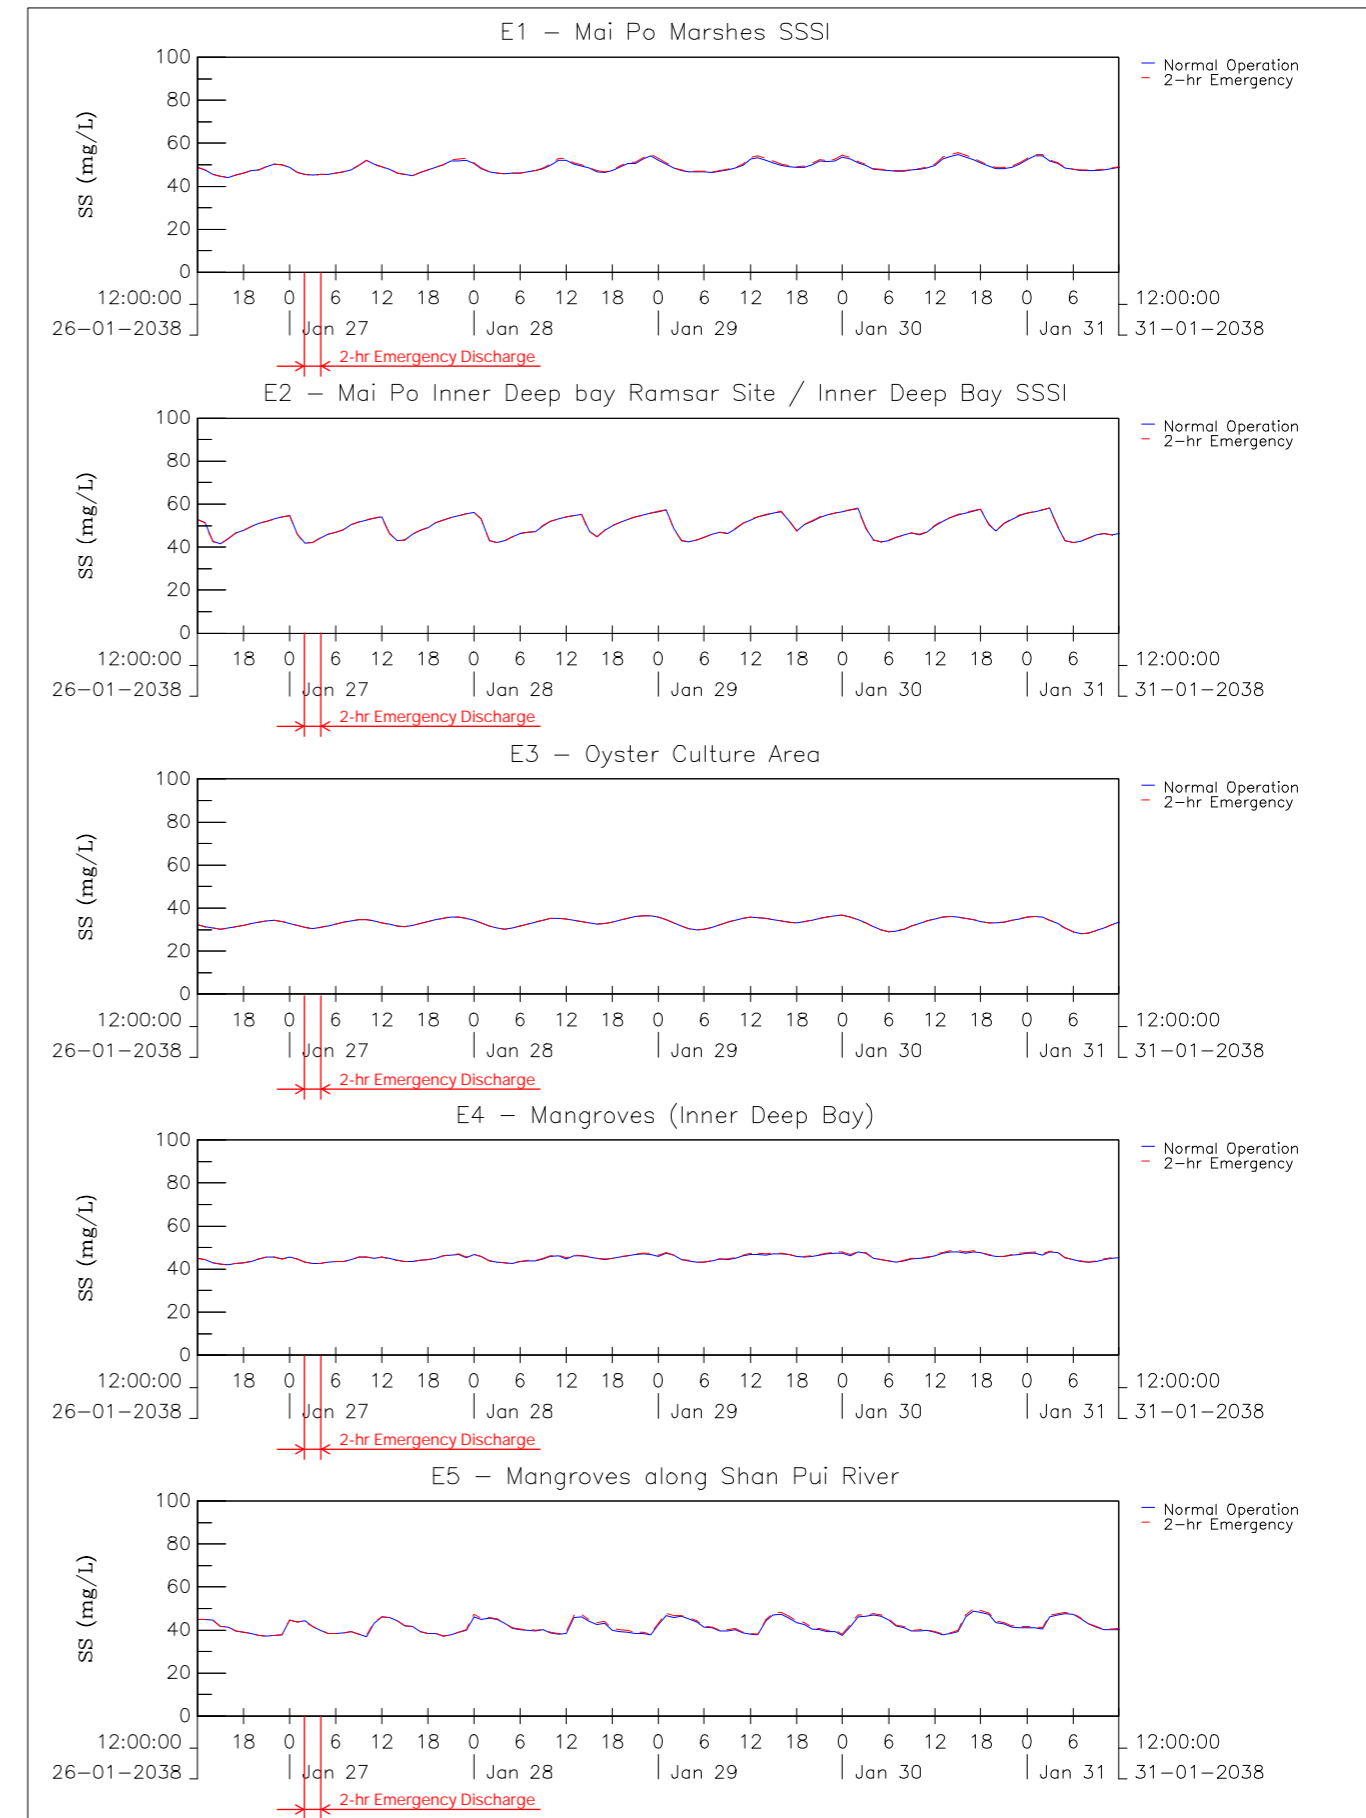
Agreement No. CE 6/2019 (DS) Hung Shui Kiu Effluent Polishing Plant and Yuen Long South Effluent Polishing Plant – Investigation Timeseries Plots for Depth Averaged Suspended Solids (mg/L) Blue: Normal Operation of YLSEPP (Scenario 1); Dashed Red: 2-hr Emergency Discharge from YLSEPP (Scenario 2)	Emergency	Dry Season
	Appendix 5.6 – 08	
AECOM	/GPP/	emergency-d.ssn
