Project title  
 Agreement No. CE 13/2021 (HY)  
 Route 11 (Section between Yuen Long and North Lantau)  
 - Investigation.

Drawing title  
**PHOTOMONTAGE OF VP-SK22 PEDESTRIANS ON FOOTBRIDGE OVER TAI LAM CHUNG RIVER**

Drawing no. <b>FIGURE 11.10.13</b>		Rev. <b>C</b>	
Drawn	Date	Checked	Approved
RY	10/21	IL	SK
Scale		Status	
		PRELIMINARY

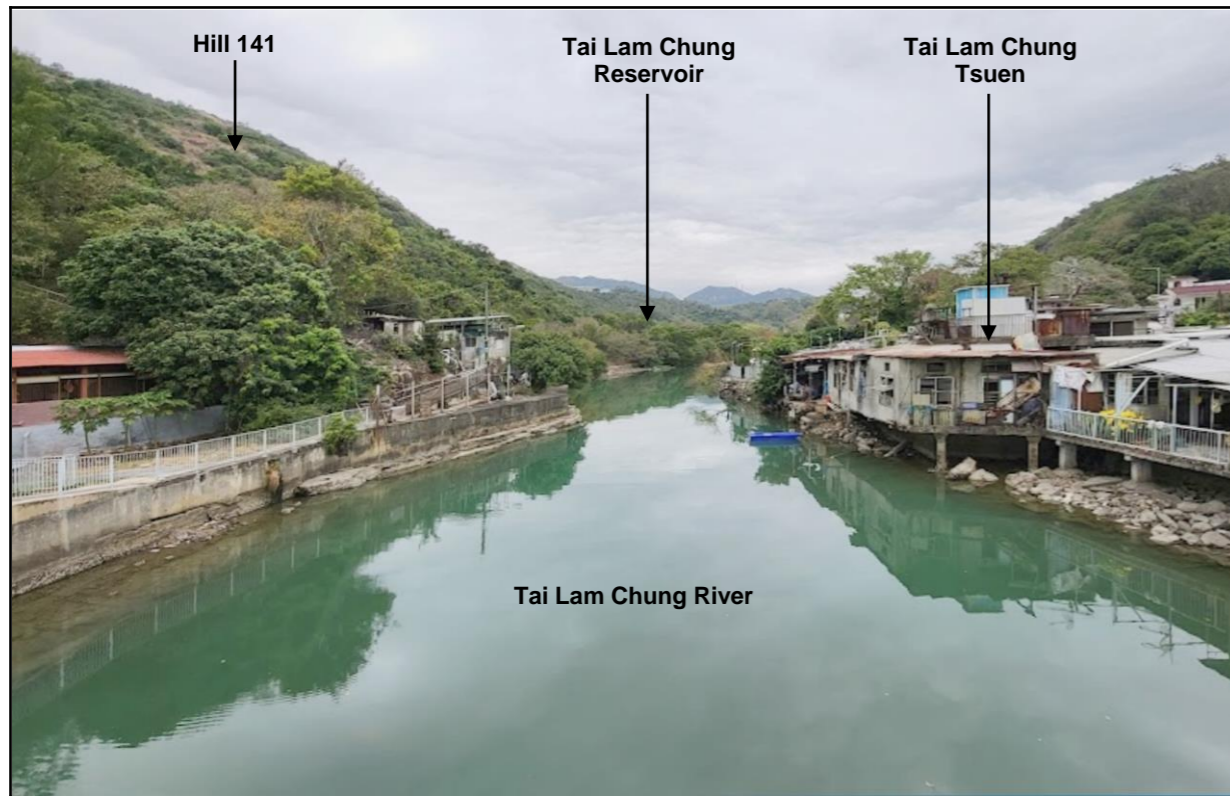
VP-SK22 – EXISTING CONDITION

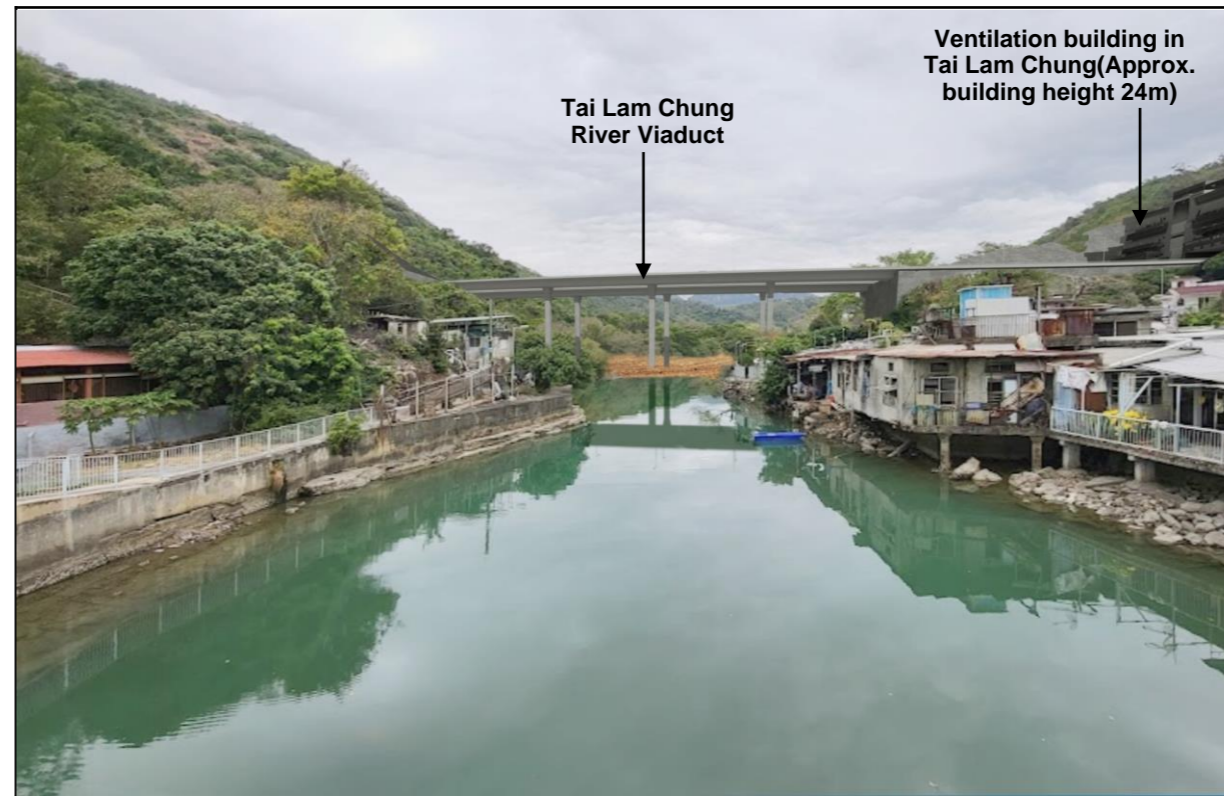
DAY 1 WITHOUT MITIGATION MEASURE

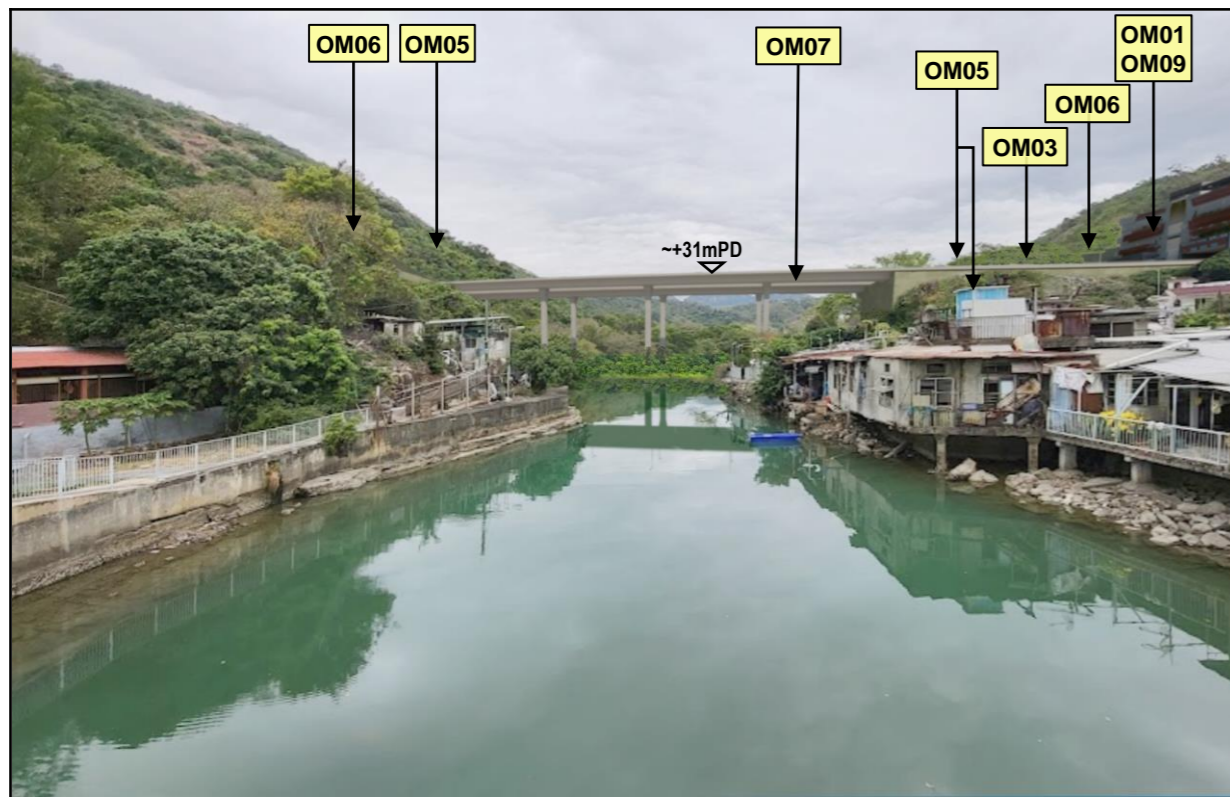
DAY 1 WITH MITIGATION MEASURE

CM01	Tree Protection and Preservation
CM02	Tree Transplantation
CM03	Works Area and Temporary Works Areas
CM04	Advance Implementation of Mitigation Planting
CM05	Decorative Screen Hoarding
CM06	Control of night-time lighting
OM01	Integrated Design Approach
OM02	Roadside Planting
OM03	Compensatory Planting Proposals
OM04	Post-Planting Monitoring
OM05	Greening Works on Slopes and associated Structure
OM06	Design of Tunnel Portals and landscape treatment
OM07	Design of an Elegant Bridge Structure and Approach Roads
OM08	Provision of Visually Pleasing Aesthetic Treatment of Noise Mitigation Measures
OM09	Provision of Green Roof

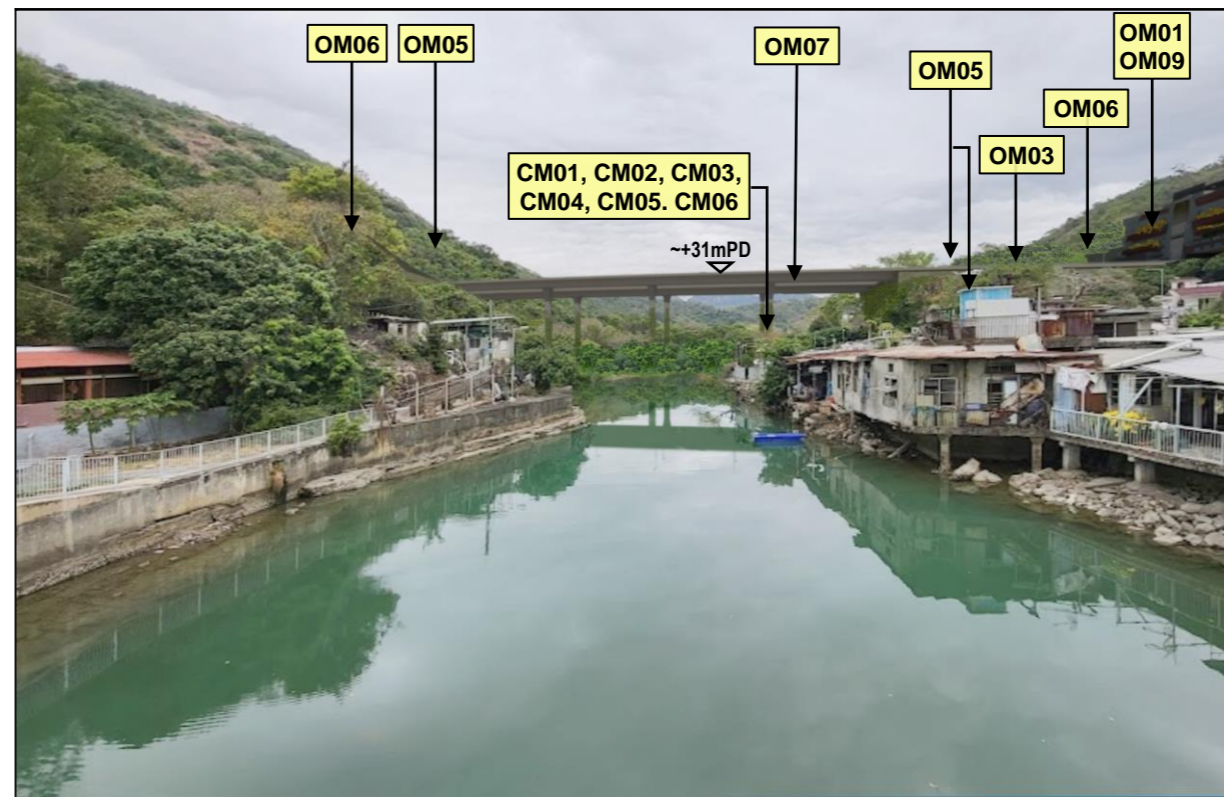
10 YEARS WITH MITIGATION MEASURE
