Project title
Agreement No. CE 13/2021 (HY)
Route 11 (Section between Yuen Long and North Lantau)
- Investigation.

Drawing title
PHOTOMONTAGE OF VP-TL1 VEHICLE TRAVELLERS ON TUEN MUN ROAD (WESTBOUND)

Drawing no. FIGURE 11.10.16		Rev. C	
Drawn RY	Date 10/21	Checked IL	Approved SK
Scale		Status PRELIMINARY

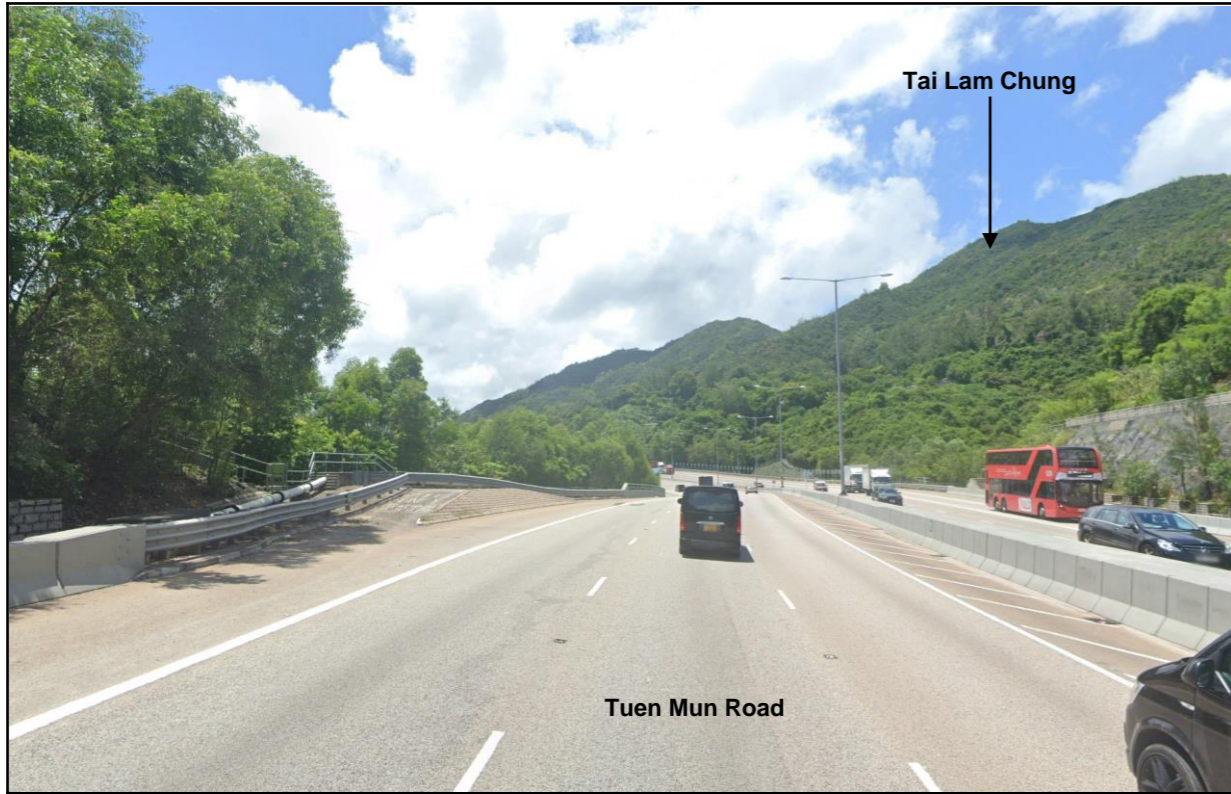
VP-TL1 – EXISTING CONDITION

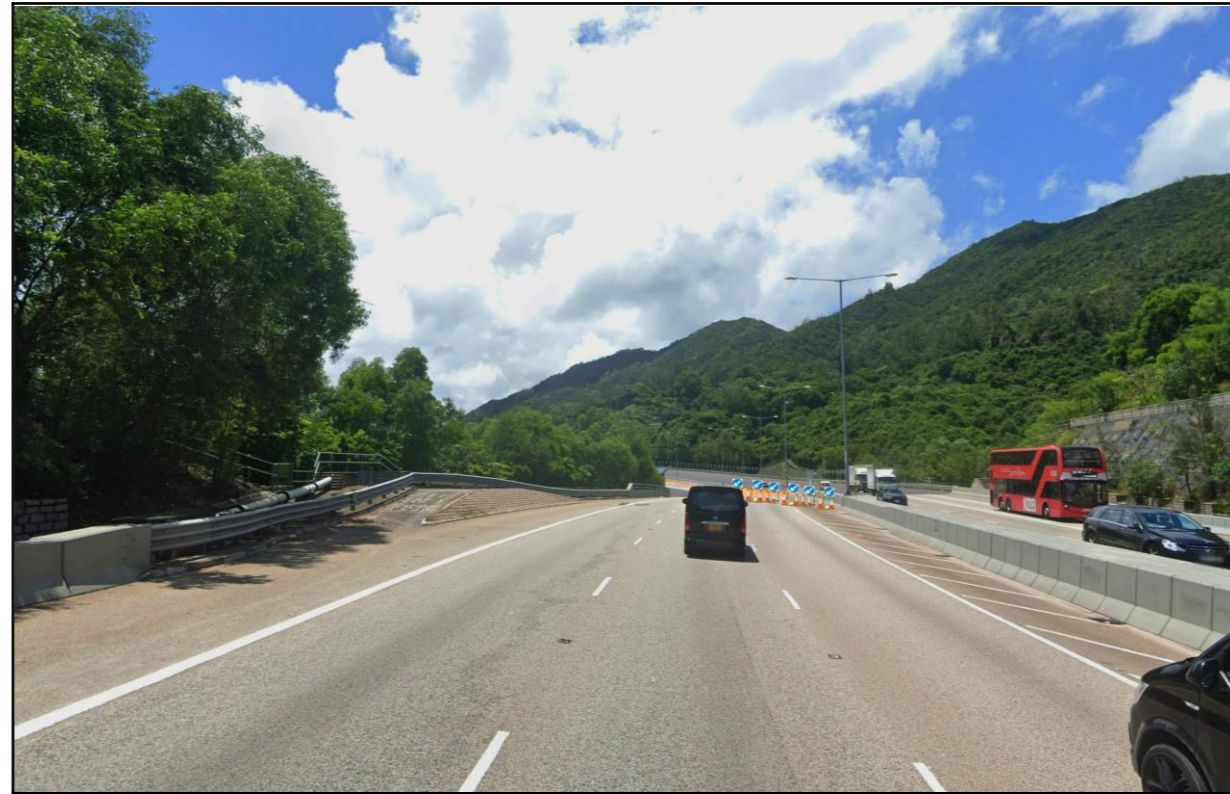
DAY 1 WITHOUT MITIGATION MEASURE

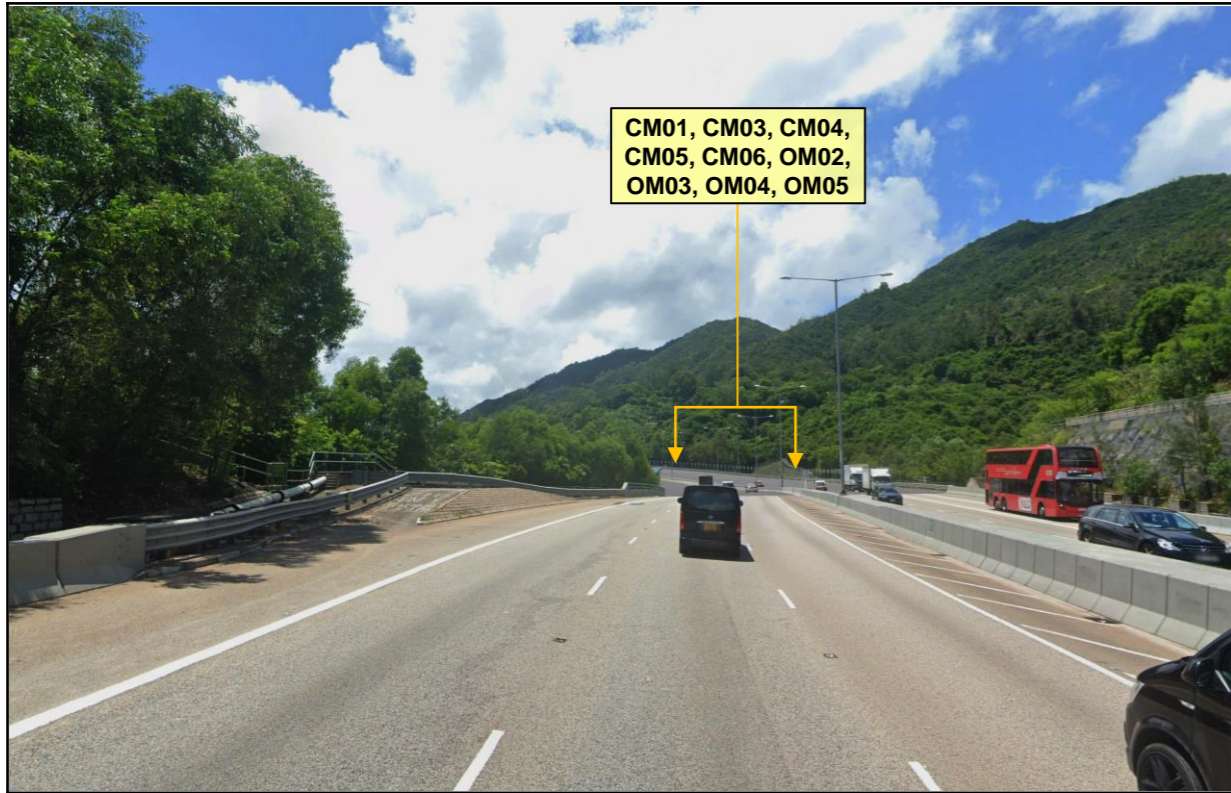
DAY 1 WITH MITIGATION MEASURE

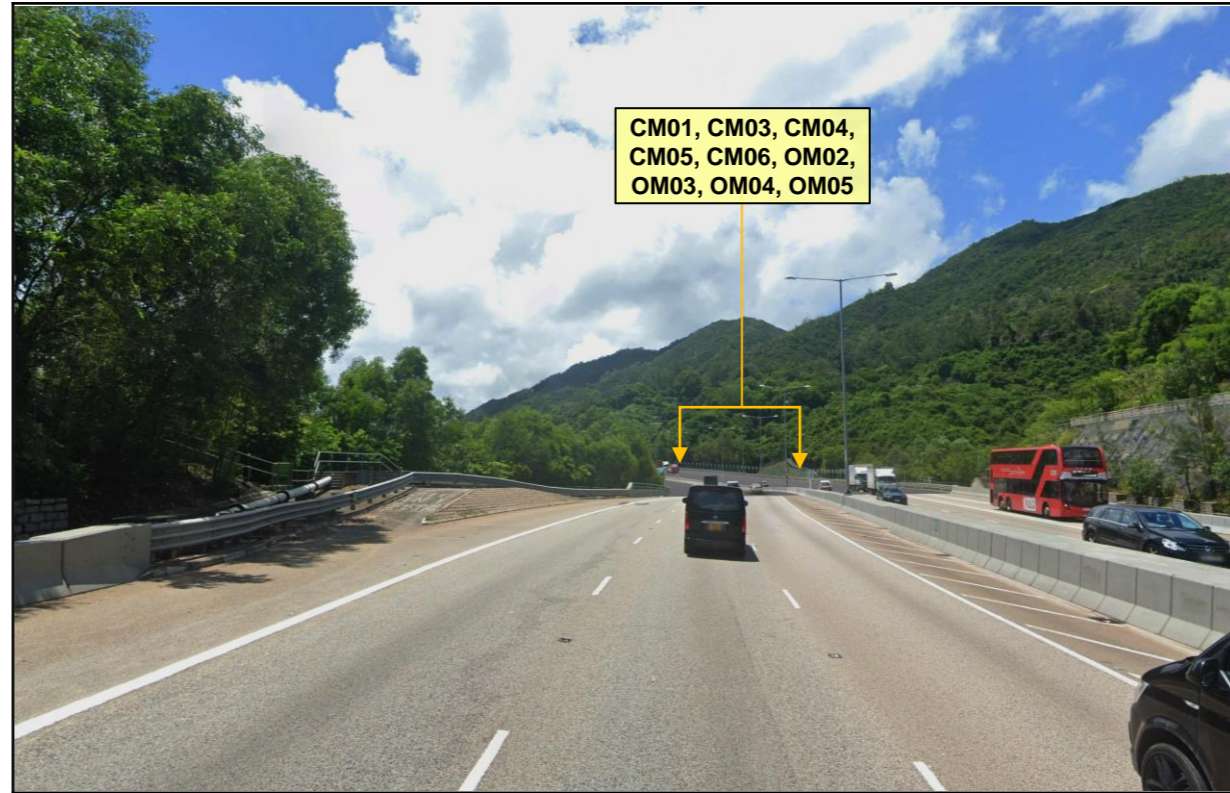
10 YEARS WITH MITIGATION MEASURE
