Project title  
AGREEMENT NO. CE 1/2021(HY)  
IMPROVEMENT TO SO KWUN PO INTERCHANGE –  
INVESTIGATION, DESIGN AND CONSTRUCTION

Drawing title  
PHOTOMONTAGE VIEWPOINT 01

Drawing no.	FIGURE 9.8.1	Rev.	0
Drawn	Date APR 2022	Checked BN	Approved CL
Scale	N.T.S	Status	FOR INFORMATION

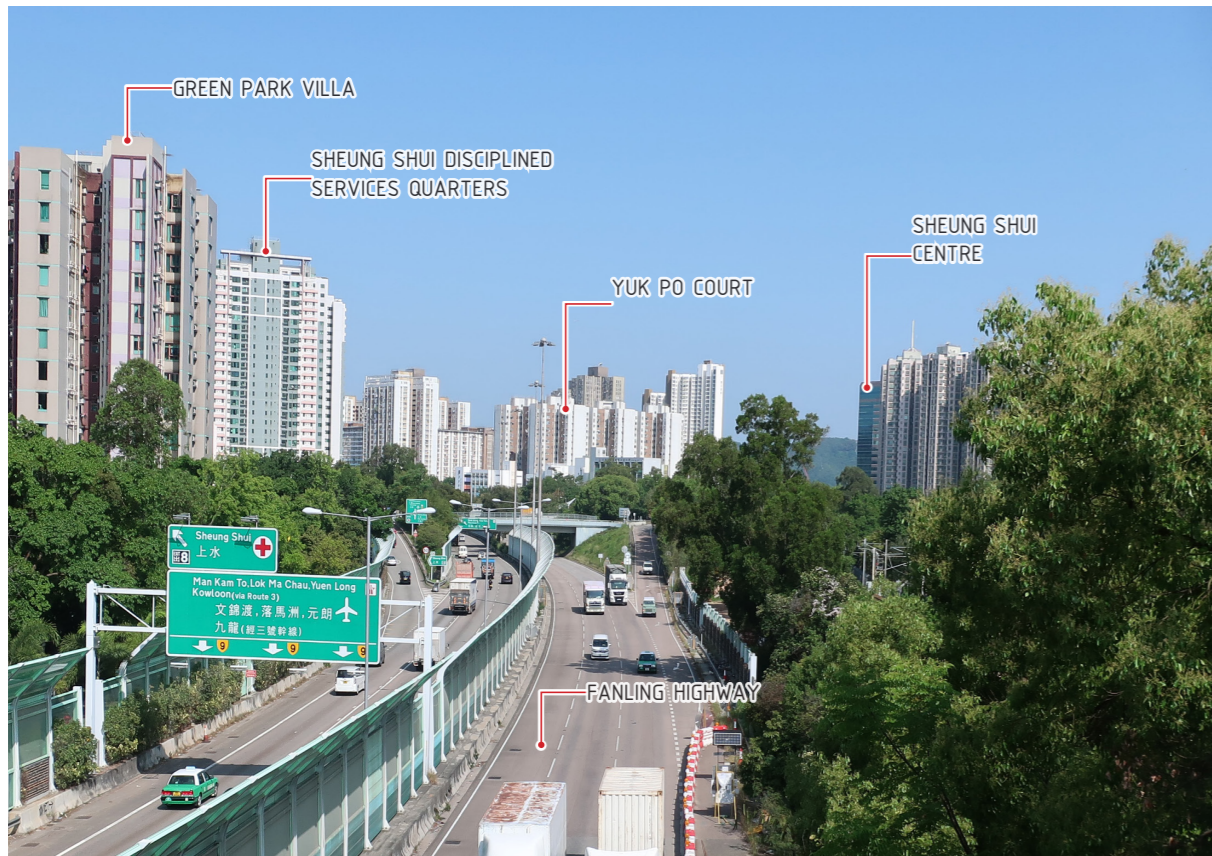
VP01 - FOOTBRIDGE AT FANLING HIGHWAY  
EXISTING CONDITION

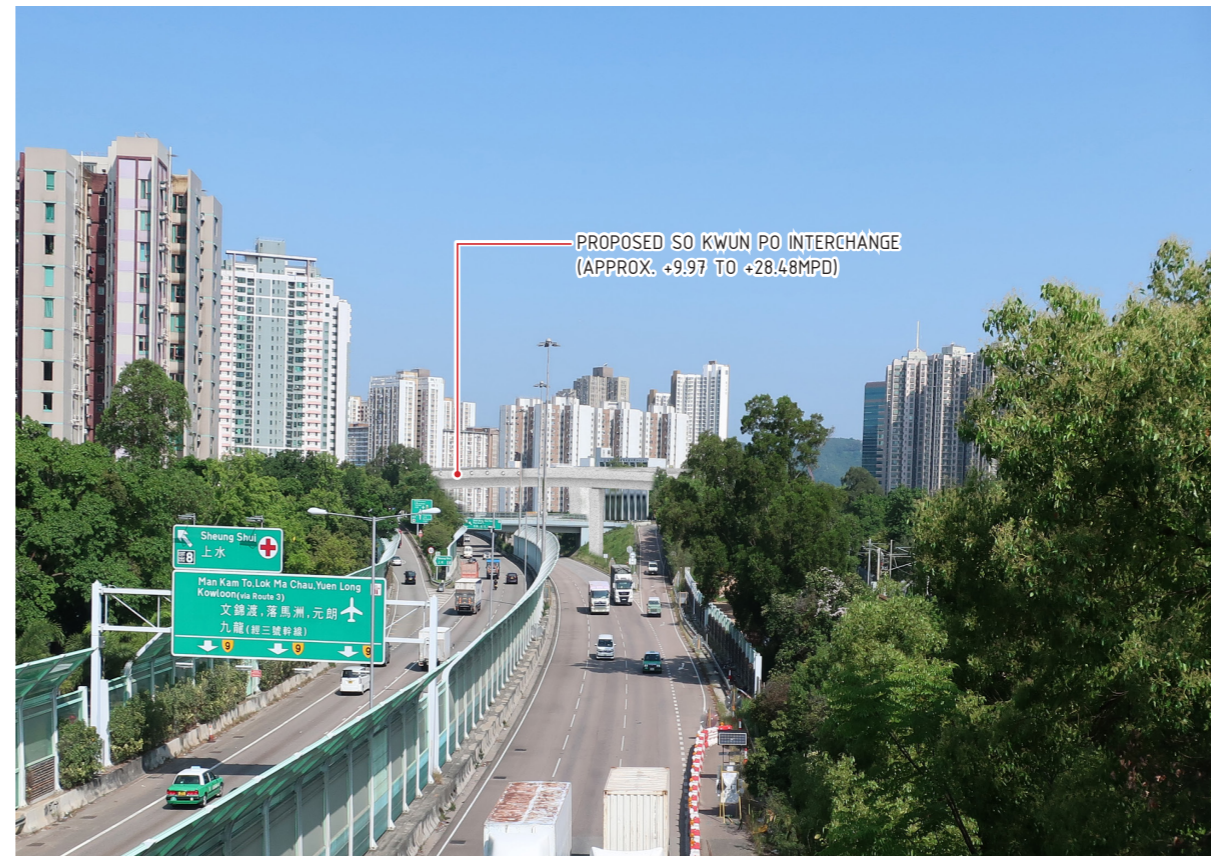
VP01 - FOOTBRIDGE AT FANLING HIGHWAY  
WITHOUT MITGATION MEASURES

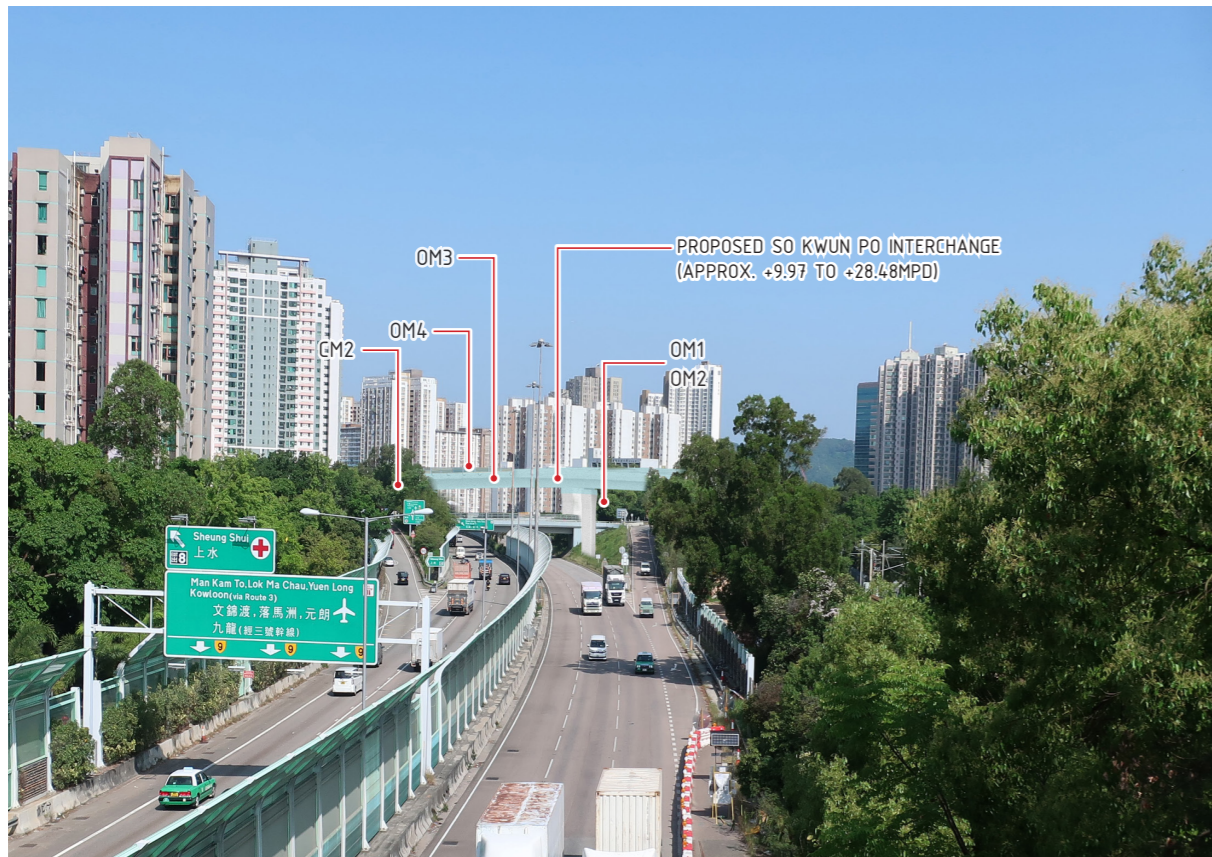
VP01 - FOOTBRIDGE AT FANLING HIGHWAY  
DAY 1 WITH MITGATION MEASURES

MITIGATION MEASURES (CONSTRUCTION PHASE)			
CM1	Re-provisioned Cycle Track and Footpath	CM5	Good Site Practice
CM2	Preservation of Existing Vegetation	CM6	Erection of Decorative Screen Hoarding
CM3	Transplanting of Affected Trees	CM7	Reinstatement of Temporarily Disturbed Landscape Areas
CM4	Control of Night-time Lighting Glare

MITIGATION MEASURES (OPERATION PHASE)	
OM1	Compensatory Tree Planting
OM2	Roadside Planting
OM3	Aesthetically pleasing design for carriageways and other highways structures
OM4	Provision of Aesthetic Pleasing Treatment on Noise Barriers

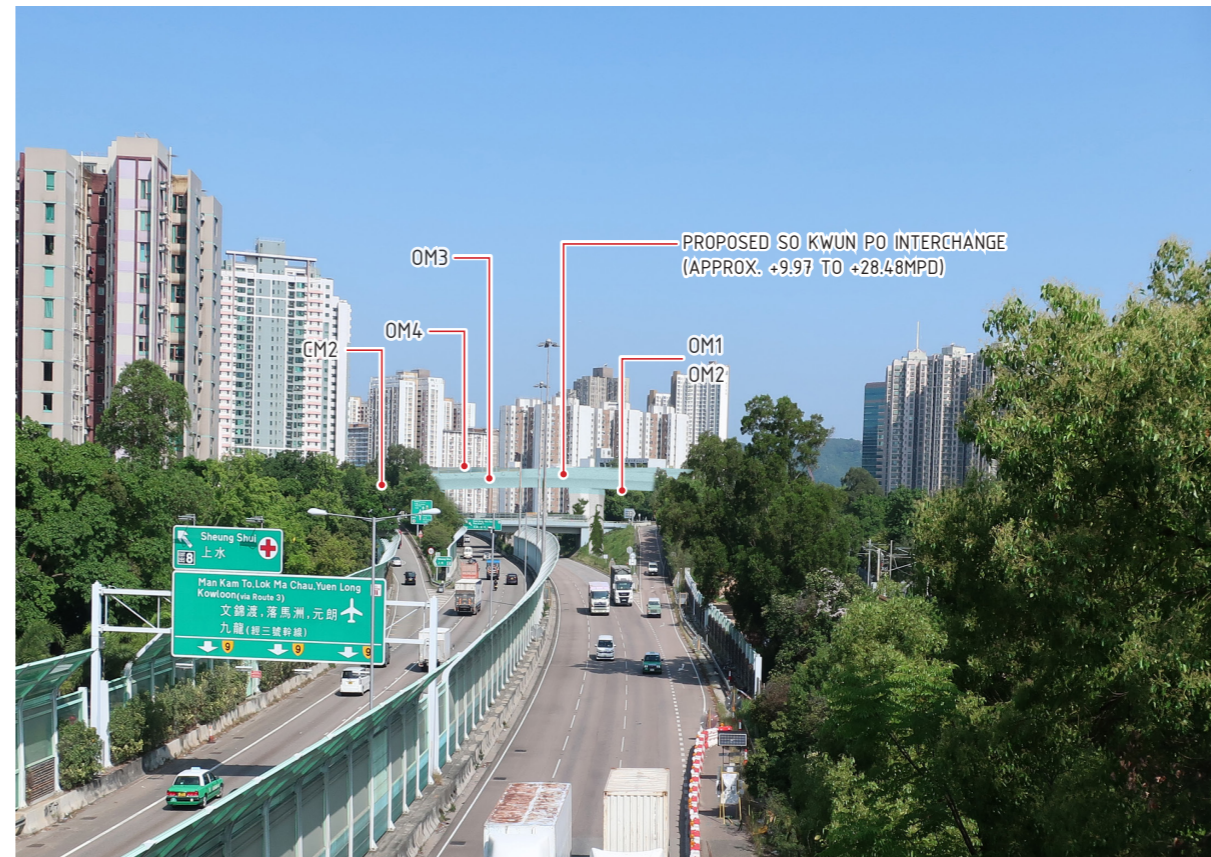
VP01 - FOOTBRIDGE AT FANLING HIGHWAY  
YEAR 10 WITH MITGATION MEASURES
