Project title  
AGREEMENT NO. CE 1/2021(HY)  
IMPROVEMENT TO SO KWUN PO INTERCHANGE –  
INVESTIGATION, DESIGN AND CONSTRUCTION

Drawing title  
PHOTOMONTAGE VIEWPOINT 09

Drawing no.	FIGURE 9.8.9	Rev.	0
Drawn	Date APR 2022	Checked BN	Approved CL
Scale	N.T.S	Status	FOR INFORMATION

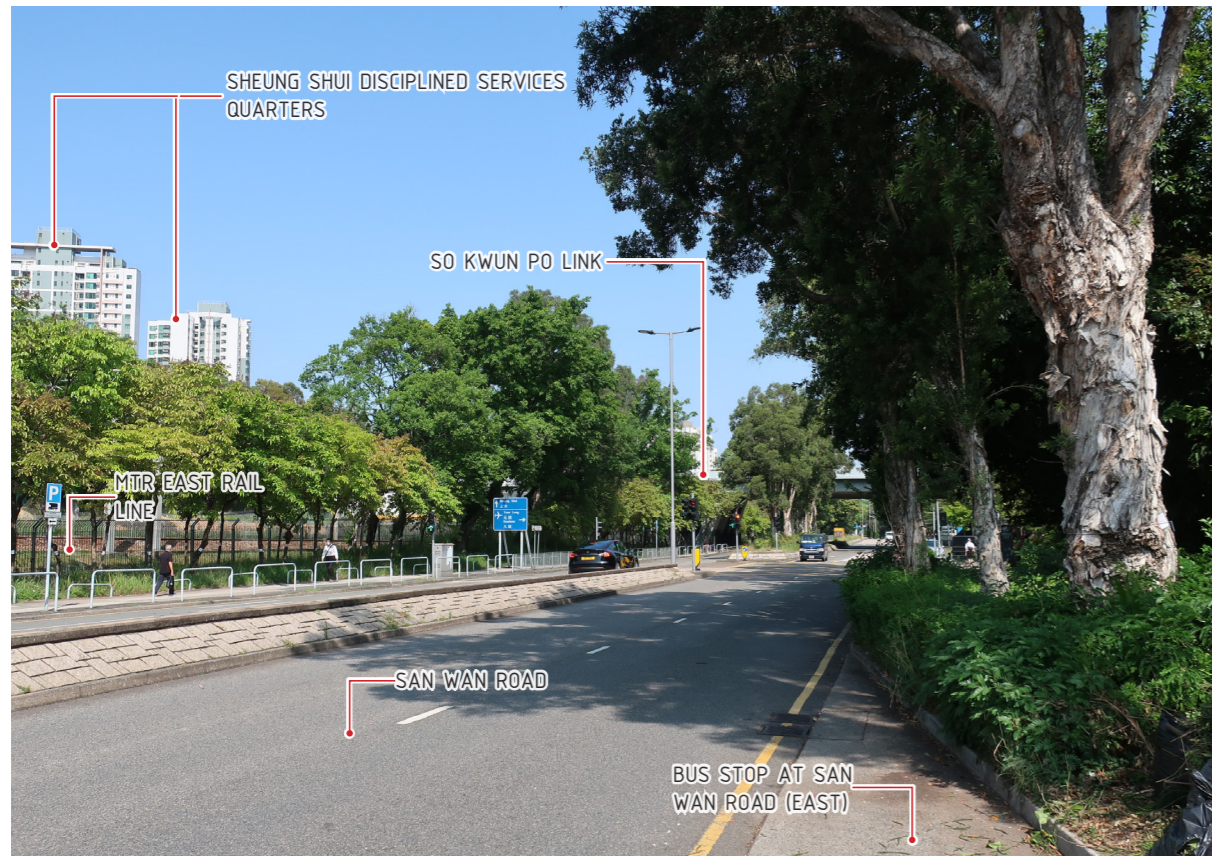
VP09 - BUS STOP AT SAN WAN ROAD (EAST)  
EXISTING CONDITION

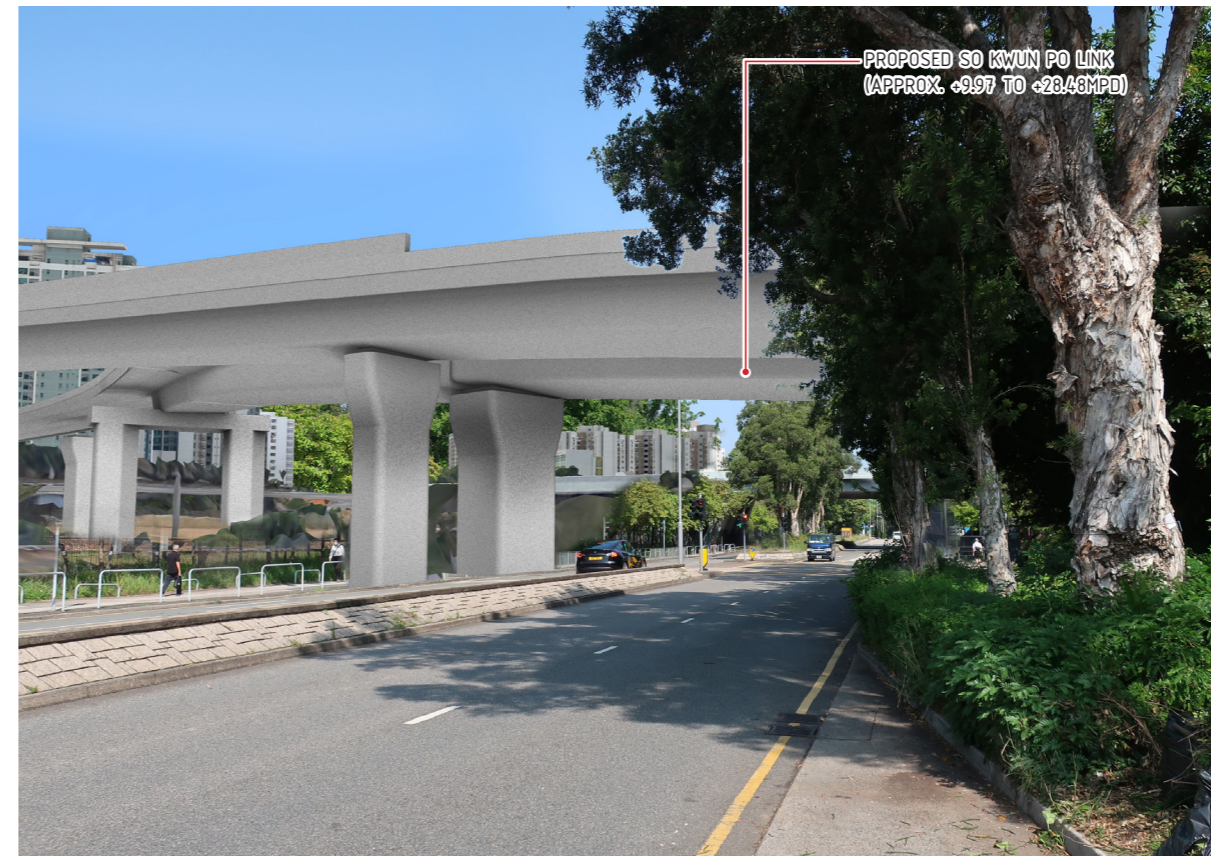
VP09 - BUS STOP AT SAN WAN ROAD (EAST)  
WITHOUT MITGATION MEASURES

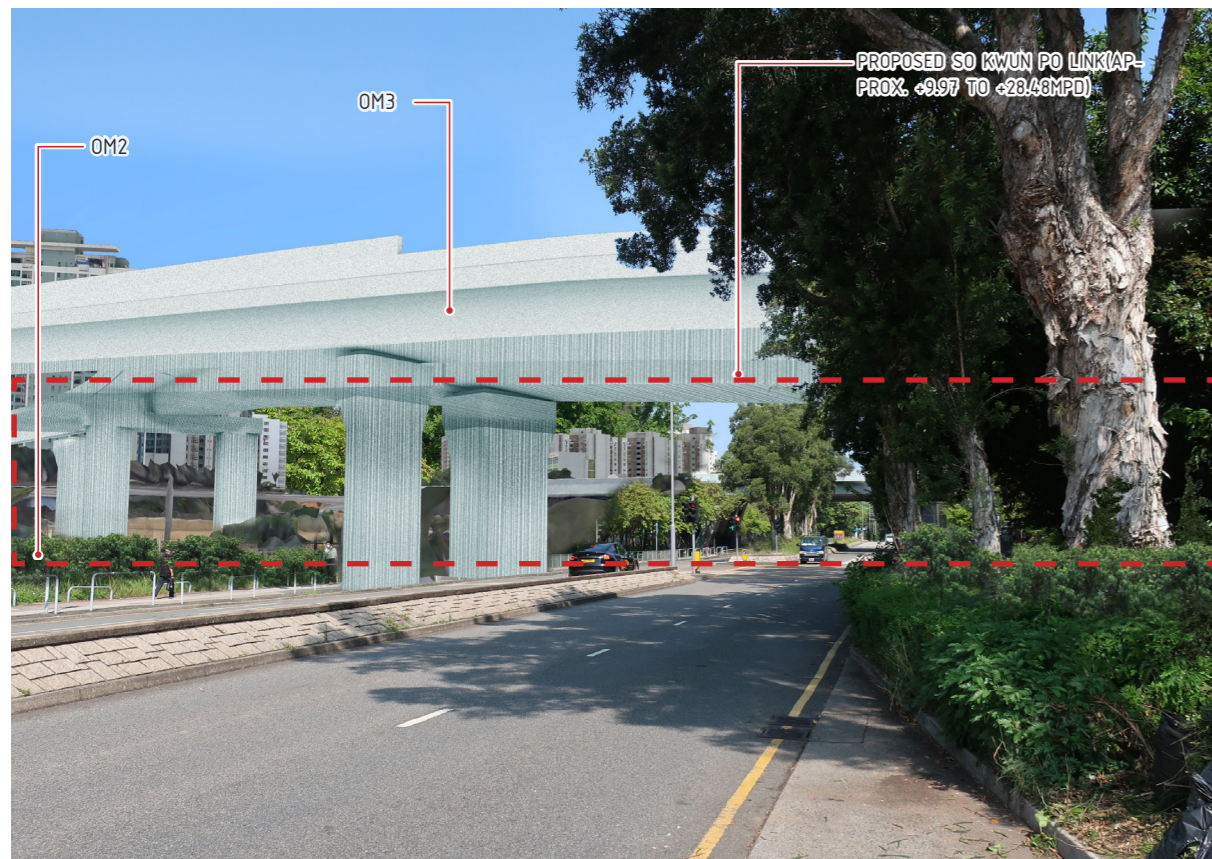
VP09 - BUS STOP AT SAN WAN ROAD (EAST)  
DAY 1 WITH MITGATION MEASURES

MITIGATION MEASURES (CONSTRUCTION PHASE)			
CM1	Re-provisioned Cycle Track and Footpath	CM5	Good Site Practice
CM2	Preservation of Existing Vegetation	CM6	Erection of Decorative Screen Hoarding
CM3	Transplanting of Affected Trees	CM7	Reinstatement of Temporarily Disturbed Landscape Areas
CM4	Control of Night-time Lighting Glare

MITIGATION MEASURES (OPERATION PHASE)	
OM1	Compensatory Tree Planting
OM2	Roadside Planting
OM3	Aesthetically pleasing design for carriageways and other highways structures
OM4	Provision of Aesthetic Pleasing Treatment on Noise Barriers

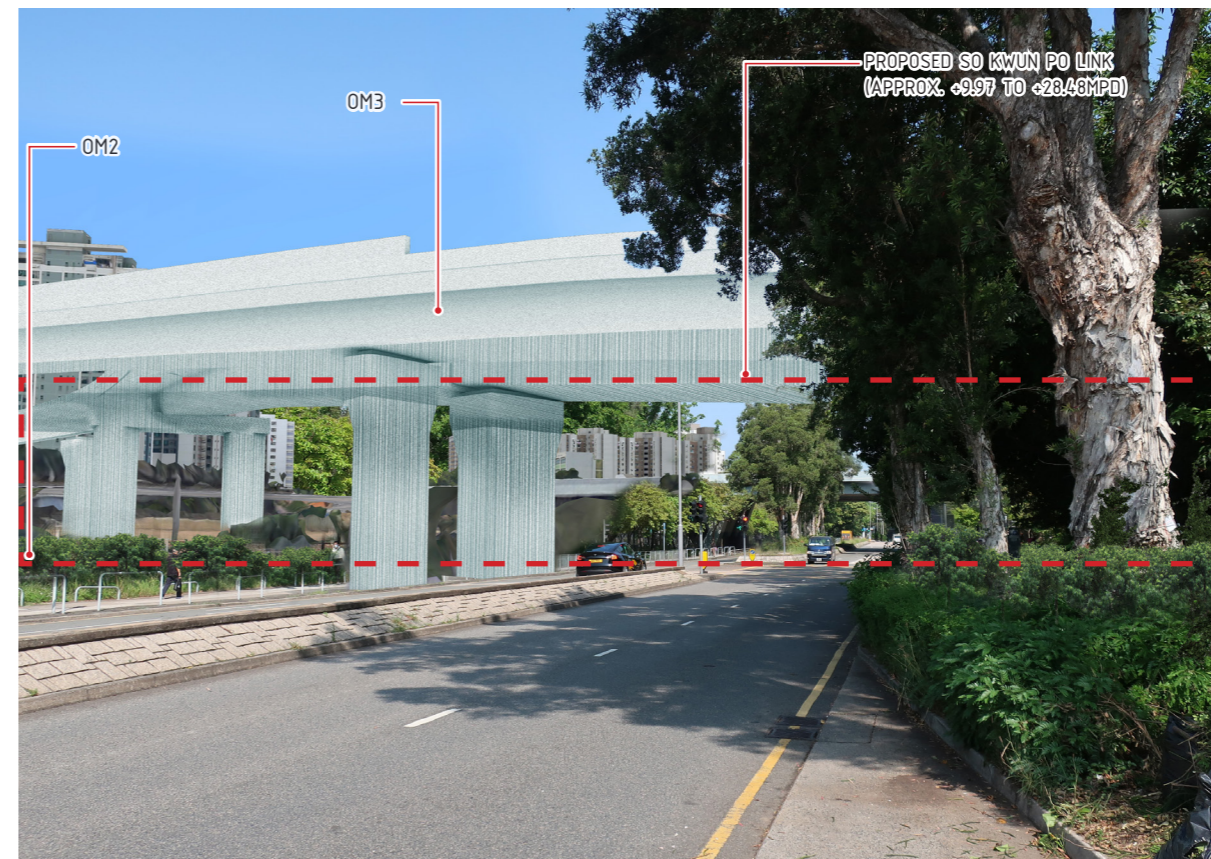
VP09 - BUS STOP AT SAN WAN ROAD (EAST)  
YEAR 10 WITH MITGATION MEASURES
