Figure 4.1, 4.1a and 4.1b
Potential Land Contaminated Area

PROJECT
 WIDENING OF YUEN LONG HIGHWAY
 (SECTION BETWEEN LAM TEI AND TONG YAN SAN TSUEN)

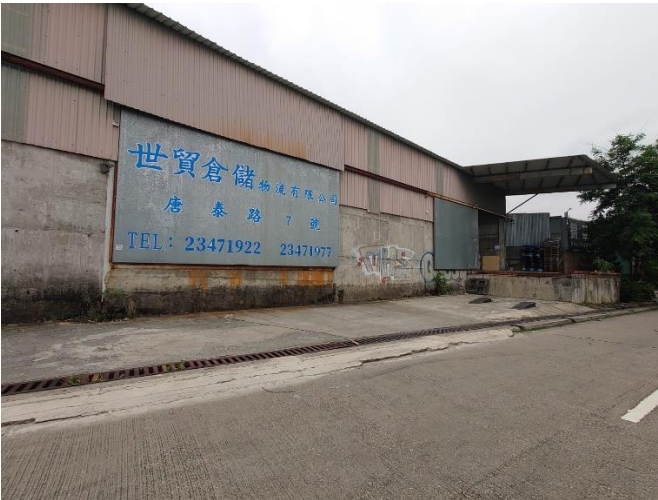
Potential Contaminated Site ID	Premise Name and Location (Approx. Site Area, m ²)	Suspected Current Use	Approx. Area encroaching the Project Limit (m ²)	Site Observation	Potential Polluting Activities and Potential Chemical of Concern (COC)	Sampling and analysis proposal	Photo Reference
C1 ^	No.7 Tong Tai Road, Tong Yan San Tsuen, Yuen Long (1868 m ²)	Warehouse	73	The site is a temporary structure. The site occupant is World Trade Warehousing Logistics Limited. The site was in operation. Loading and unloading activities of goods was observed. Access for site inspection was not available.	N/A	N/A

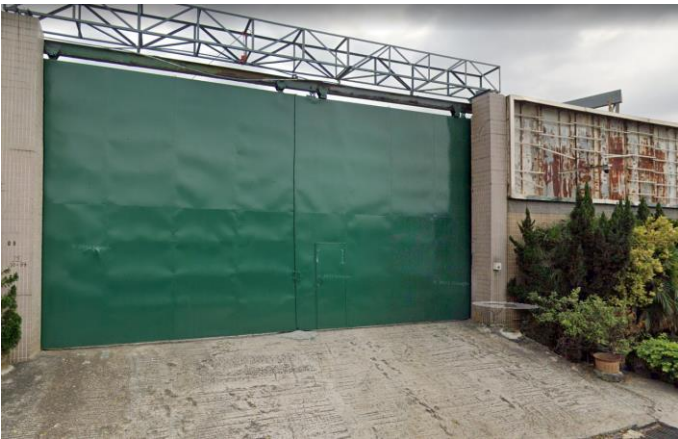
C2 ^	No.9 Tong Tai Road, Tong Yan San Tsuen, Yuen Long (1546 m ²)	Warehouse	160	The site gate was close and not in operation. The site occupant is unknown. The site gate was closed. Access for site inspection was not available.	N/A	N/A

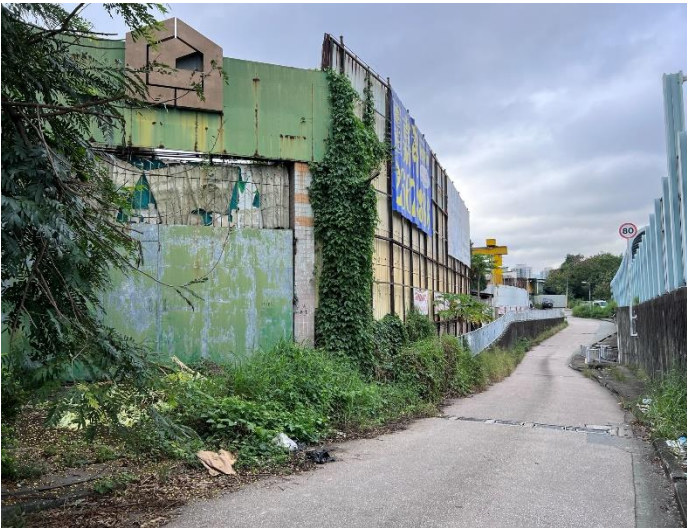
C3 ^	Temporary structure at Tong Tai Road, next to No. 9 Tong Tai Road (960m ²)	Warehouse	158	The site gate was close and not in operation. The site occupant is unknown. The site gate was closed. Access for site inspection was not available.	N/A	N/A

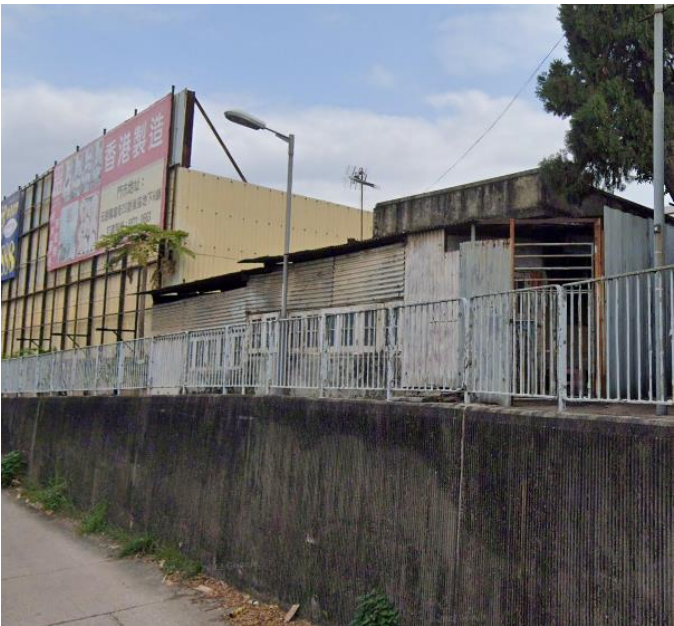
Potential Contaminated Site ID	Premise Name and Location (Approx. Site Area, m ²)	Suspected Current Use	Approx. Area encroaching the Project Limit (m ²)	Site Observation	Potential Polluting Activities and Potential Chemical of Concern (COC)	Sampling and analysis proposal	Photo Reference
C4 ^	Temporary structure at Tong Tai Road (333m ²)	Warehouse	97	The site gate was close and not in operation. The site occupant is unknown. The site gate was closed. Access for site inspection was not available.	N/A	N/A

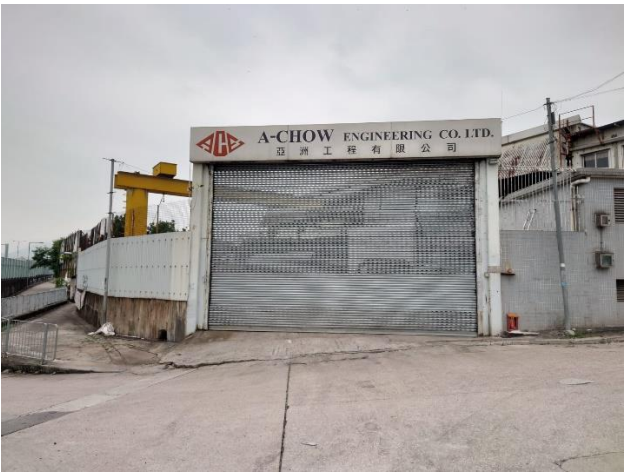
C5 ^	78 Tong Yan San Tsuen Road, Yuen Long (5043m ²)	Construction materials and equipment storage	92	The site occupant is A-Chow Engineering Company Ltd. The site gate was close. Access for site inspection was not available.	N/A	N/A

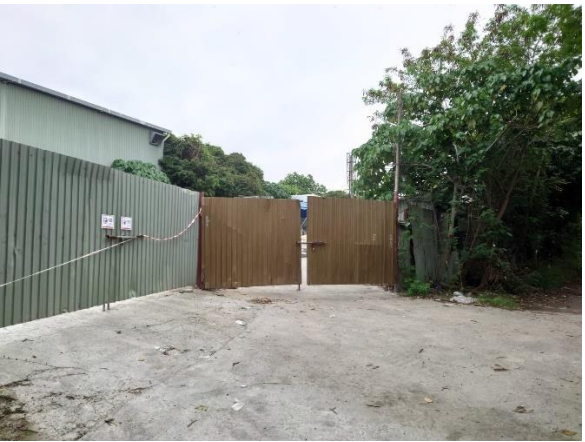
Potential Contaminated Site ID	Premise Name and Location (Approx. Site Area, m ²)	Suspected Current Use	Approx. Area encroaching the Project Limit (m ²)	Site Observation	Potential Polluting Activities and Potential Chemical of Concern (COC)	Sampling and analysis proposal	Photo Reference
C6 ^	Temporary structure at South of Yuen Long Highway, West of Tong Yan San Tsuen Road (2046m ²)	Construction materials and equipment storage	482	The site gate was close and not in operation. The site occupant is unknown. Some construction materials were observed in the site. Access for site inspection was not available.	N/A	N/A

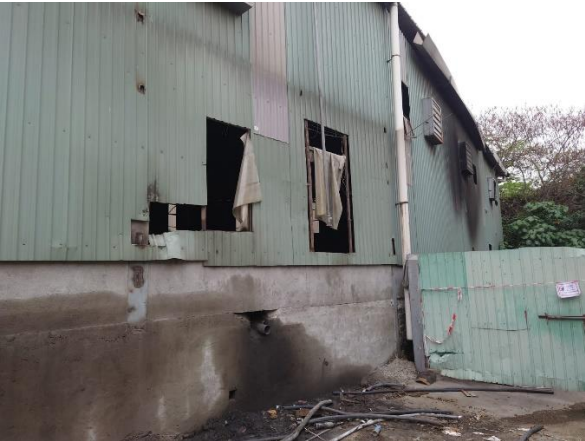
C7 ^	South of Yuen Long Highway, West of Tong Yan San Tsuen Road (974m ²)	Not in used	64	The site is unoccupied. Some oil stains were observed at the wall of the temporary structure and on the ground outside the temporary structure. A suspected oil pipe was observed. The gate was locked. Access for site inspection was not available.	N/A	N/A

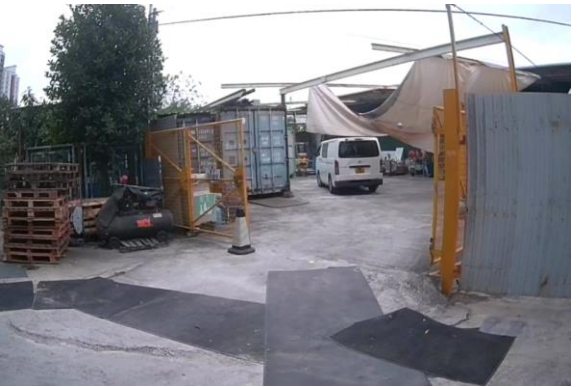
C8 ^	Temporary structure at Fui Sha Wai South Road, at the North of Hung Tin Road (470m ²)	Warehouse and open area storage	60	The site occupant is unknown. The site was in operation. Temporary structures and open space storage of goods are observed within the Site. Access for site inspection was not available.	N/A	N/A

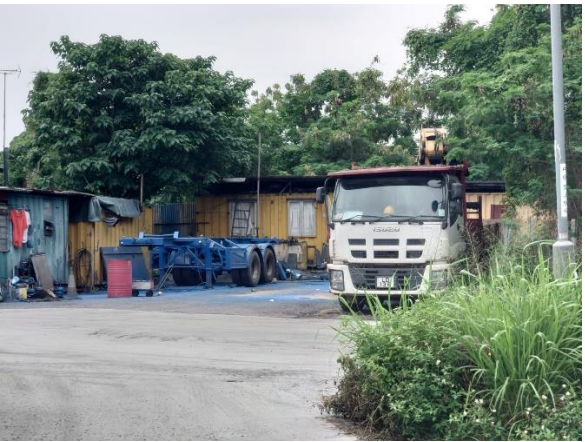
Potential Contaminated Site ID	Premise Name and Location (Approx. Site Area, m ²)	Suspected Current Use	Approx. Area encroaching the Project Limit (m ²)	Site Observation	Potential Polluting Activities and Potential Chemical of Concern (COC)	Sampling and analysis proposal	Photo Reference
C9 ^	A vacant land at Fui Sha Wai South Road, at the North of Hung Tin Road (493 m ²)	Vehicle Maintenance	55	The site occupant is unknown. Some chemical/ lubricant drums and trucks were observed within the site. Vehicle painting were observed on the ground. The site was in operation. Access for site inspection was not available.	N/A	N/A

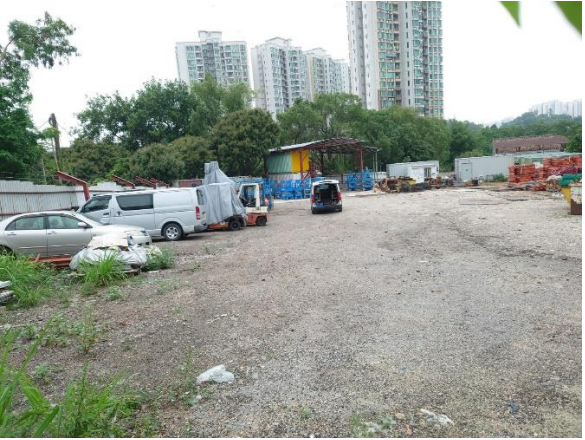
C10	A vacant land at Fui Sha Wai South Road next to Tai Tao Tsuen (2286 m ²)	Construction materials and equipment storage/ Open area storage	1201	The occupant is unknown. Some construction equipment was observed within the site. The site gate was closed and not in operation. Access for site inspection was not available.	Loading, unloading, storage and transfer of goods. COC: Metals, PCRs, VOCs, SVOCs	As specific hotspots of contamination cannot be identified due to inaccessibility, 8 boreholes based on regular size grid 13m x 13m at this stage is proposed determined by the area of encroachment with reference to Practice Guide.
