## 8. IMPACT TO CULTURAL HERITAGE

- 8.1.1. The Project comprises the construction of a new Annex Block at the HKO Headquarters, for meeting the existing shortfall in office space and functional areas for developing and delivering HKO's essential operation and services and organising public education and outreach activities. Other associated and supporting facilities will also be provided to suit HKO's operational needs.
- 8.1.2. The Project also covers the refurbishment works to convert the existing Red House as a History Room for telling the heritage story of HKO, road widening works for EVA at the existing access road, and other associated works.

- 8.1.3. The Project Site is located within the boundary of HKO Headquarters. HKO Headquarters, located at 134A Nathan Road, Tsim Sha Tsui, was a Declared Monument (DM) in 1984 under the *Antiquities and Monuments Ordinance (Cap. 53)*. The HKO Headquarters is also considered as a predominate ecological hub in South Kowloon area. Developments in the vicinity include Tsim Sha Tsui District Kaifong Welfare Association, Mira Place, St. Andrew's Church Compound (Grade 1 historic building), Antiquities and Monuments Office (AMO) Head Office

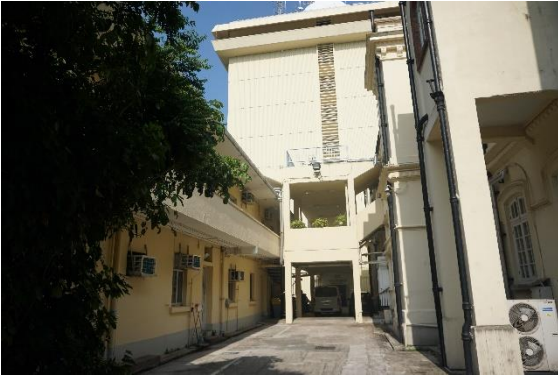
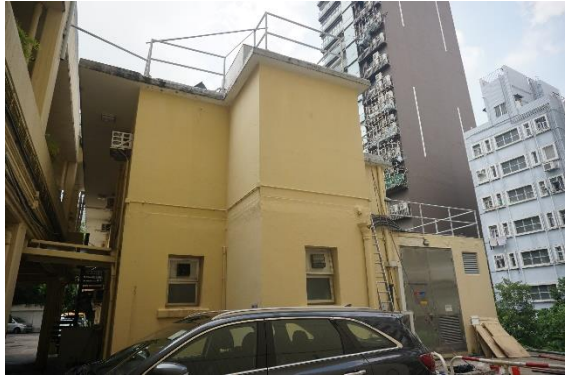
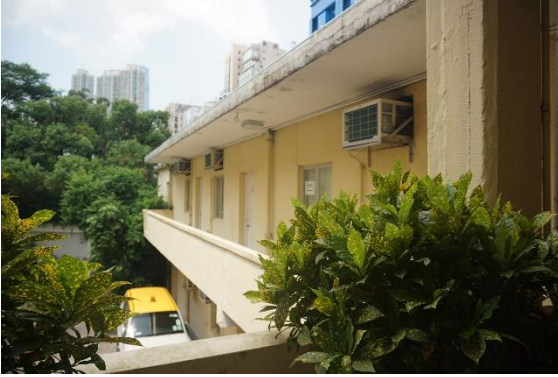
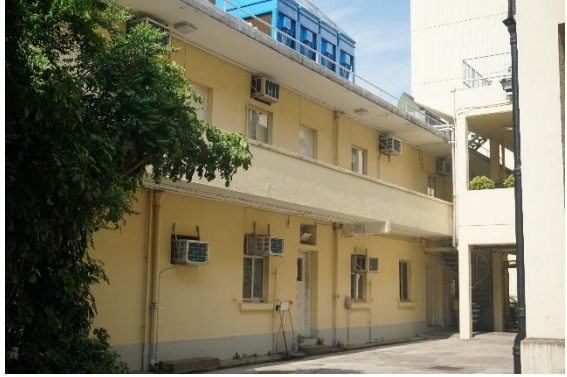
Current Appearance

<p>Architectural Appraisal</p>	<p>The Annex Building was originally a single-storey building with a gable roof. Built as a servants' quarters, the building carries a humble design. The building experienced several expansions. Two rooms were added to</p>

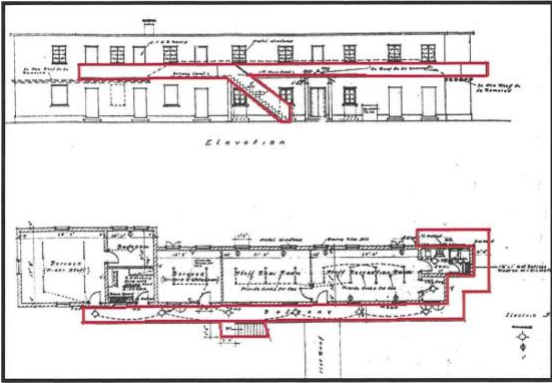
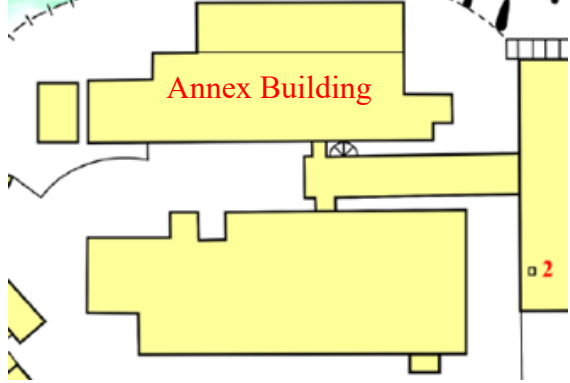
<p>Annex Building in 1955. An additional floor was constructed with a flat roof. (Source: Horizon Asia Limited : 《香港天文台 2015 年後勤大樓地基探考古評估報告》, 2016 年。)</p>	<p>Annex Building in 2015. There are more additions to the north and west of the building. It is connected to the 1883 Building and the Centenary Building by bridges (Source: HKO Technical Note 108, 2016)</p>
<p>Location</p>

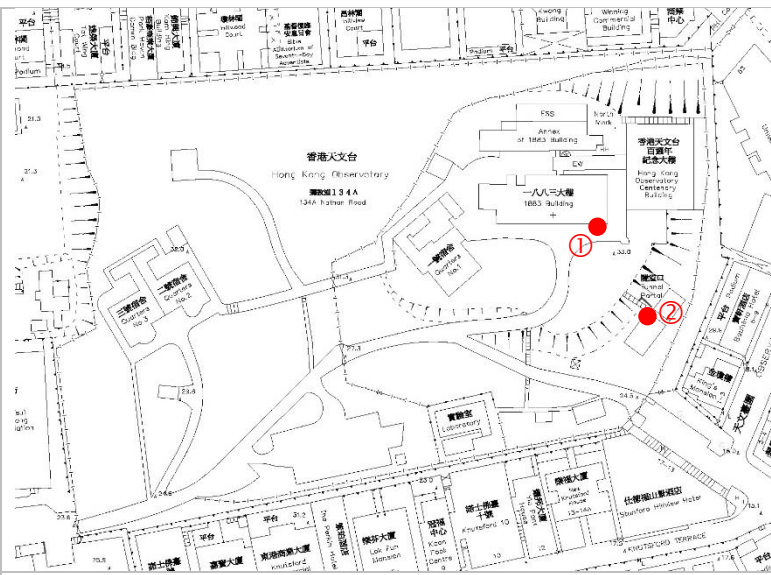
<p>① Entrance staircase          ② Tunnel portal</p>
<p>Built Year</p>	<p>1924</p>
<p>Previous Use</p>	<p>Housing seismographs and clocks</p>
<p>Present Use</p>	<p>Housing seismographs</p>
<p>Historical Appraisal</p>	<p>The Underground Chamber is historically significant as the place for seismic observation in Hong Kong for more than 90 years. The Chamber reveals the early start of Hong Kong observing earthquake activities.</p>
<p>Architectural Appraisal</p>	<p>Built in early 1920s, the Underground Chamber is architecturally significant of having a specially designed ceiling that allows a column free interior. There is a tunnel next to the entrance of the Chamber leading to the tunnel portal at the eastern part of the site.</p>

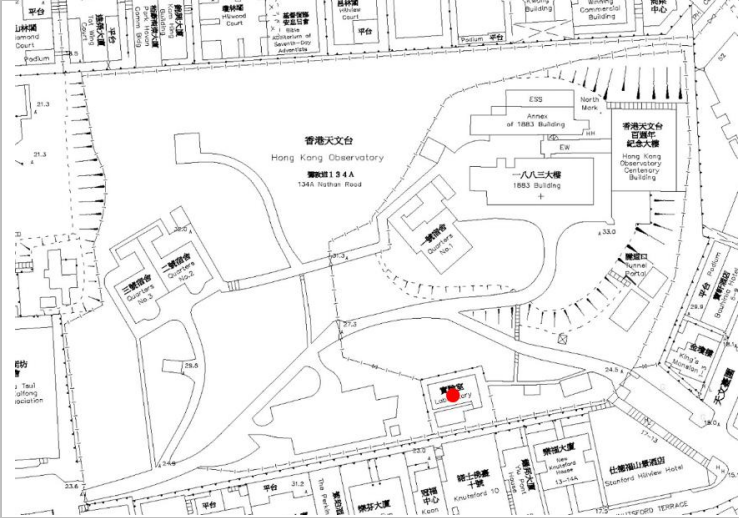
Location

Built Year	1926
Previous Use	Wireless Station, Staff Recreational Room
Present Use	Laboratory and Office
Historical Appraisal	Red House is historically important as a supplementary building for the Headquarter for more than 90 years. It has been served for various purposes throughout the history. It was built as a wireless station, which was later used as a staff recreational room since the early post-war period. It is now used as a laboratory and office.
Architectural Appraisal	Red House is a fair-faced red-brick building built as an L-shaped building with gable roof, which adopted a utilitarian design to suit its original

function as a wireless station. The pitched roof is laid with Chinese pan and roll tiles on timber rafters and king post trusses, which are supported on red brick piers and load bearing walls. From the old plan and site observations, it is believed that the original layout comprises a big rectangular room to the west, a smaller rectangular room to the east, and a small square room at the rear. South facing façade experienced intervention, with the concrete extension added in 1975-76 which affects its original appearance. The building façade is also being obscured by the concrete extension greatly. The extension added in 1975-76 comprises a new barrack room and two lavatories when it was built. It is currently a laboratory and office. Although it has experienced change of uses throughout the history, the original structure and layout are believed to be largely retained in a good condition.

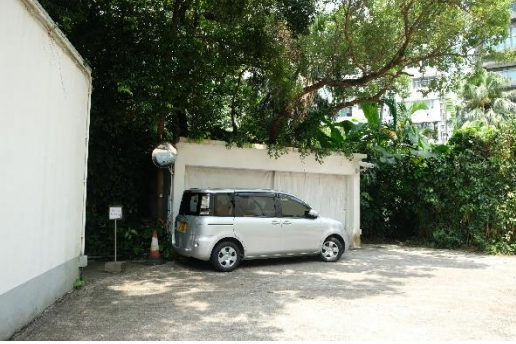
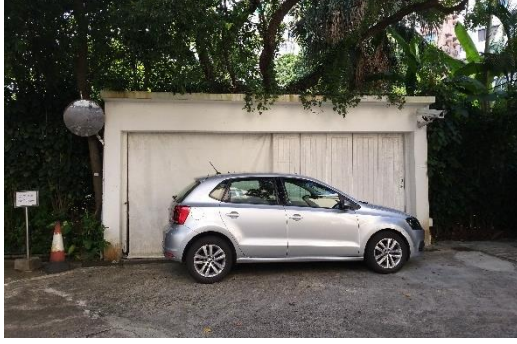
Current Appearance

Built Year:	c. 1955-57
Previous Use	Garage
Present Use	Garage
Historical Appraisal	The garage was still absent on the site plan in 1955 and first appeared on the survey map dated 1957 which was marked 'GARAGE'.
Architectural	The garage is a single-storey building which adopted a simple cubic form

Appraisal	with a flat roof. A row of timber plank door panels is found on the front.
-----------	--

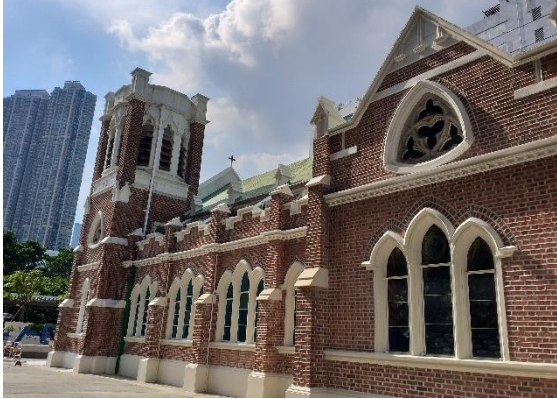
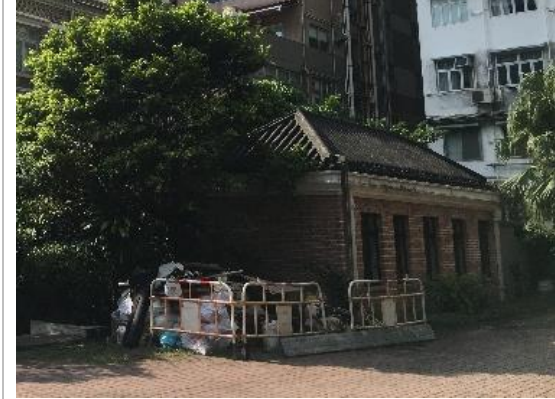
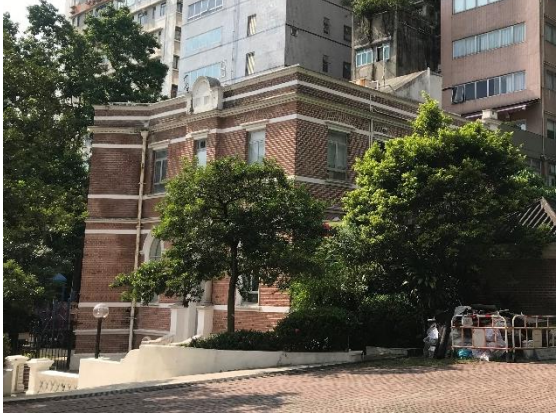
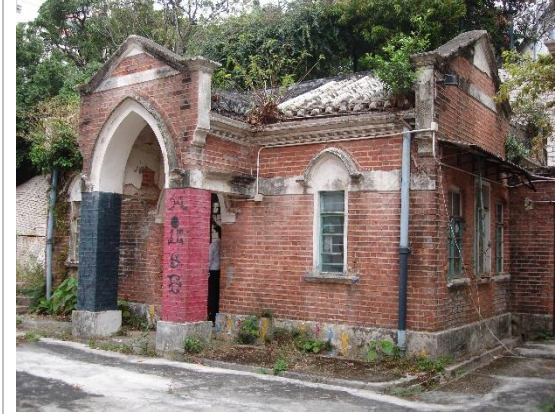
<p data-bbox="290 864 606 896">St. Andrew's Church in 2019</p>

<p data-bbox="865 864 1149 896">Amah's Quarters in 2019</p>

<p data-bbox="290 1335 526 1366">Old Vicarage in 2019</p>

<p data-bbox="865 1335 1149 1366">Verger's Cottage in 2009</p>
Tunnel Portal	Old Appearance

elements of this cruciform fair-faced red brick building include a bell tower, pointed arches, flying buttress, and stained-glass windows. Although the spire has gone, the authenticity of the building is still regarded high. The Old Vicarage is a two-storey brick structure with the features of Gothic style. The Amah's Quarters is composed of two independent single-storey red-brick blocks. The Verger's Cottage comprises of two single-storey red-brick blocks. The two tunnel portals have been vacant and sealed.

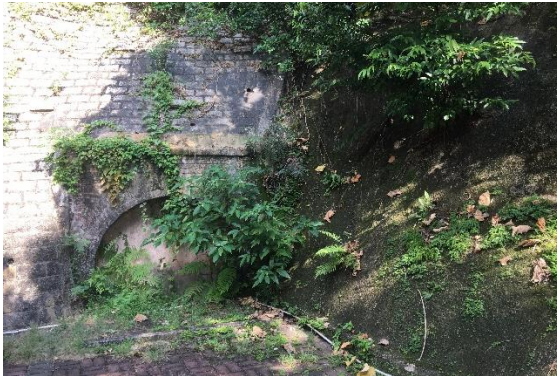
<p data-bbox="290 1836 845 1904">Tunnel portal at the carpark of St. Andrew's Church Compound in 2019</p>

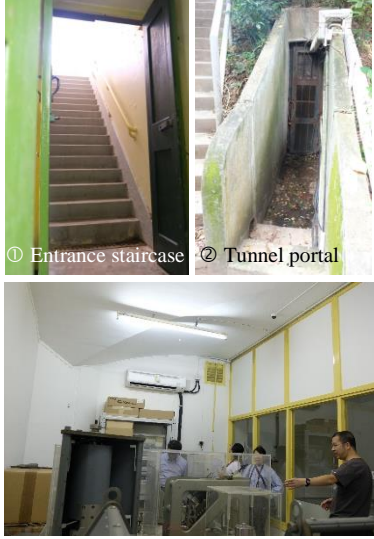
Key Character Defining Elements	Level of significance	Photos	Location <sup>4</sup>
B-04	Underground chamber with tunnel portal	High

<p>① Entrance staircase    ② Tunnel portal</p>

8.4.24. The proposed work area of UU diversion works near to the entrance of the 1883 building, which requires excavation of 1.8m from the ground level, is located near to the underground chamber and the stairs connecting the tunnel portal to underground chamber. As limited record is found for the underground chamber with tunnel portal, its exact alignment and depth are unknown. Indicative location of the underground chamber with tunnel portal is overlaid in [Figure 8.1](#) with reference to the Sketch Map of Royal Observatory in 1950s shown in [Figure 8.9](#). Details of the underground chamber with tunnel portal are shown in [Table 8.6](#). Based on field survey observations, the proposed work area of UU diversion work is located horizontally approximately 1.5m away from the underground chamber and 4m from the stairs connecting the tunnel portal to underground chamber. Moreover, the floor level of the underground chamber is estimated (based on field inspection) to be about 5.3m below ground level which is approximately +32.95 mPD and the internal ceiling of the chamber is about 3.3m high, which is approximately 2m below the ground floor. Potential indirect vibration/settlement /tilting impact to the underground chamber, stairs and tunnel portal may be a concern.

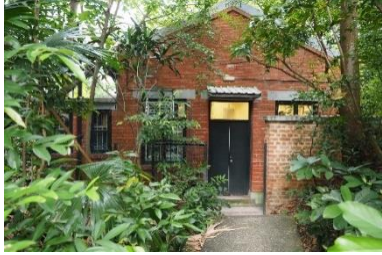
Key Character Defining Elements	Level of significance	Photos	Location
R-01	L-shaped form	High

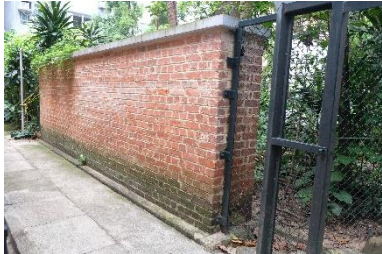
R-02	External brick walls	Medium

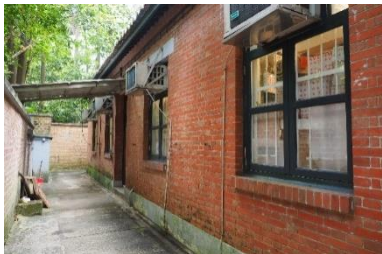
R-03	North facing façade <ul style="list-style-type: none"> <li>Fair-face brickworks</li> <li>Plastered plinth</li> </ul>	High

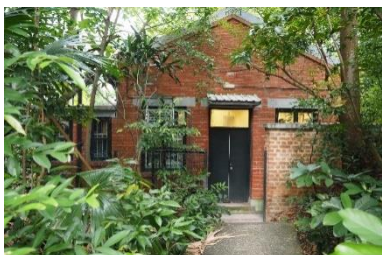
R-04	East facing façade <ul style="list-style-type: none"> <li>Triangular gable wall</li> <li>Fair-face brickworks</li> <li>Plastered plinth</li> </ul>	High

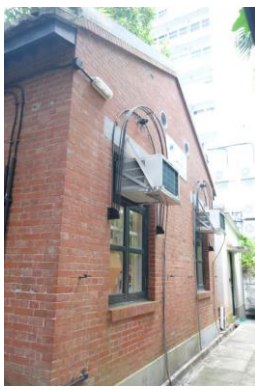
R-05	West facing façade <ul style="list-style-type: none"> <li>Triangular gable wall</li> <li>Fair-face brickworks</li> <li>Plastered plinth</li> <li>Circular vent</li> </ul>	High

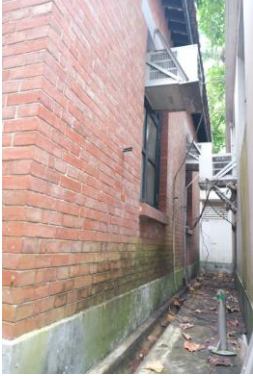
Key Character Defining Elements	Level of significance	Photos	Location
R-06	<p><b>South facing façade</b></p> <ul style="list-style-type: none"> <li>• Fair-face brickworks</li> <li>• Plastered plinth</li> </ul> <p>Remarks: South facing façade experienced intervention, with the concrete extension added in 1975-76 which affects its original appearance. The building façade is also being obscured by the concrete extension greatly</p>	Medium

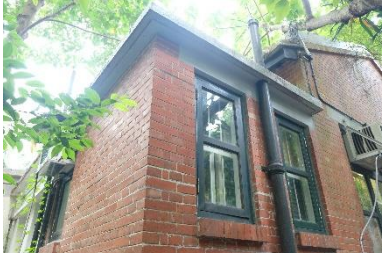
R-07	<p><b>Rear block façades</b></p> <ul style="list-style-type: none"> <li>• Fair-face brickworks</li> <li>• Plastered plinth</li> </ul>	Medium

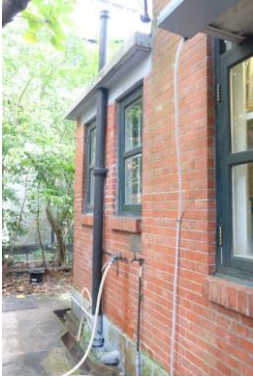
R-08	<p><b>Vent pipe</b></p>	Medium

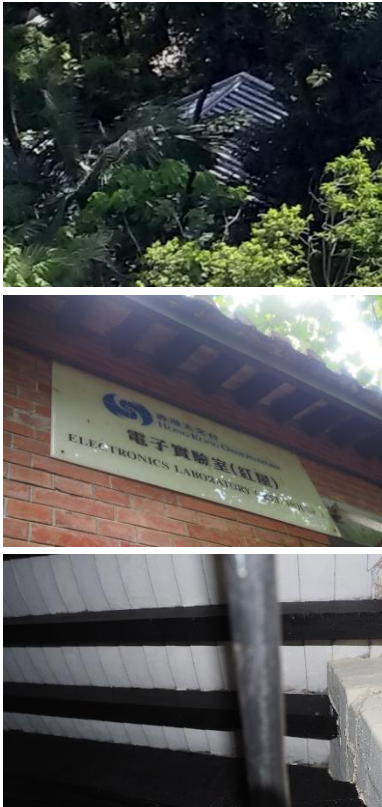
Key Character Defining Elements	Level of significance	Photos	Location
R-09	Main roof with Chinese pan and roll tiles pitched roof	High

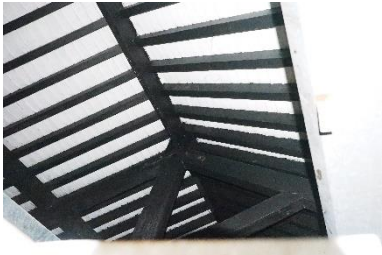
R-10	Roof structure with timber rafters supporting on timber trusses	High

<p data-bbox="1102 1518 1219 1550">--- Truss</p>

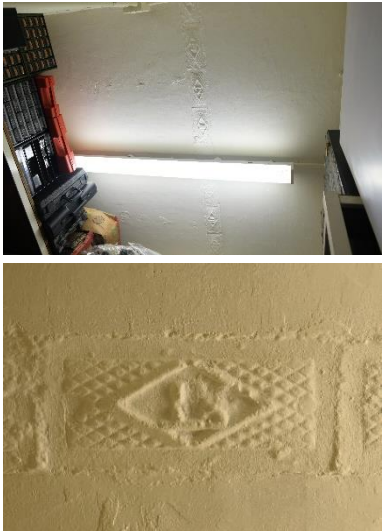
Key Character Defining Elements	Level of significance	Photos	Location
R-11	Concrete flat roof with special marks	High

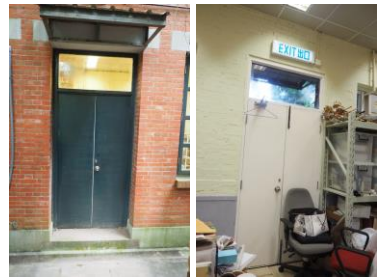
R-13	Entrance door opening <ul style="list-style-type: none"> <li>• concrete lintel</li> <li>• granite threshold</li> </ul>	High

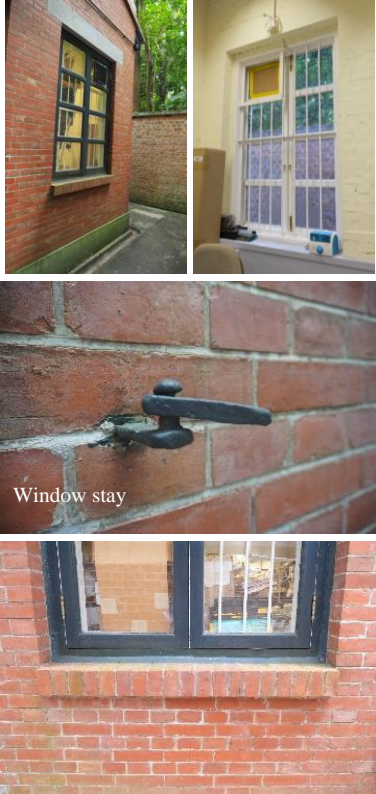
Key Character Defining Elements	Level of significance	Photos	Location
<b>R-14</b>	<p><b>Window opening</b></p> <ul style="list-style-type: none"> <li>• concrete lintel</li> <li>• brick window sill</li> <li>• ironmongery of period style</li> </ul> <p>* Excluding later additions, e.g. air-conditioning units and vents, metal security bars</p> <p>Existing window leaf appears to be later interventions.</p>	<b>High</b>

- Existing window type air-conditioners and vents are considered intrusive and shall be removed in order to restore the original window appearance. Split-type air conditioning unit shall be considered. Outdoor units shall be considered at the rear of the Red House, which is a less prominent location. The proposed design, location and routing shall be submitted for AMO's comment before proceeding the *Section 6* permit application (*Antiquities and Monuments Ordinance*) for the Project.

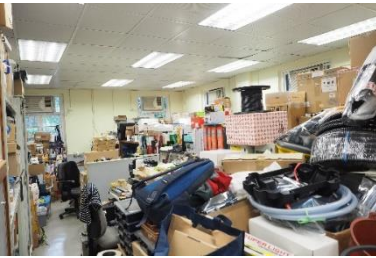
<b>Interior</b>				
<b>R-15</b>	<p><b>Spatial arrangement – bigger room (former club house)</b></p>	<b>High</b>

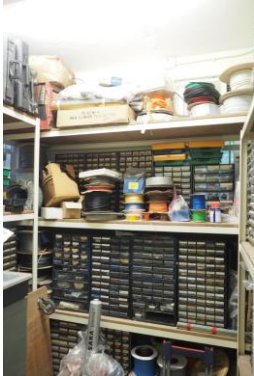
<b>R-16</b>	<p><b>Spatial arrangement - small room (former latrine)</b></p>	<b>Medium</b>

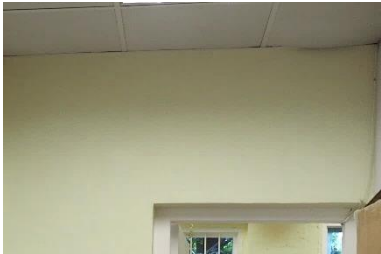
Key Character Defining Elements	Level of significance	Photos	Location
R-17	Plastered internal walls with paint	High

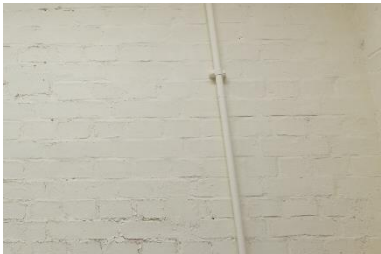
R-18	Exposed brickworks with paint over	High

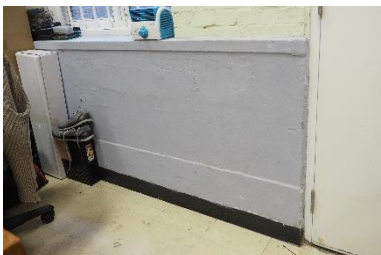
R-19	Plastered dado	High

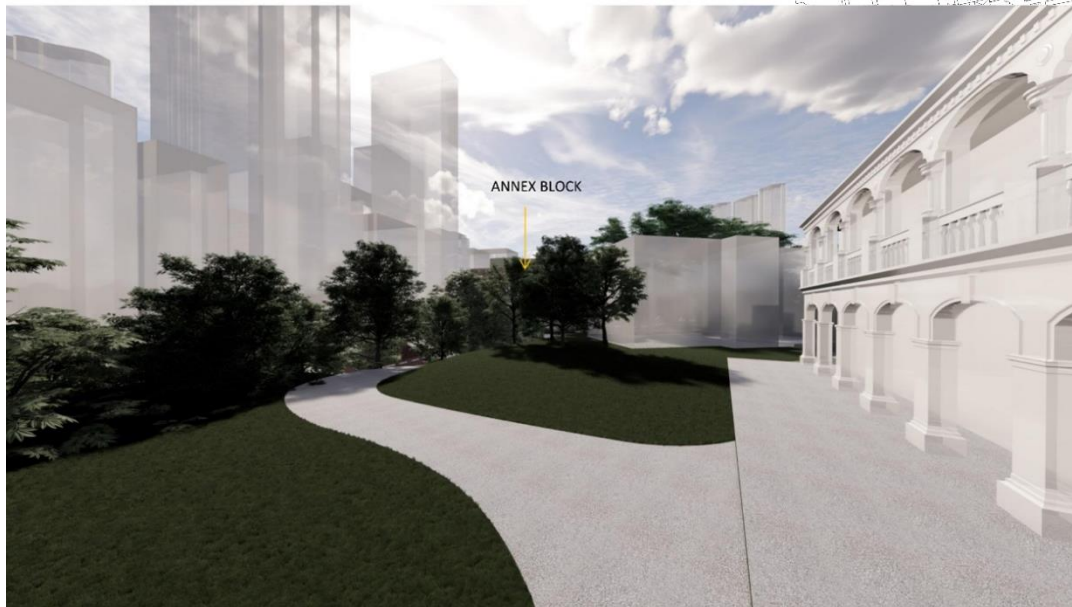
PEDESTRIAN VIEW FROM 1883 BUILDING TO NEW ANNEX BLOCK

**Figure 8.32. Artist's impression with pedestrian view from 1883 Building to New Annex Block**
