94th Consolidated Monthly EM&A Report (August 2024)

0087/16/ED/1233 [00]

Contact No. KLN/2016/05 - Independent Environmental Checker for Contract No. KL/2015/02 Kai Tak Development- Stage 5A Infrastructure at Former North Apron Area

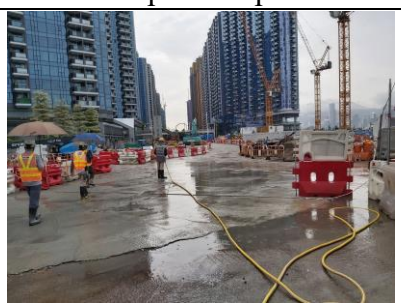
Inspection Date	Key Observations	Recommendations / Actions	Close-out Date / Status
01 August 2024	 Observation: The NRMM label was missing at Part 2A.	 Action Taken: The NRMM label was displayed at a conspicuous position.	Closed-out on 06 August 2024
06 August 2024	 Observation: The site entrance (L12D road) should be sprayed water regularly

Action Taken: The site entrance (L12D road) has been sprayed water regularly.	Closed-out on 15 August 2024

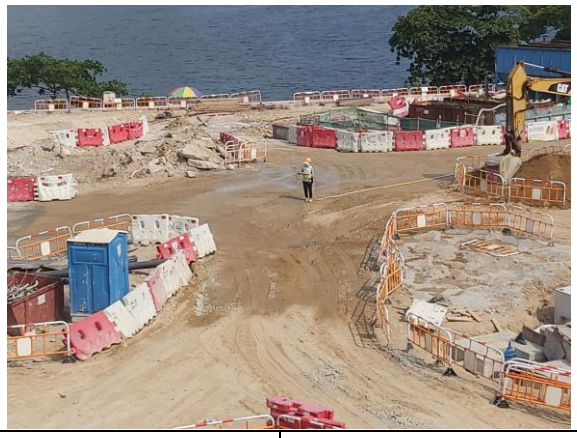
Date:	15 August 2024	Date:	15 August 2024
Mitigation Measures:	The stock of more than 20 bags of cement materials on sites were covered.	Mitigation Measures:	The silt curtains were deployed around the Harbour step.
