Re: Contract No. ED/2018/01 – Kai Tak Development
Stage 4 Infrastructure at the Former Runway and South Apron

Monthly EM&A Report for November 2024

Environmental Monitoring and Audit Report

Kai Tak Development – Stage 4 infrastructure at the former runway and south apron

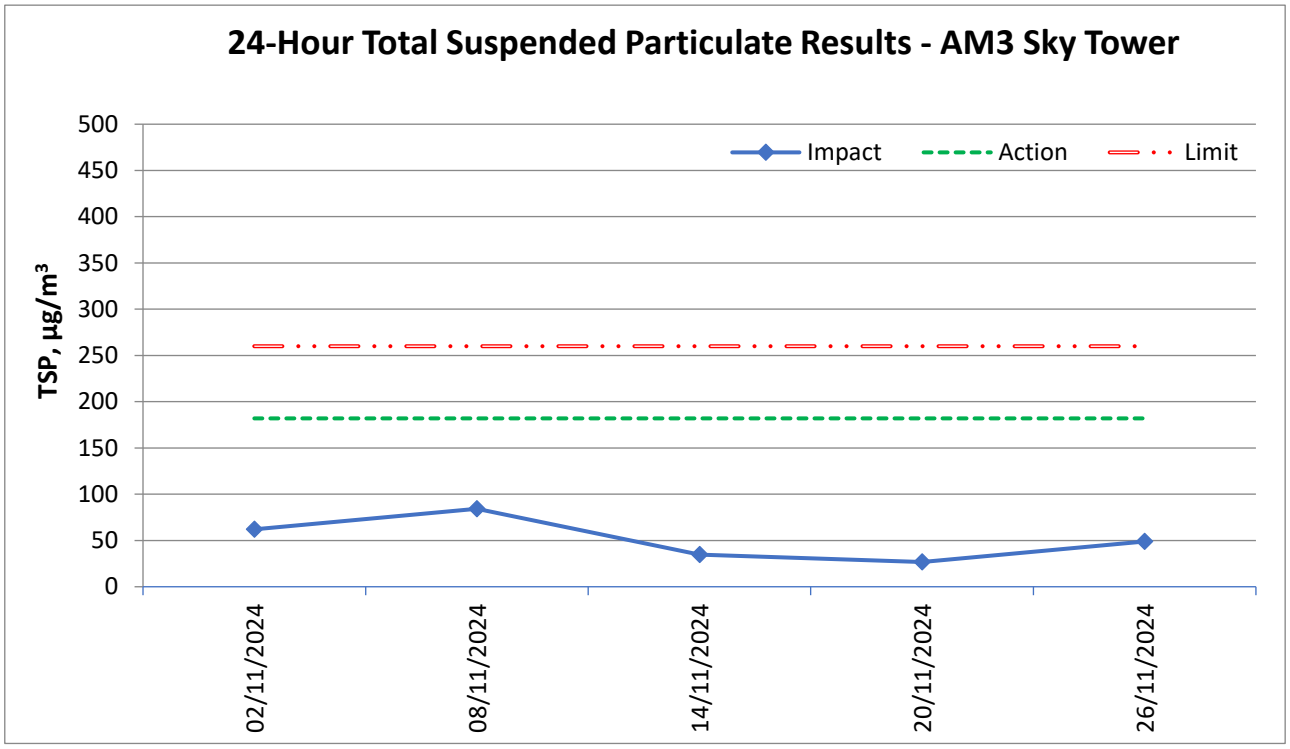
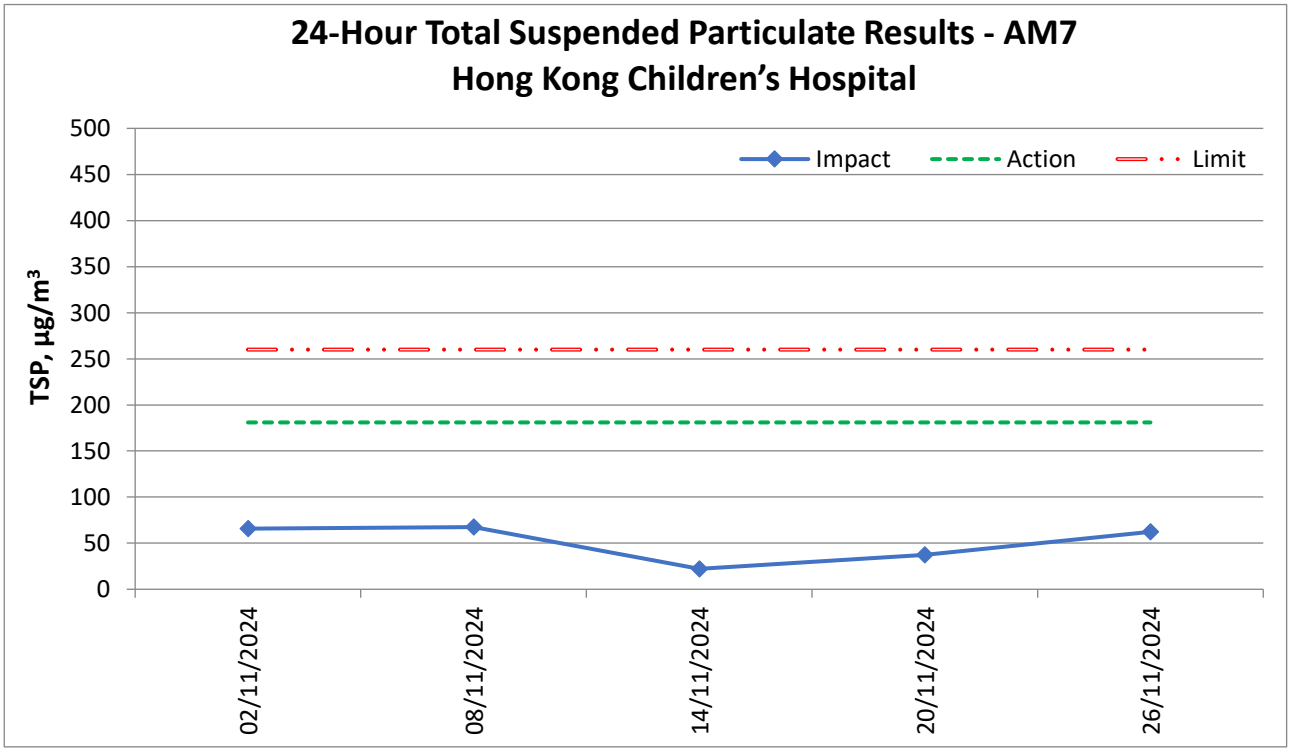
24-hour average TSP

Note: Due to the relocation of The Hong Kong Society for the Blind's Factory cum Sheltered Workshop (AM4(A)), the premises owner rejected ET to conduct impact monitoring since 1 Sept 2022. No 24-TSP monitoring was conducted at AM4(A). ET will resume the impact monitoring once the alternative monitoring location for AM4(A) is confirmed.

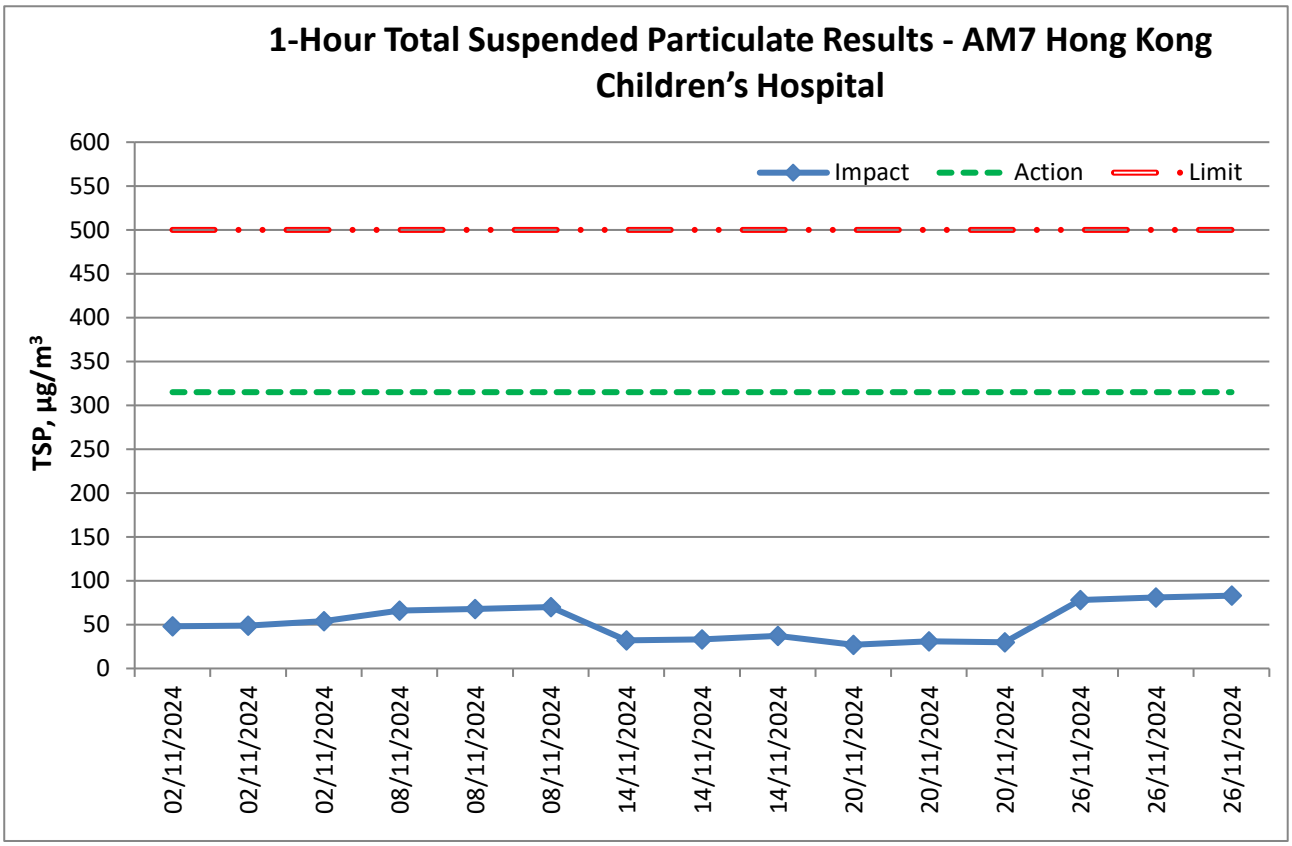
NOTE: Due to the relocation of The Hong Kong Society for the Blind's Factory cum Sheltered Workshop (AM4(A)), the premises owner rejected ET to conduct impact monitoring since1 Sept 2022. 1-hr TSP monitoring at AM4(A) were conducted on the ground floor with orienting to the Project site. ET will resume the impact monitoring once the alternative monitoring location for AM4(A) is confirmed.

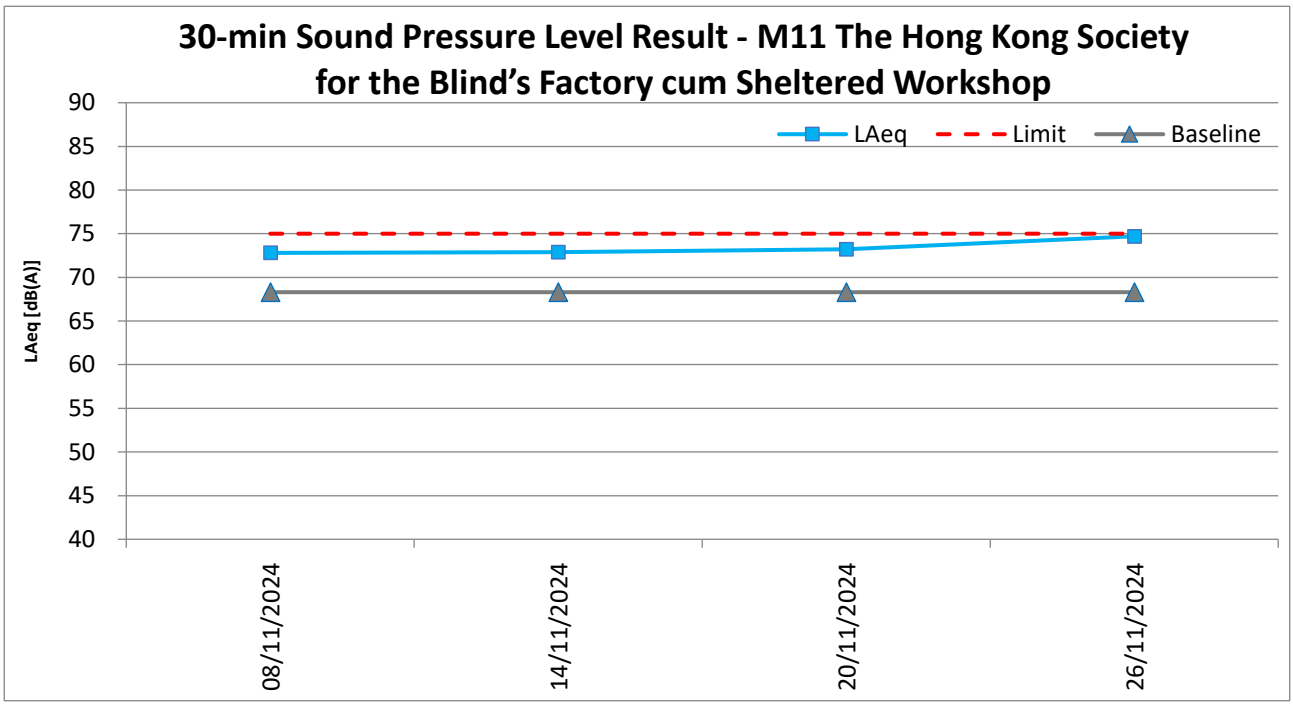
$L_{Aeq, 30\text{-}min}$ graphical results of M11 - The Hong Kong Society for the Blind's Factory cum Sheltered Workshop

NOTE: Due to the relocation of The Hong Kong Society for the Blind's Factory cum Sheltered Workshop (M11), the premises owner rejected ET to conduct impact monitoring since 1 Sept 2022. 30-min noise monitoring at M11 were conducted on the ground floor with orienting to the Project site. ET will resume the impact monitoring once the alternative monitoring location for M11 is confirmed.
