CONTRACT NO. 1/WSD/19 & 6/WSD/21

IN-SITU REPROVISIONING OF SHA TIN WATER TREATMENT WORKS (SOUTH WORKS) – WATER TREATMENT WORKS AND ANCILLARY FACILITIES
Environmental Permit EP-494/2015

In-Situ Reprovisioning of Sha Tin Water Treatment Works (South Works) – Water Treatment Works and Ancillary Facilities
Environmental Permit EP-494/2015
Submission of 98th monthly EM&A Report

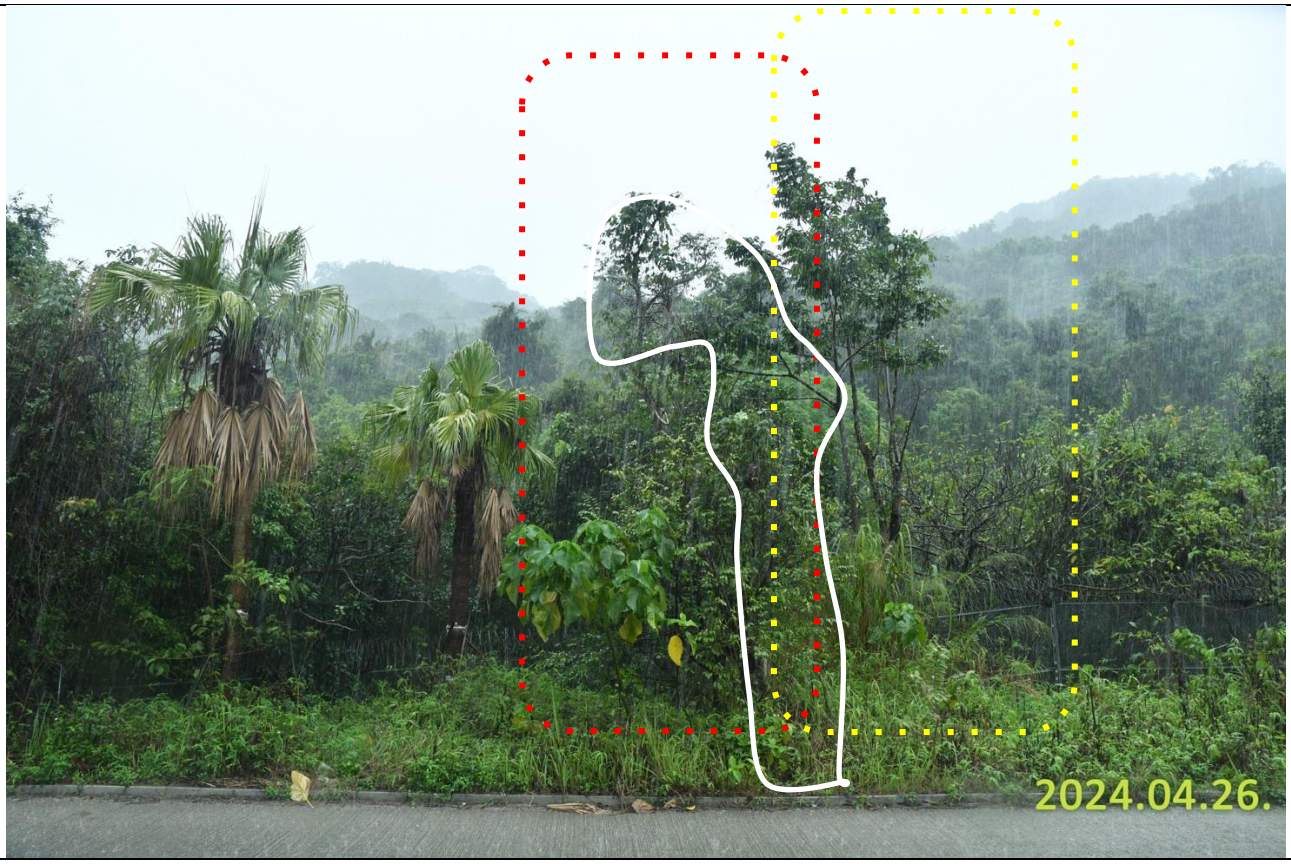
Photo 7. Transplanted Incense Tree (*Aquilaria sinensis*) – TA327 (red); and Ailanthus (*Ailanthus fordii*) – TA572 (yellow). Climber (white) should be removed, including the roots, to relieve the canopy

Photo 8. Sprouts at lower trunk of TA327 (*Aquilaria sinensis*). Climber (red) should be removed, including the roots, to relieve the canopy

2.5.7 Root ball of TA572 and TA327 tree should be kept moisture especially during dry and non-raining day.

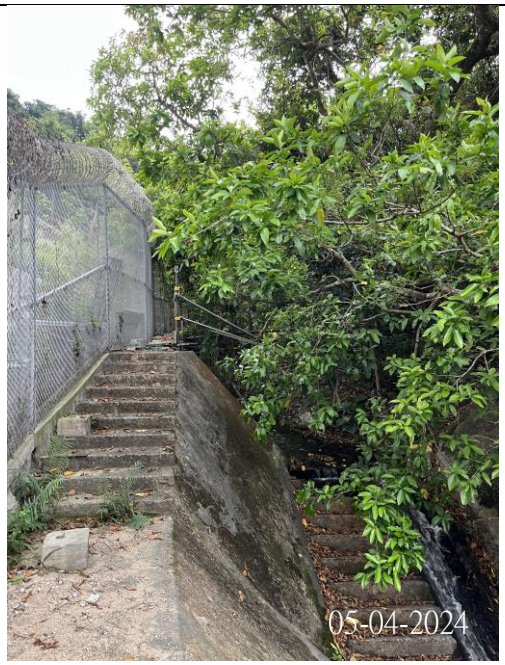
Photo 1 (C1)

1) According to the field observation from the Environmental Team (ET) on 5 April 2024, no polluted discharge made from construction site to the Control Station C1 (Photo 1), since C1 is a control station upstream of Impact Monitoring Station M1. Moreover, the construction of Logistic center (next to C1, Photo 5) have been completed in December 2020, no construction work was conducted nearby C1. In general, the condition of water at Control Station C1 was in order and no discharge from construction was observed (Photo 1). The water quality monitoring locations and contract site area are illustrated in Figure 1.

5) Nevertheless, the Contractor should continually fully implement the water mitigation measures as recommended in the implementation schedule for environmental mitigation measures in the EM&A Manual.

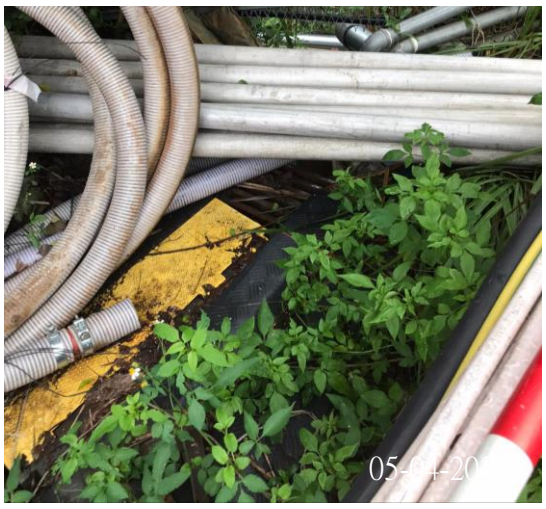
Photo 4 (Discharge point at 6/WSD)

4) In our investigation on 5 April 2024, the Contractor had implemented water quality mitigation measures (eg. sandbags were put within the site to avoid wastewater from leaking out of the site) and wastewater have been properly treated (Photo 3 & 5). No adverse water quality impact was observed during the site inspection (Photo 4). Based on the site observation, it is concluded that the exceedance of action level and limit level was non-project related.

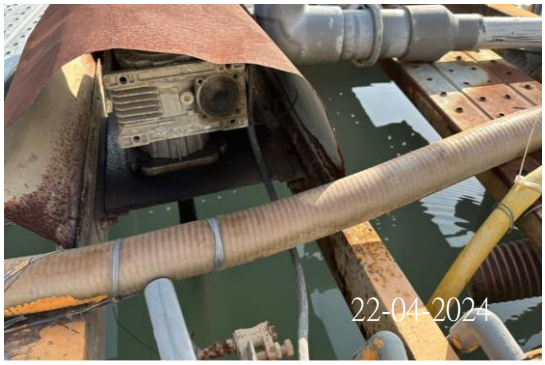
Photo 5 (Water accumulation on the site area at 6/WSD)

Date	Environmental Observations	Follow-up Status
3 April 2024	It is observed that water accumulation in the sire area. Contractor reminded to clear it	Water accumulation has been cleaned it.
10 April 2024	No environmental issue was observed during the site inspection.	N/A
16 April 2024	1. It is observed that water accumulation in the sire area. Contractor reminded to clear it. 2. It is observed that waste disposal in the site area. Contractor reminded to clear it.	1. Water accumulation has been cleaned it. 2. Waste has been cleaned it
24 April 2024	It is observed that water accumulation in the sire area. Contractor reminded to clear it.	Water accumulation has been cleaned it.
30 April 2024	No environmental issue was observed during the site inspection.	N/A
