TUEN MUN SOUTH EXTENSION

(No. EP-615/2022)

Monthly EM&A Report No.8

(For July 2024)

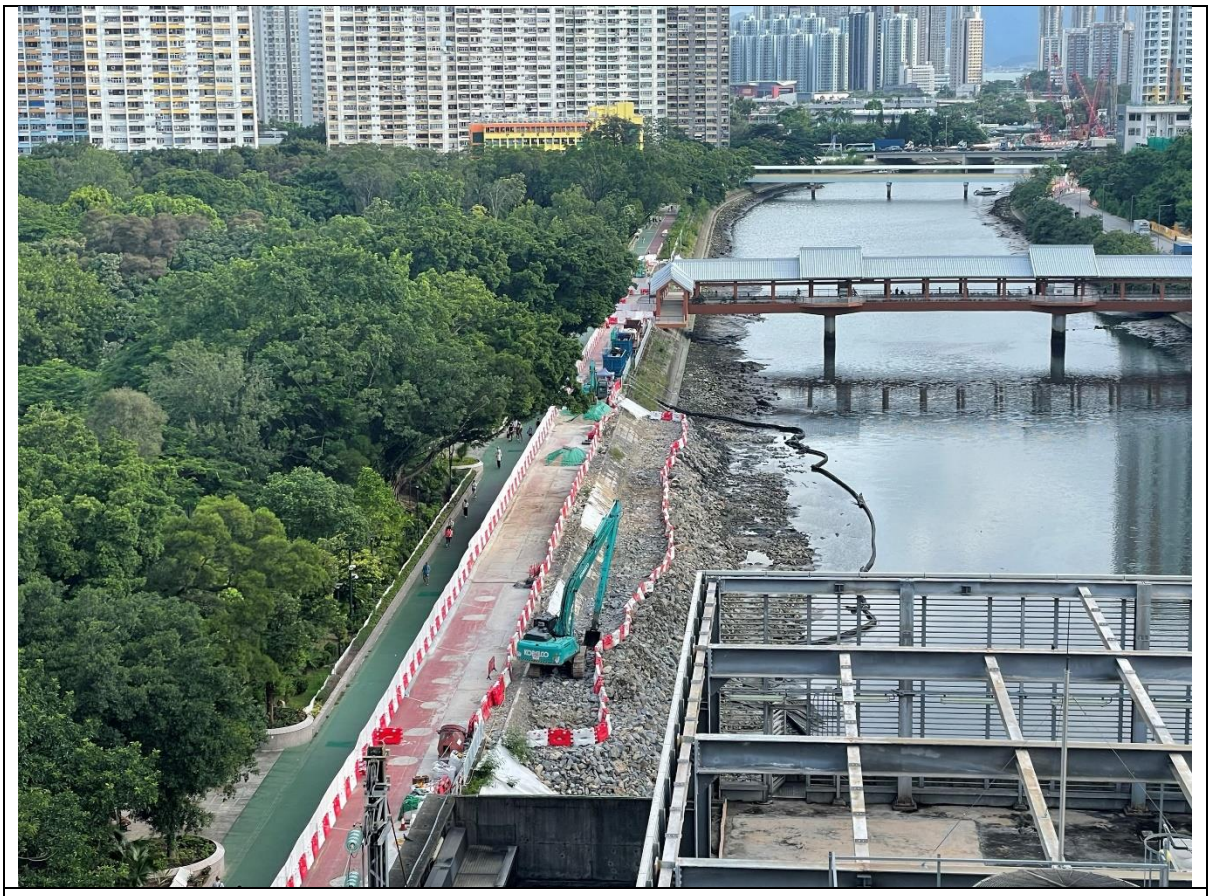
Latest aerial view of the TMP Night Roost
