JOB NO.: TCS01216/21

Reclaimed Water Supply to Sheung Shui and Fanling

MONTHLY ENVIRONMENTAL MONITORING & AUDIT REPORT (NO.35) – OCTOBER 2024

WATER SUPPLIES DEPARTMENT

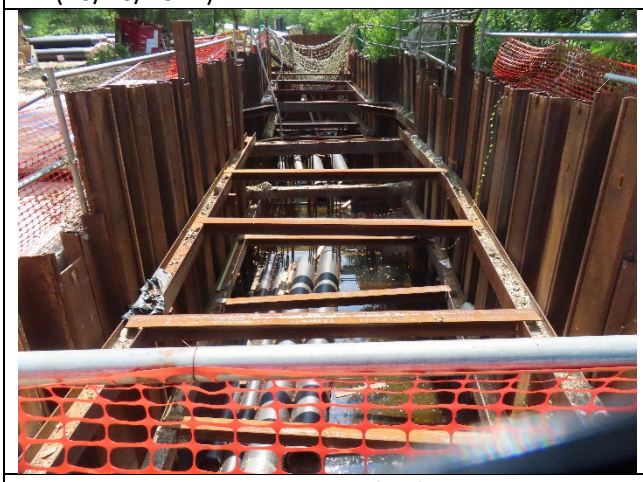
Photo 3 Extension of road construction at T2 near P4 (10/10/2024)	**Photo 4** Construction at T3 by CEDD (15/10/2024)
