Contract No. 13/WSD/17

Design, Build and Operate First Stage of Tseung Kwan O Desalination Plant

Monthly EM&A Report No.51
(Period from 1 May to 31 May 2024)

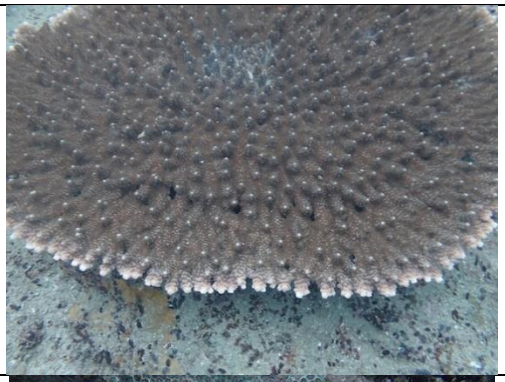
Photo Plate A Tagged Corals at Control Site C8

4.2 No sediment, bleaching or increased mortality in the general condition of all other tagged coral colonies were observed during the monthly operation phase monitoring period. No deterioration of the coral community was observed in the ecological monitoring results when compared with the baseline ecological monitoring results. There is no AL/LL exceedance during the monitoring period. Photos of each tagged corals colonies were taken and shown in Appendix A (Photo Plates A, B and C).
