Project Title:
 Site Formation and Associated Infrastructural Works for Development of
 Columbarium, Crematorium and Related Facilities at Sandy Ridge Cemetery

Contract No.
 CEDD Contract CV/2017/02
 Development of Columbarium at Sandy Ridge Cemetery –
 Infrastructural Works at Man Kam To Road and Lin Ma Hang Road

Landscape & Visual Mitigation and Tree Preservation Plan

Appendix K	Tree condition report of Tree T2769 in January 2021

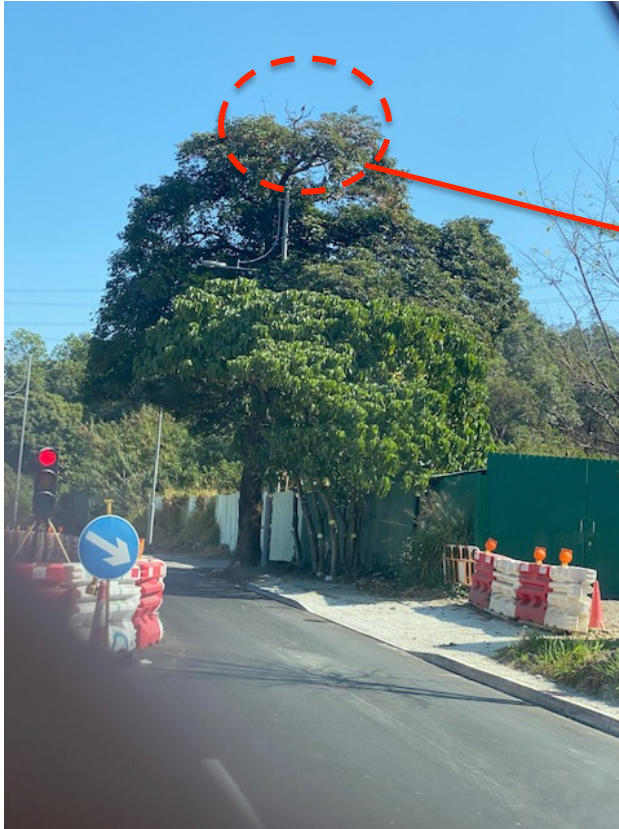
General view

According to the regular inspection for the tree of *Bischofia avanica* 秋楓 (Tree no: T2769). The tree condition is keeping poor and worse and worse.

Both the amenity value and the survival rate are low with reference to the existing of poor tree condition. Especially for the root system might occurred some serious problem. The mentioned tree may have high risk of falling down in sudden. Hence, the tree removal is recommended.

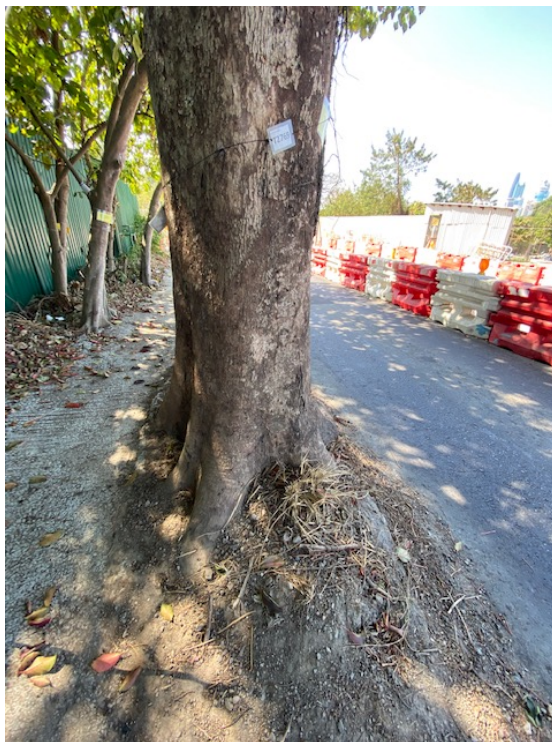
Lower trunk photo 1

The condition of lower trunk and root collar compare with 7 Jan. 2019 until now. The root condition might be occurred a serious problem. Please see the page 8 for the details.

The condition of lower trunk and root collar are poor. And all *Ficus pumlia* 薛荔 is dry out from the early of 2020 until now. The root condition might occurred some serious problem.
