**DRAINAGE IMPROVEMENT
WORKS AT YUEN LONG –
STAGE 2**

Contract No.: DC/2022/02

**Pre-Construction
Condition Survey
Report for Impacted
Graded Historic
Buildings**

**Wing Tat Civil Engineering
Company Limited**

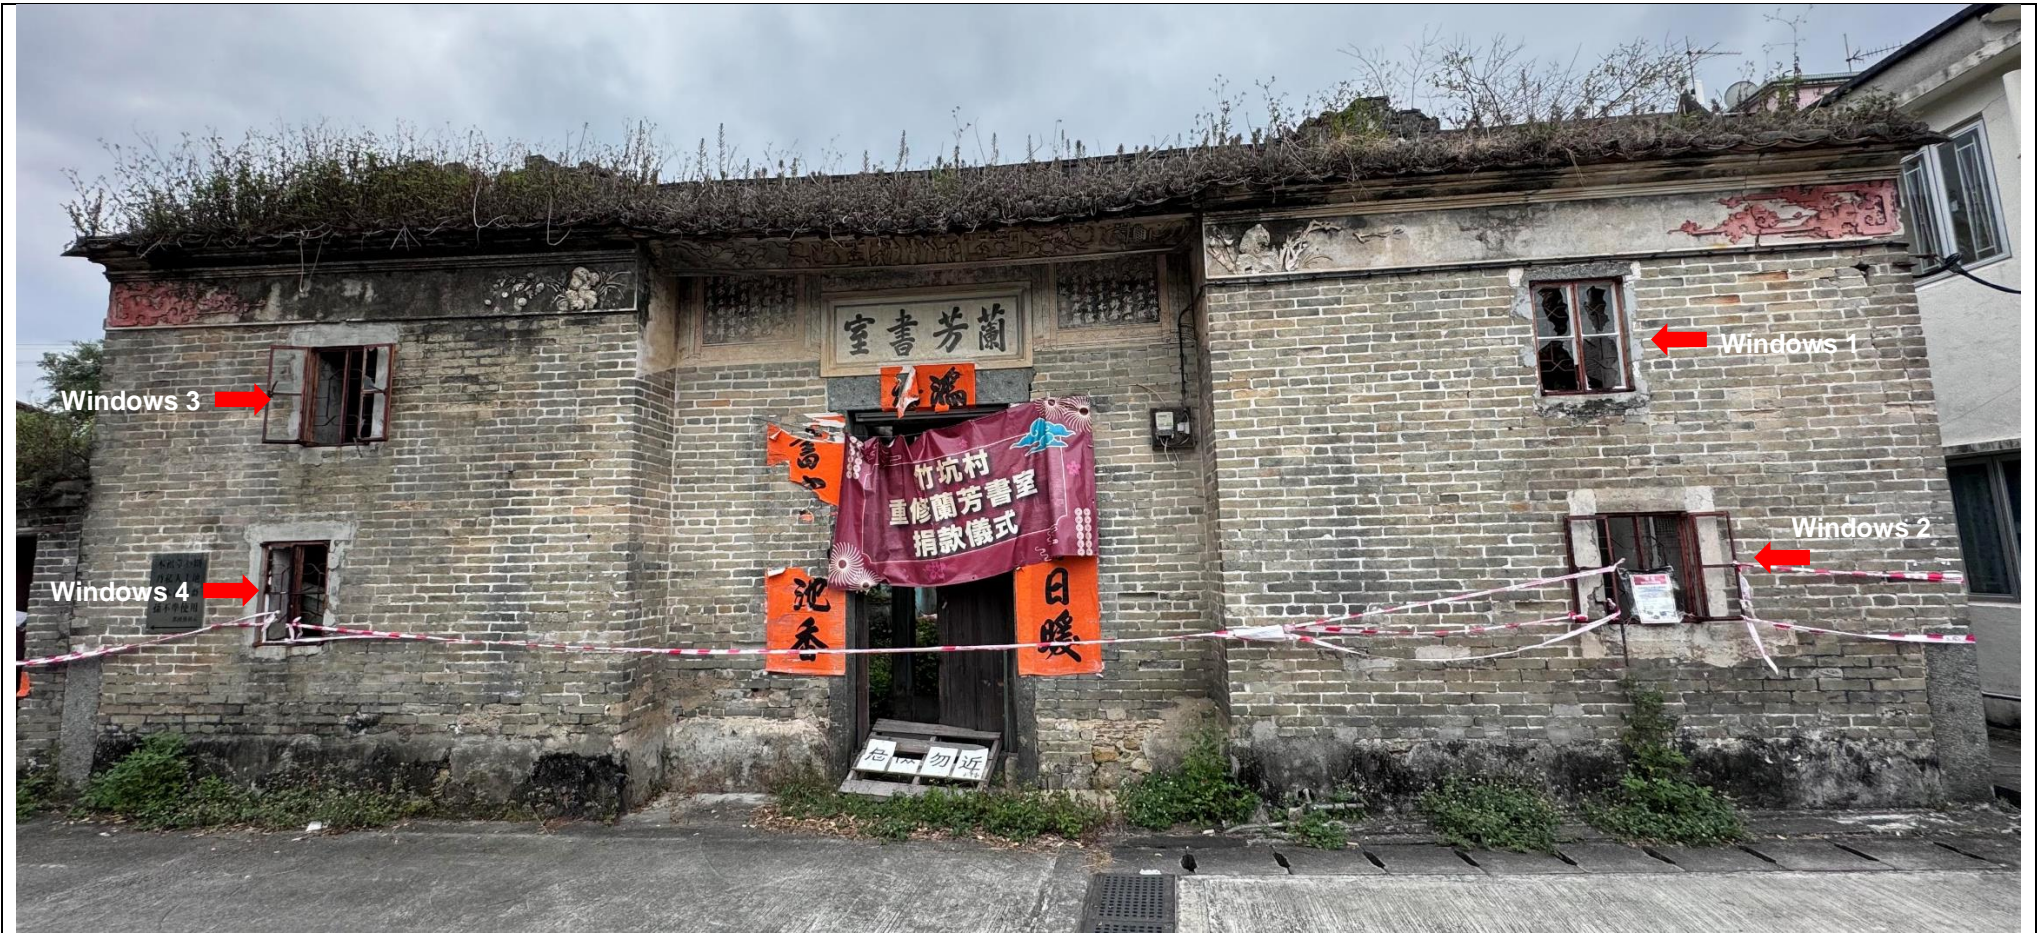
G2.1 W Elevation – General View of Study Hall (Front door, Windows 1, Windows 2, Windows 3 and Windows 4)
