**Agreement no. CE 47/2014 (GE)
-Landslip Prevention and Mitigation
Programme near Bride's Pool Road,
Tai Po – 3SE-D/SA2**

**Monthly Environmental Monitoring and
Audit Report for
April 2024**

(Version 1.0)

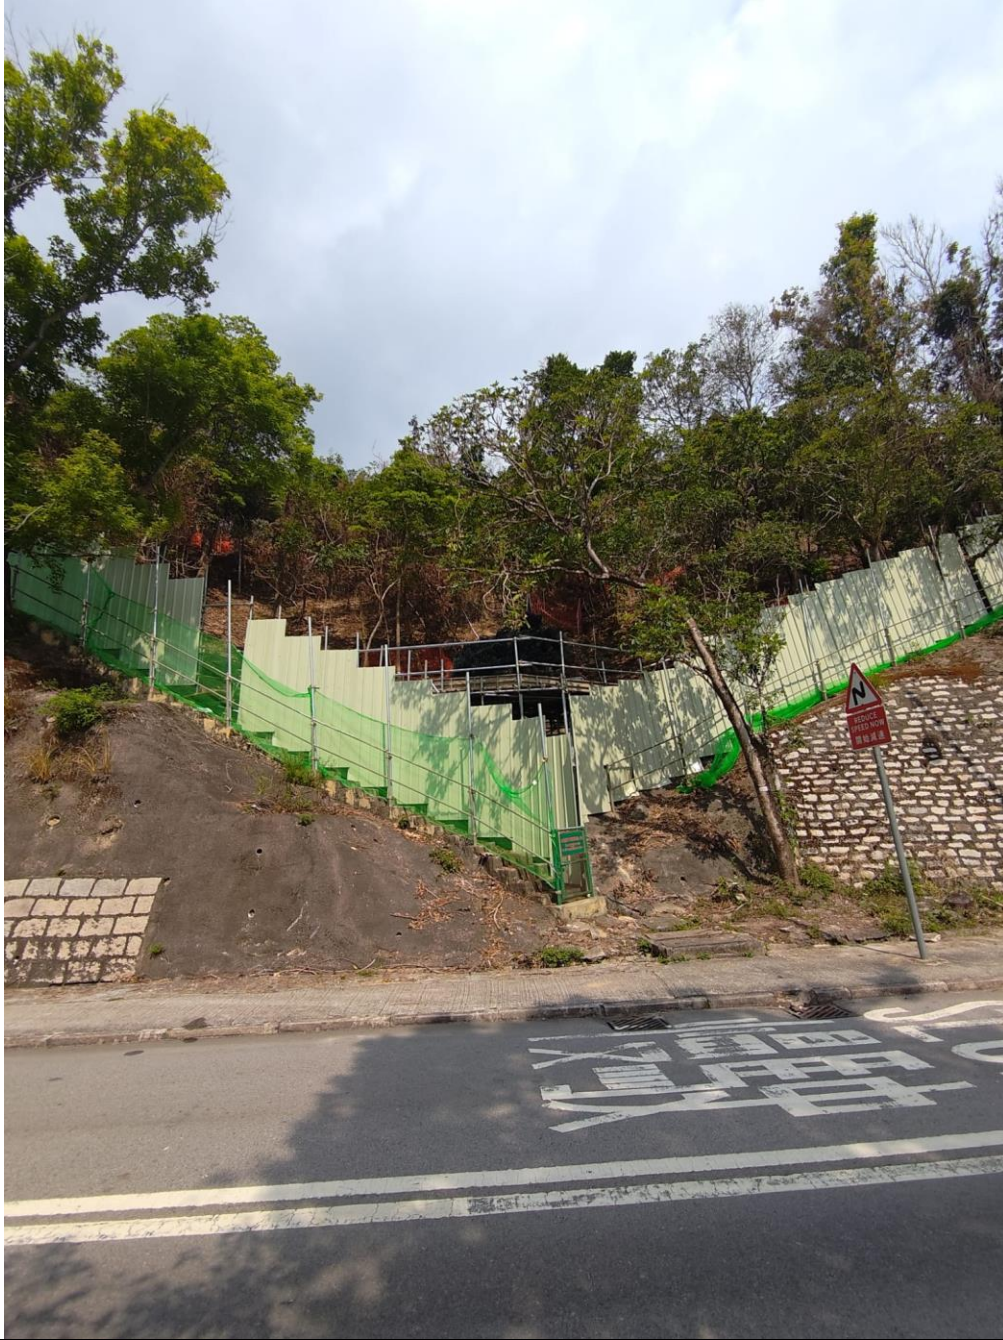
Photo 2: Site photo of Catchment B

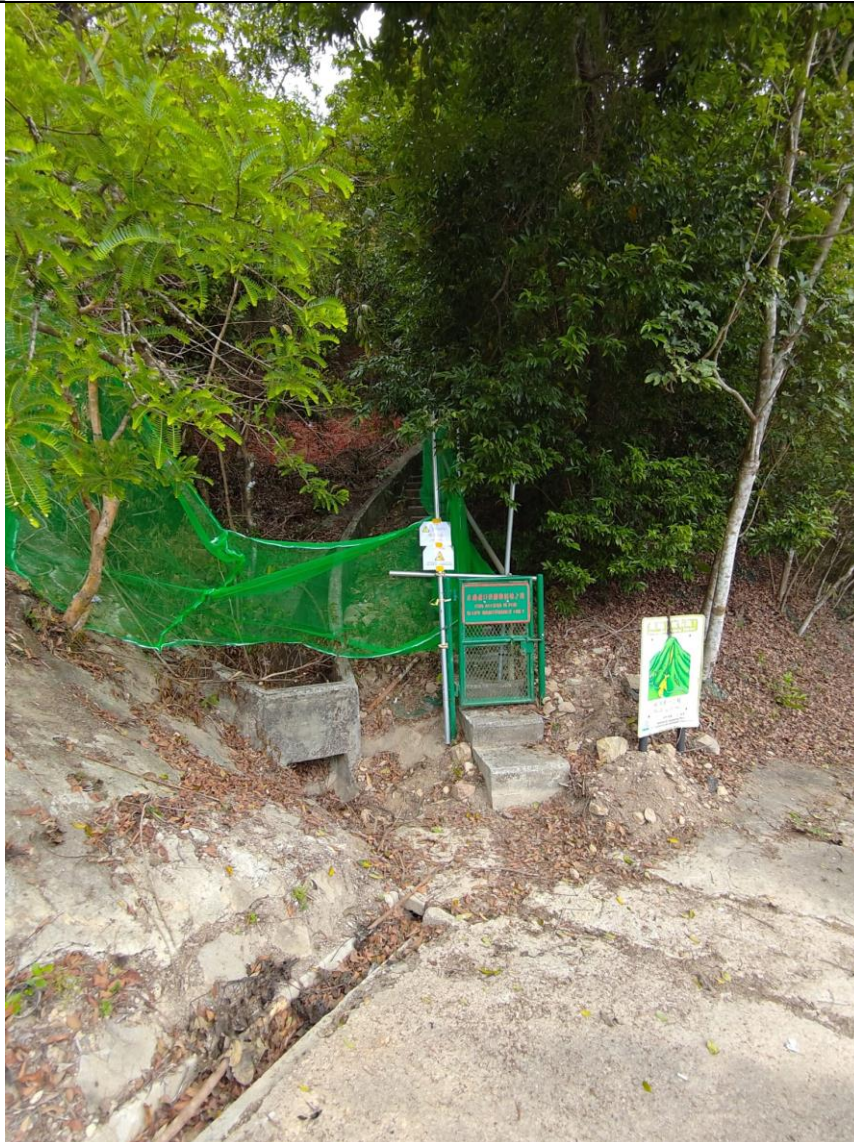
Photo 2: Site photo of Catchment C

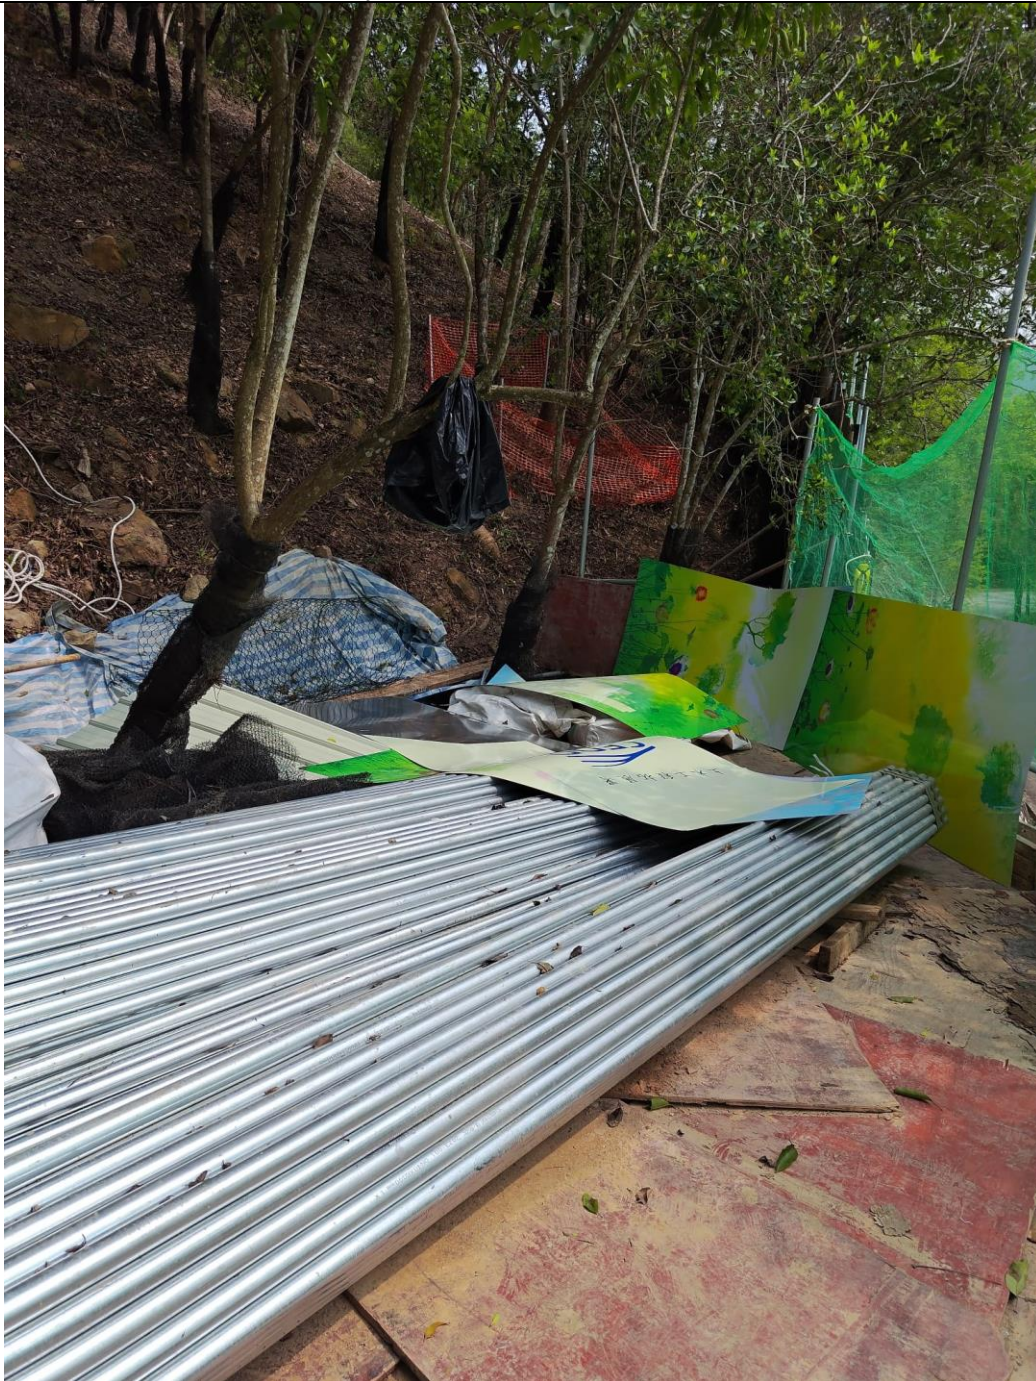
Photo 2: Site photo of Catchment B

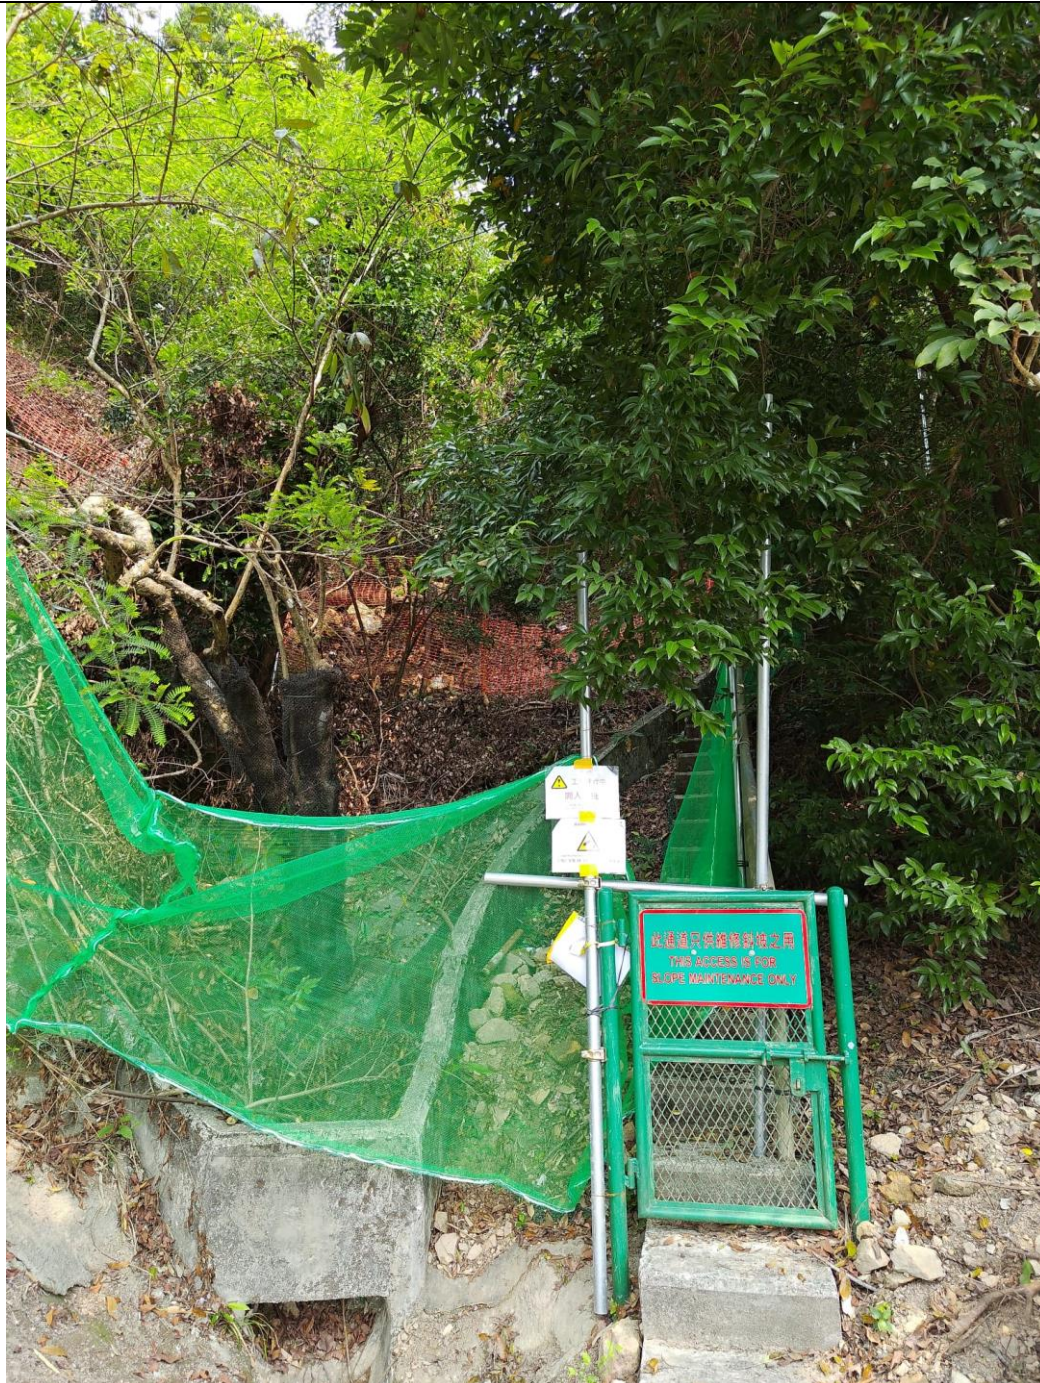
Photo 2: Site photo of Catchment C

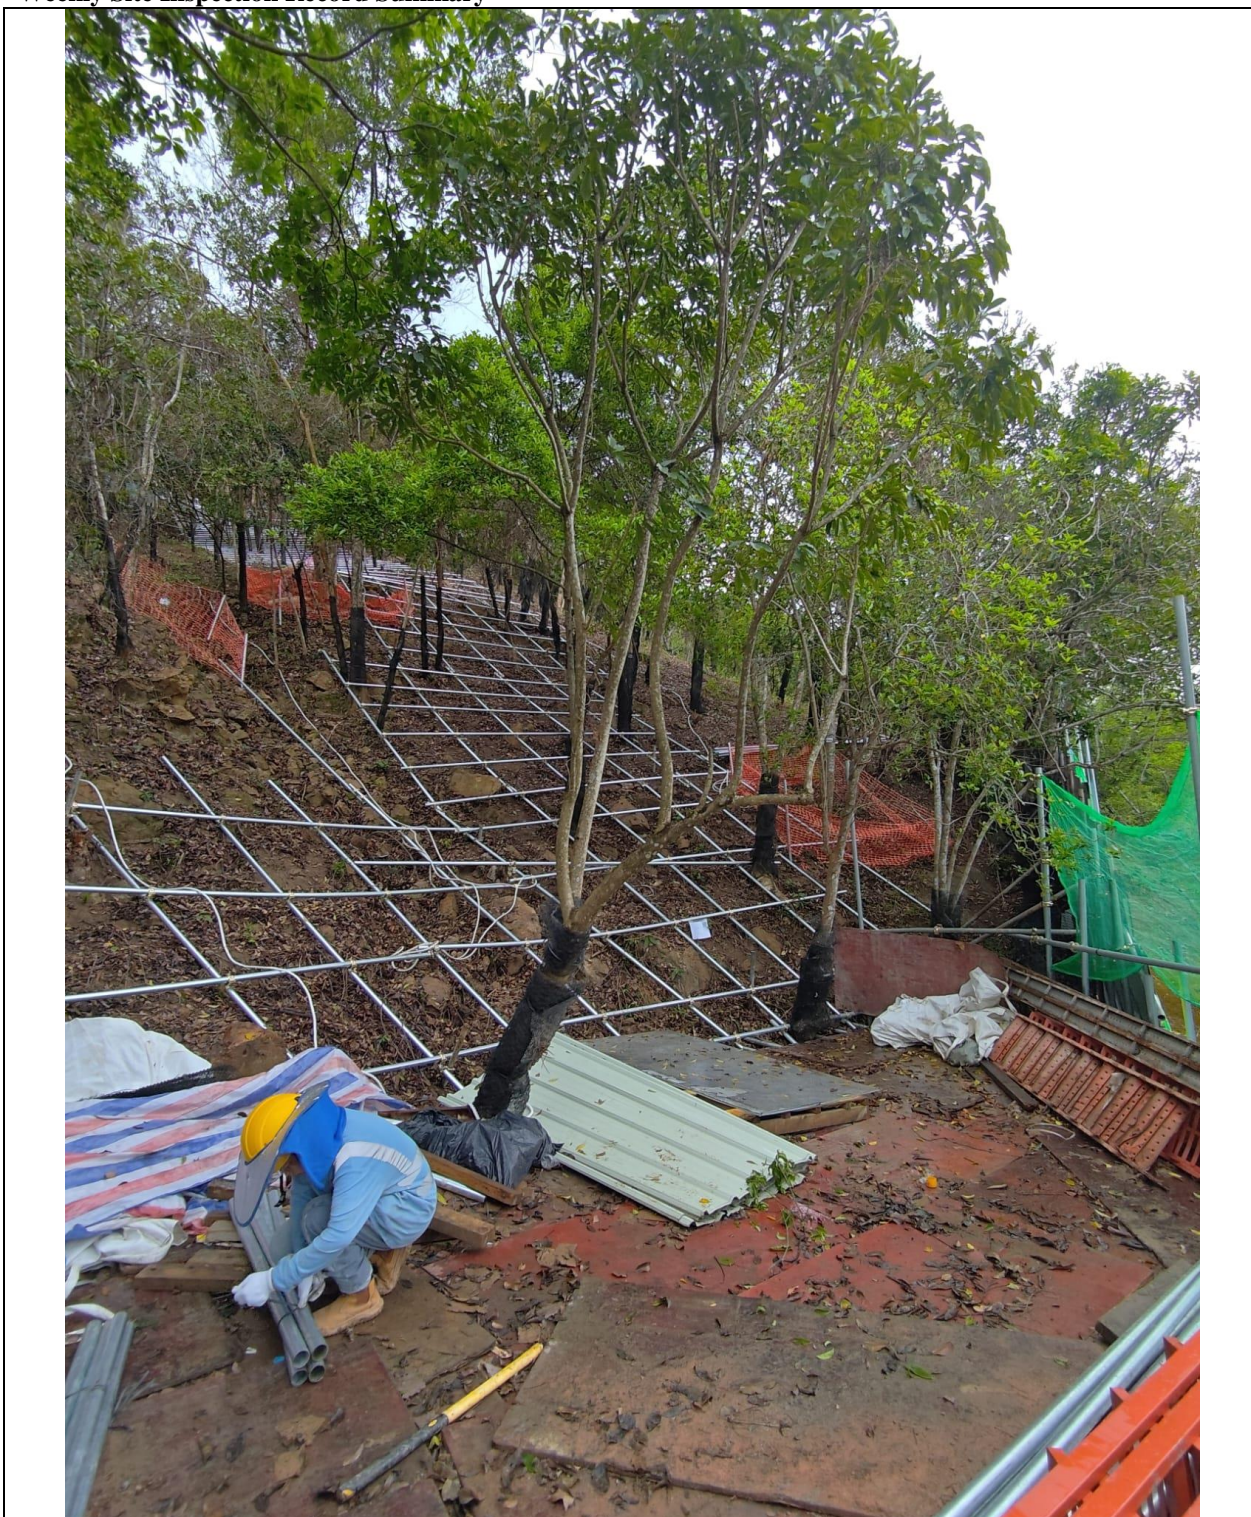
Photo 2: Site photo of Catchment B

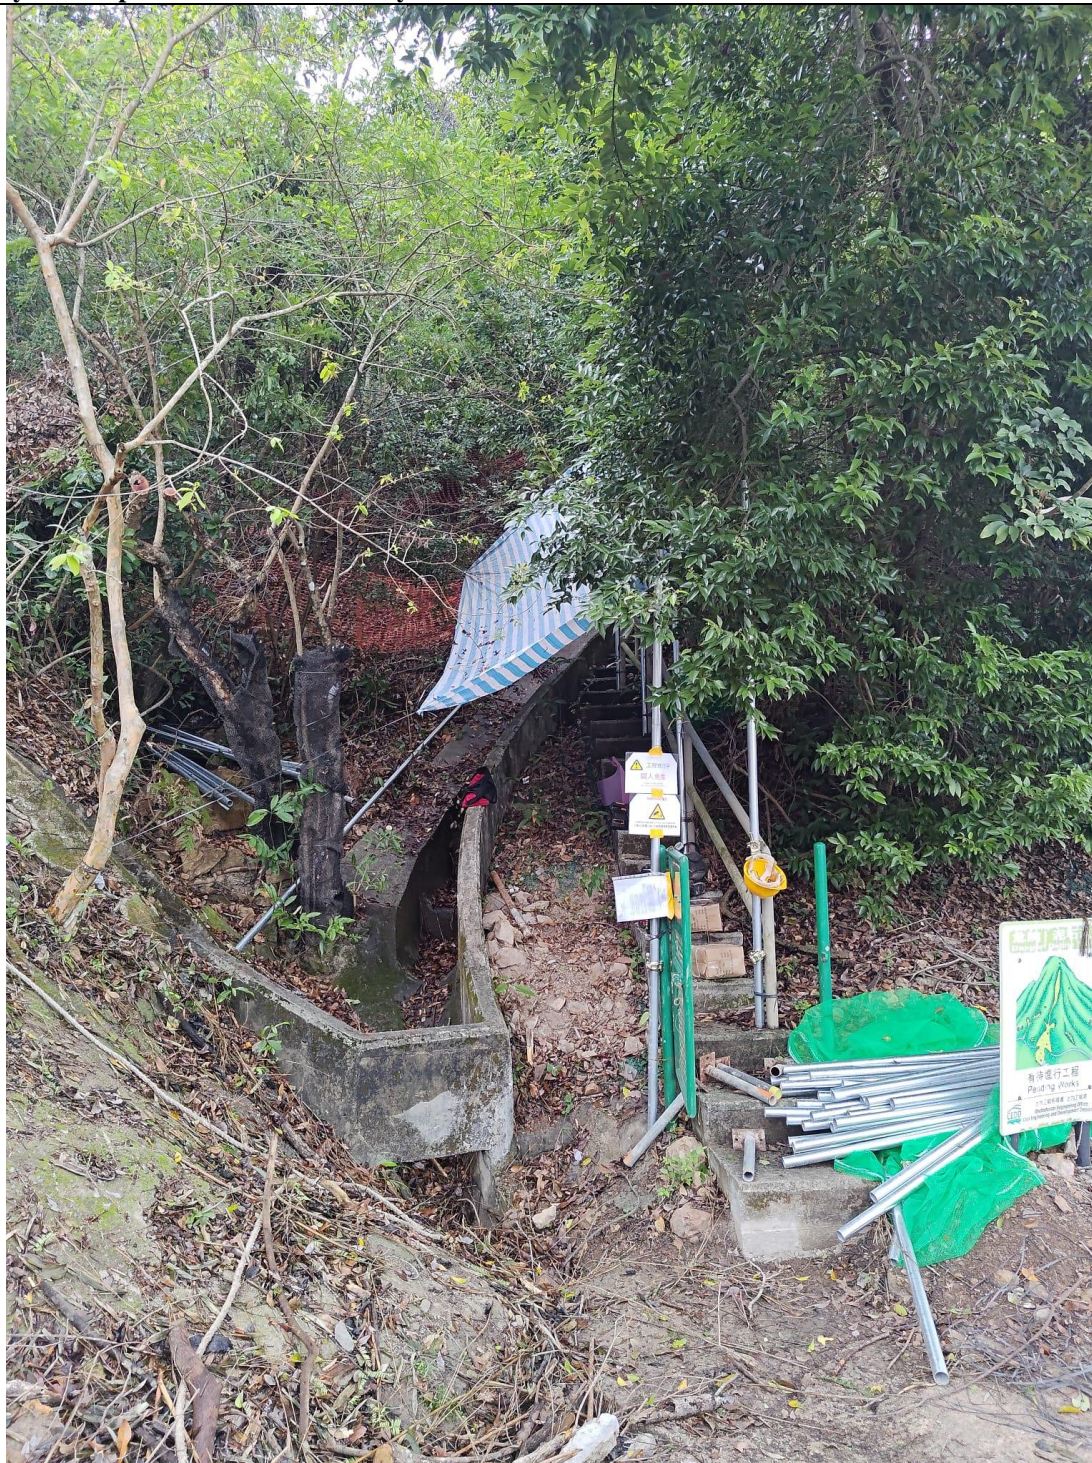
Photo 2: Site photo of Catchment C

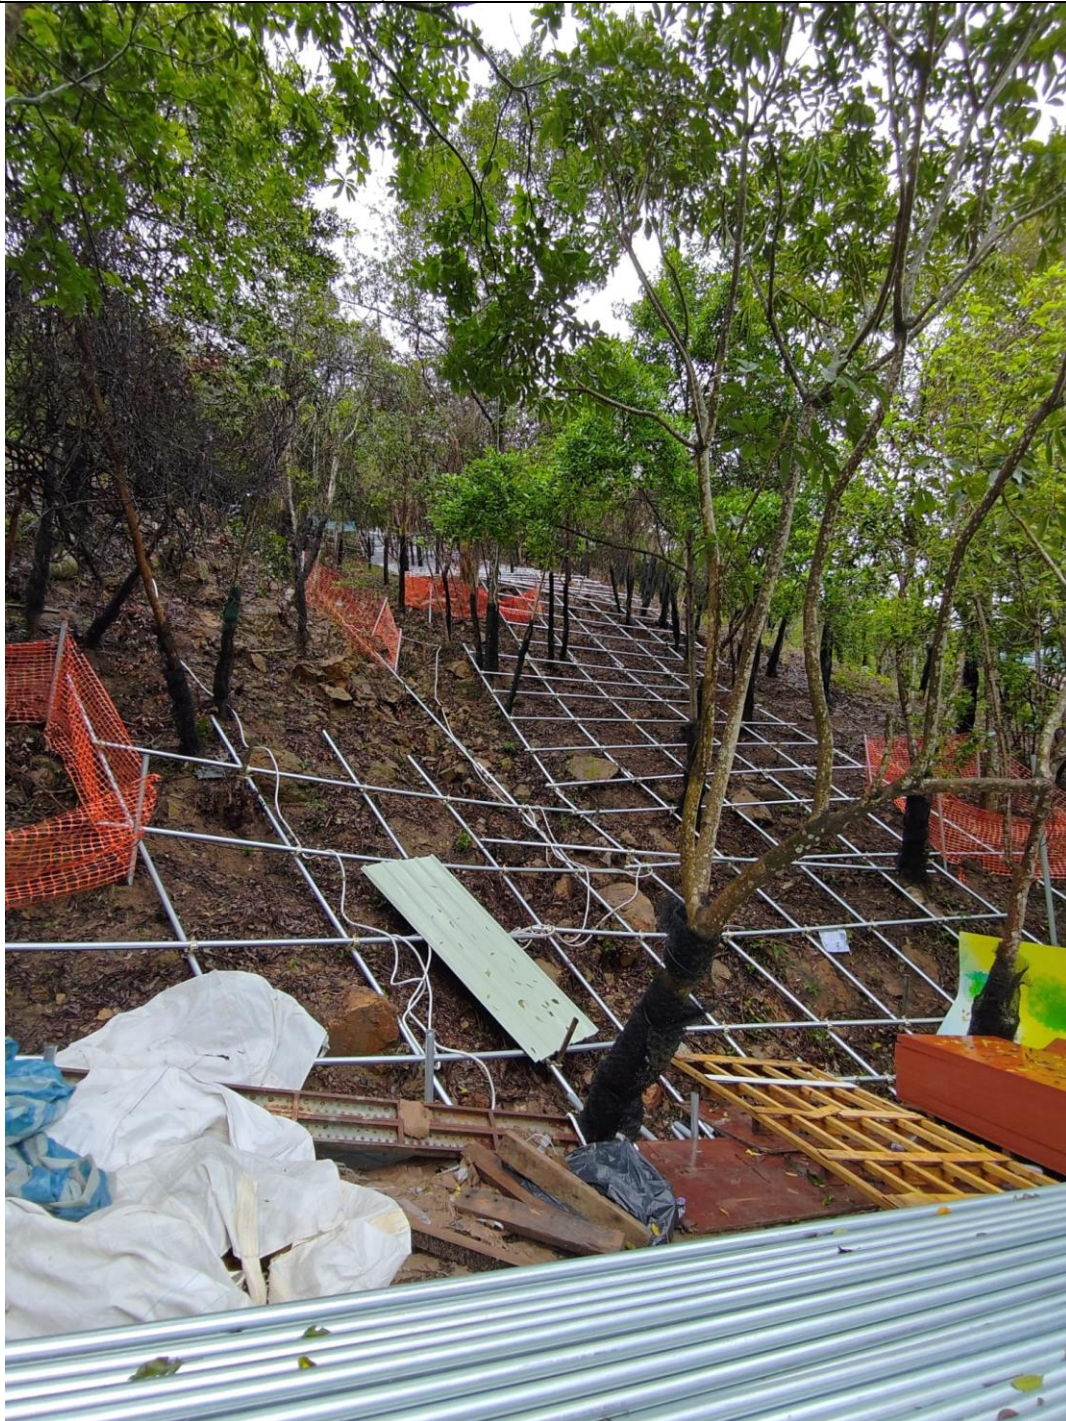
Photo 2: Site photo of Catchment B

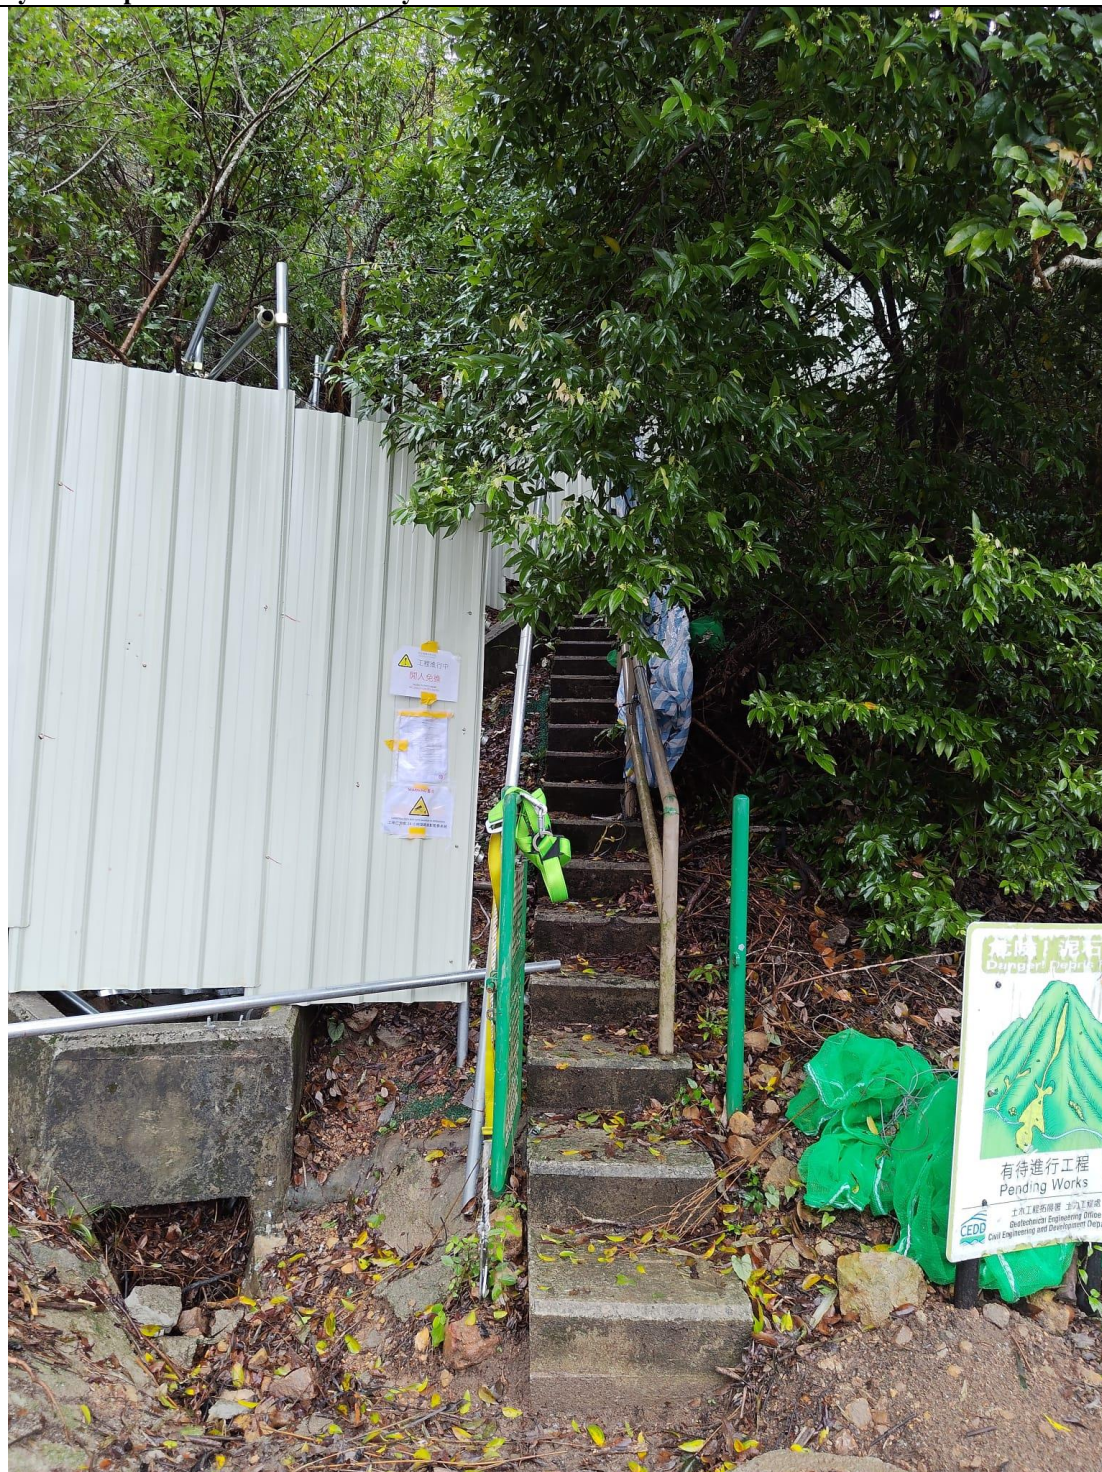
Photo 2: Site photo of Catchment C
