# Civil Engineering and Development Department

**Agreement no. CE 47/2014 (GE)  
-Landslip Prevention and Mitigation  
Programme near Bride's Pool Road,  
Tai Po – 3SE-D/SA2**

**Monthly Environmental Monitoring and  
Audit Report for  
May 2024**

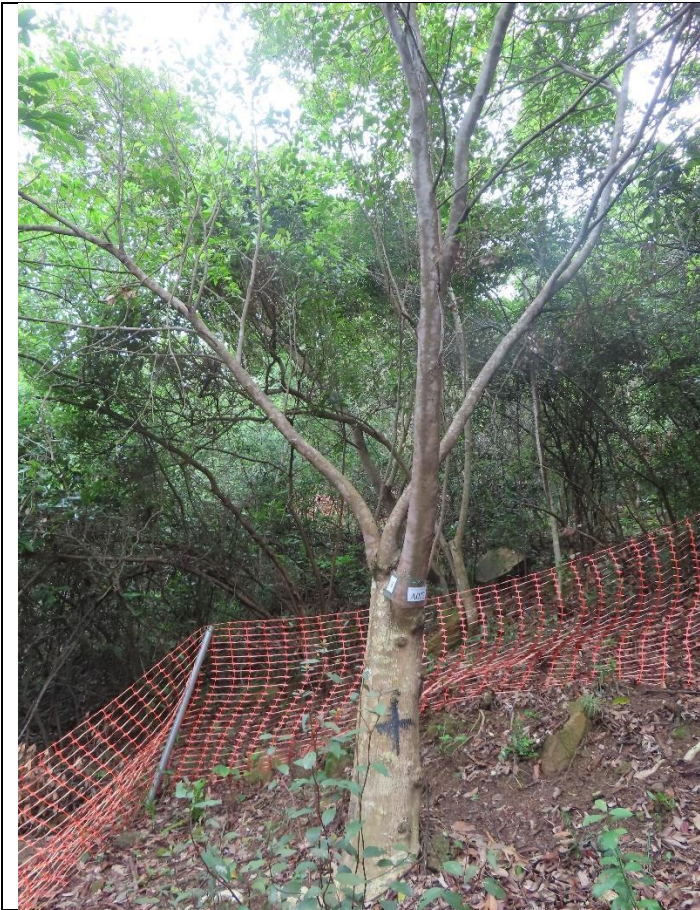
Tree No.	Chinese name	Scientific name	Jurisdiction (AFCD & Highways)	Amenity value	Form	Health	Structural condition	Conservation status	Remarks	Remarks (May)
				(High(H)/ Medium(M)/ Low(L))						
T62	土沉香	<i>Aquilaria sinensis</i>	AFCD	M	P	A	A	Cap 586 Near Threatened (Rare and Precious Plants of Hong Kong (Status in China)) Vulnerable (China Plant Red Data Book) Vulnerable (IUCN Redlist)	chopped	grow on slope, main trcnk chopped, water sprouts, dead branch
T65	鴨腳木	<i>Schefflera heptaphylla</i>	AFCD	M	G	A	A	/	have wound	grow on slope, covered by climbers, water sprouts
T66	銀柴	<i>Aporusa dioica</i>	AFCD	L	P	A	P	/	broken branch	grow on slope, broken trunk, incline, water sprouts
T67	銀柴	<i>Aporusa dioica</i>	AFCD	L	G	A	G	/	many water sprouts, covered by climbers	grow on slope, dead branch, water sprouts
T68	鴨腳木	<i>Schefflera heptaphylla</i>	AFCD	M	G	G	G	/	covered by climbers	grow on slope, incline, covered by climbers

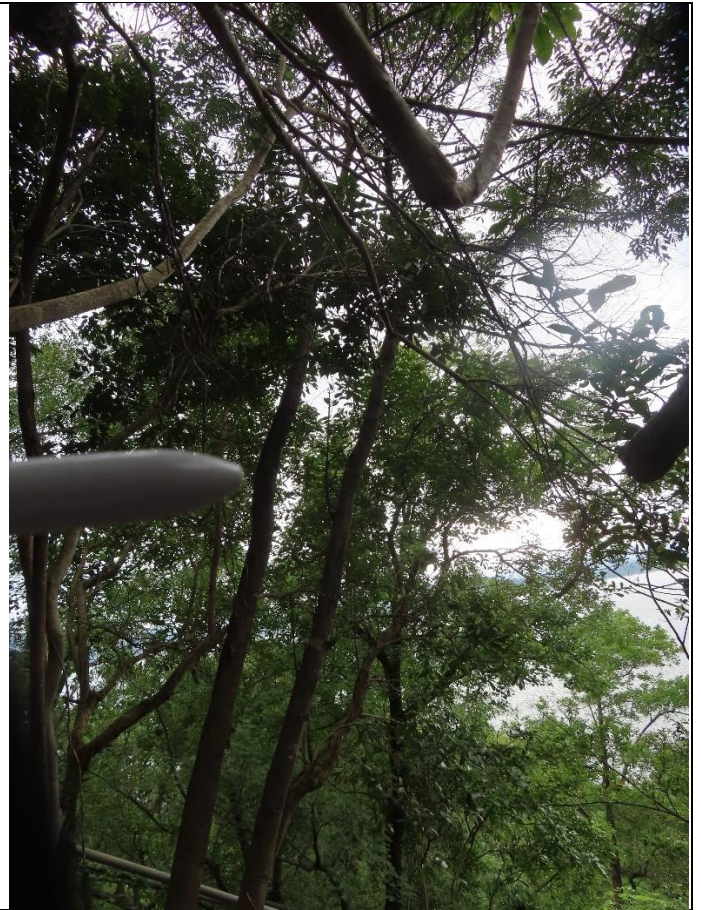
T70	魚骨木	<i>Canthium dicoccum</i>	AFCD	M	G	G	A	Vulnerable (IUCN RedList)	codominant	grow on slope, dieback, incline
T78	鴨腳木	<i>Schefflera heptaphylla</i>	AFCD	M	G	G	G	/	/	grow on slope, incline, covered by climbers
T79	鴨腳木	<i>Schefflera heptaphylla</i>	AFCD	M	G	G	G	/	covered by climbers	grow on slope, covered by climbers, broken branches
T81	竹節樹	<i>Carallia brachiata</i>	AFCD	M	P	A	P	/	chopped	grow on slope, broken trunk, water sprouts
T87	陰香	<i>Cinnamomum burmannii</i>	Highways	M	A	G	P	/	/	grow on slope, water sprouts, chopped branch
T88	水團花	<i>Adina pilulifera</i>	Highways	M	G	G	G	/	/	grow on slope, grow on concrete, water sprouts, broken trunk
T98	野漆樹	<i>Rhus succedanea</i>	AFCD	M	P	A	P	/	many water sprouts	grow on slope, incline, covered by climbers, water sprouts

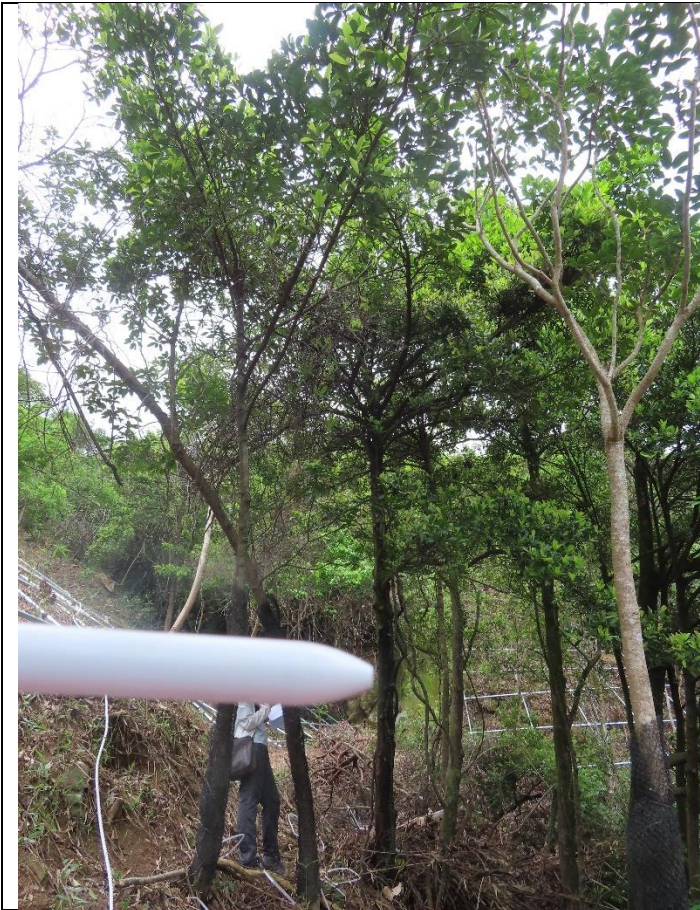
Tree No.	Chinese name	Scientific name	Jurisdiction (AFCD & Highways)	Amenity value	Form	Health	Structural condition	Conservation status	Remarks	Remarks (May)
				(High(H)/ Medium(M)/ Low(L))	(Good(G)/ Average(A)/ Poor(P))					
T100	竹節樹	<i>Carallia brachiata</i>	AFCD	M	A	G	G	/	covered by climbers	grow on slope, covered by climbers, broken branches
T101	木荷	<i>Schima superba</i>	AFCD	M	P	A	P	/	many water sprouts	grow on slope, covered by climbers, incline, water sprouts
T102	黃牙果	<i>Garcinia oblongifolia</i>	AFCD	M	A	A	A	/	covered by climbers	grow on slope, covered by climbers, incline
T103	鴨腳木	<i>Schefflera heptaphylla</i>	AFCD	M	G	A	A	/	many water sprouts	grow on slope, broken branches, water sprouts, exposed root
T104	鴨腳木	<i>Schefflera heptaphylla</i>	AFCD	M	G	G	G	/	/	grow on slope, covered by climbers, exposed root
T105	銀柴	<i>Aporosa dioica</i>	AFCD	M	P	G	P	/	many water sprouts	grow on slope, broken branches, chopped branch, incline

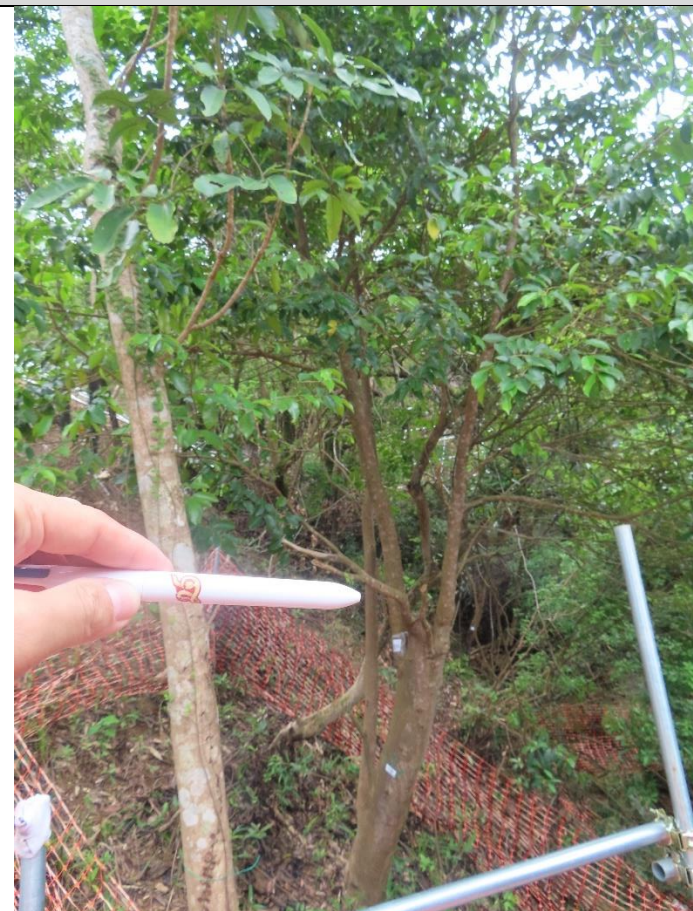
T106	土沉香	<i>Aquilaria sinensis</i>	AFCD	M	A	A	A	Cap 586 Near Threatened (Rare and Precious Plants of Hong Kong (Status in China)) Vulnerable (China Plant Red Data Book) Vulnerable (IUCN Redlist)	broken branch	grow on slope, covered by climbers, water sprouts
T107	鴨腳木	<i>Schefflera heptaphylla</i>	AFCD	M	G	G	G	/	/	grow on slope, dieback, broken branches, incline
T108	鴨腳木	<i>Schefflera heptaphylla</i>	AFCD	M	P	P	P	/	/	grow on slope, co-dominant, covered by climbers, low foliage, broken branches
T110	dead tree	/	AFCD	N/A	N/A	N/A	N/A	N/A	/	/
T111	鴨腳木	<i>Schefflera heptaphylla</i>	AFCD	M	P	P	P	L	covered by climbers, many water sprouts	grow on slope, incline, covered by climbers, water sprouts
T112	竹節樹	<i>Carallia brachiata</i>	AFCD	M	G	G	G	L	covered by climbers	grow on slope, exposed root, covered by climbers, dieback
T113	鴨腳木	<i>Schefflera heptaphylla</i>	AFCD	M	P	P	P	L	multi-trunk, many water sprouts	grow on slope, covered by climbers, broken branches, dead branch, exposed root

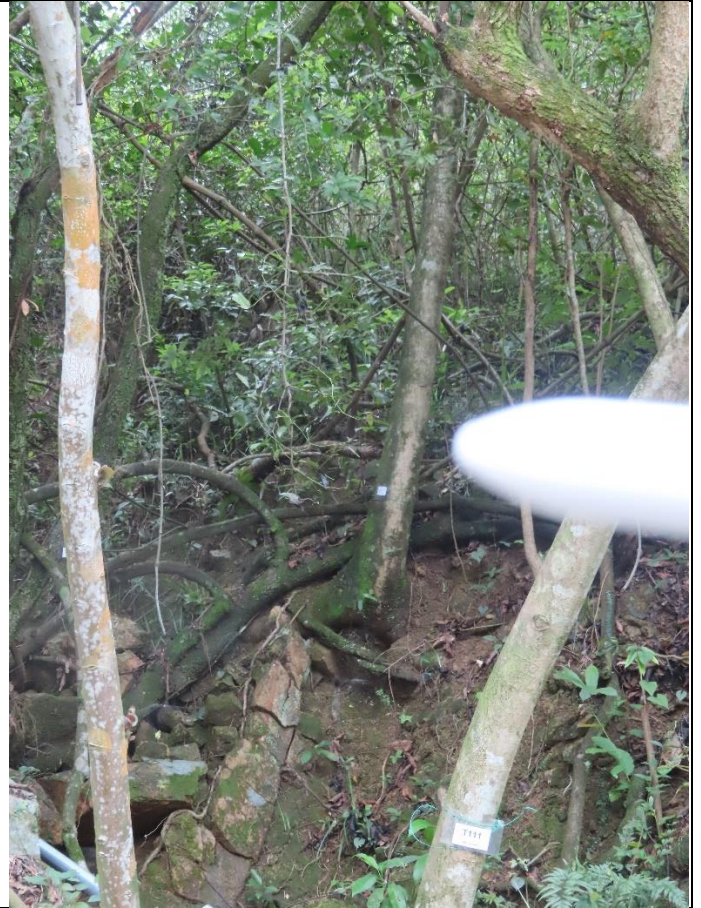
Tree No.	Chinese name	Scientific name	Jurisdiction (AFCD & Highways)	Amenity value	Form	Health	Structural condition	Conservation status	Remarks	Remarks (May)
				(High(H)/ Medium(M)/ Low(L))	(Good(G)/ Average(A)/ Poor(P))					
T114	鴨腳木	<i>Schefflera heptaphylla</i>	AFCD	M	A	A	G	L	covered by climbers	grow on slope, exposed root, incline
T333	木荷	<i>Schima superba</i>	AFCD	M	G	G	G	/	/	grow on slope, broken branches, dieback, water sprouts
T339	鴨腳木	<i>Schefflera heptaphylla</i>	AFCD	M	G	A	A	/	/	grow on slope, dead branches, broken branches, water sprouts
T342	黃牙果	<i>Garcinia oblongifolia</i>	AFCD	H	G	G	G	/	/	grow on slope, broken branches, co-dominant, dieback
T343	木荷	<i>Schima superba</i>	AFCD	G	G	G	G	/	/	grow on slope, dieback
T344	木荷	<i>Schima superba</i>	AFCD	M	G	G	G	/	/	grow on slope, dead branches, dieback, chopped branches
T345	木荷	<i>Schima superba</i>	AFCD	M	G	G	G	/	/	grow on slope, dead branches

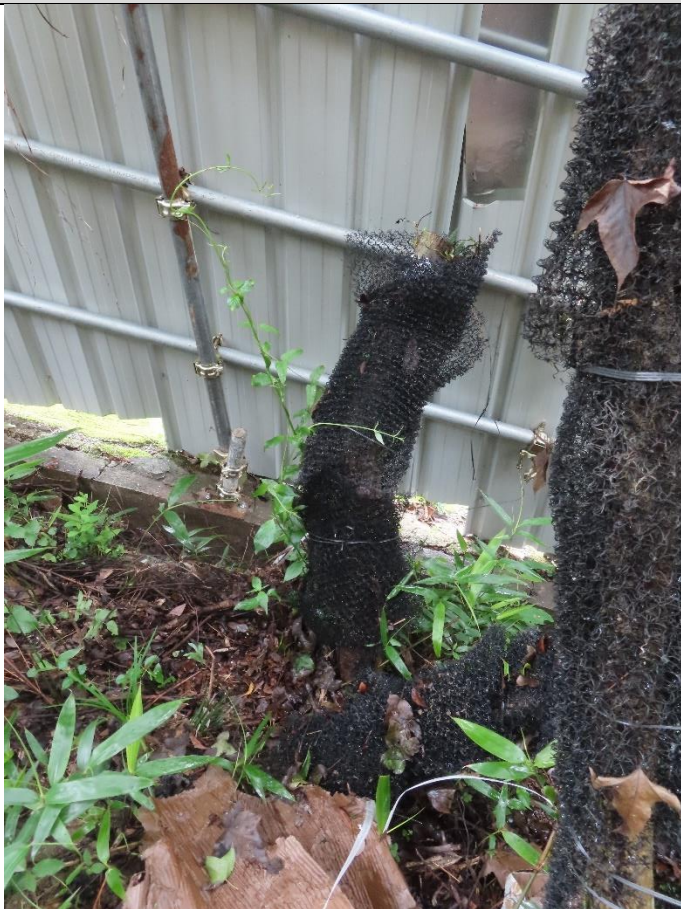
**T564 (dead, chopped)**

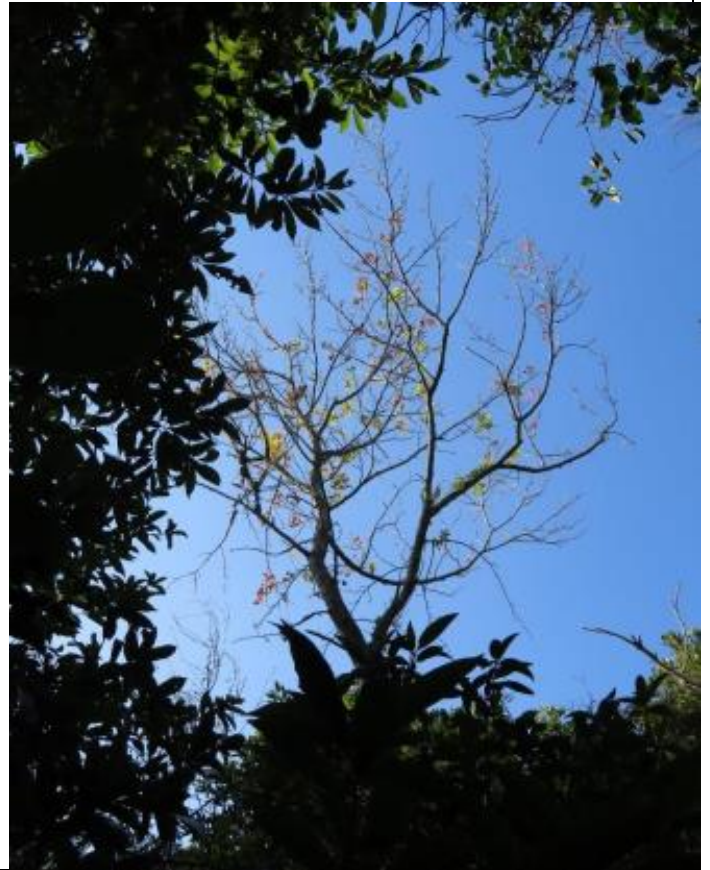
**T683 (dead)**

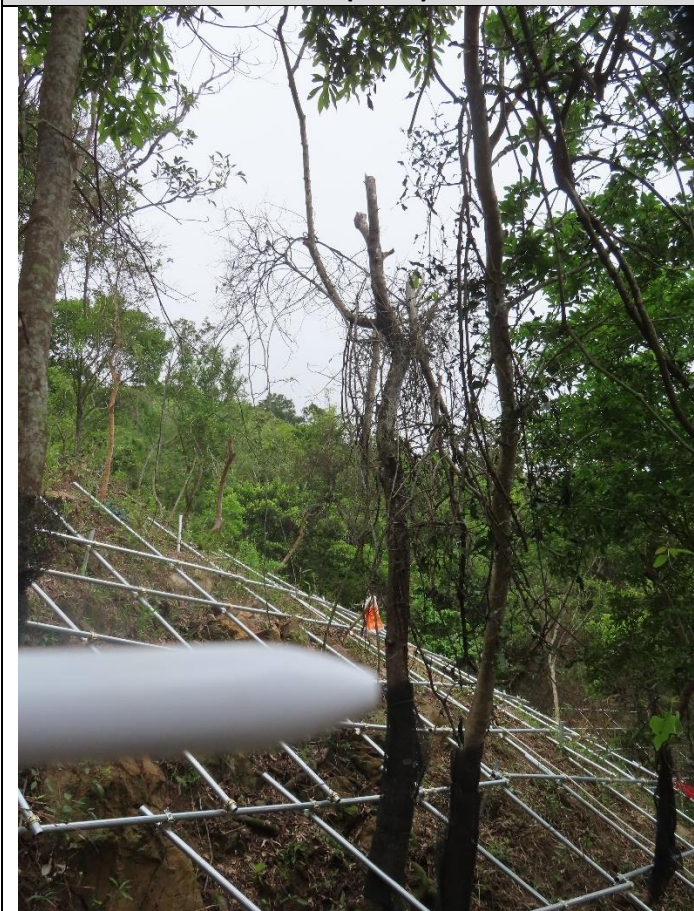
**T685 (dead)**
