Civil Engineering and Development Department

**Agreement no. CE 47/2014 (GE)
-Landslip Prevention and Mitigation
Programme near Bride's Pool Road,
Tai Po – 3SE-D/SA2**

**Monthly Environmental Monitoring and
Audit Report for
September 2024**

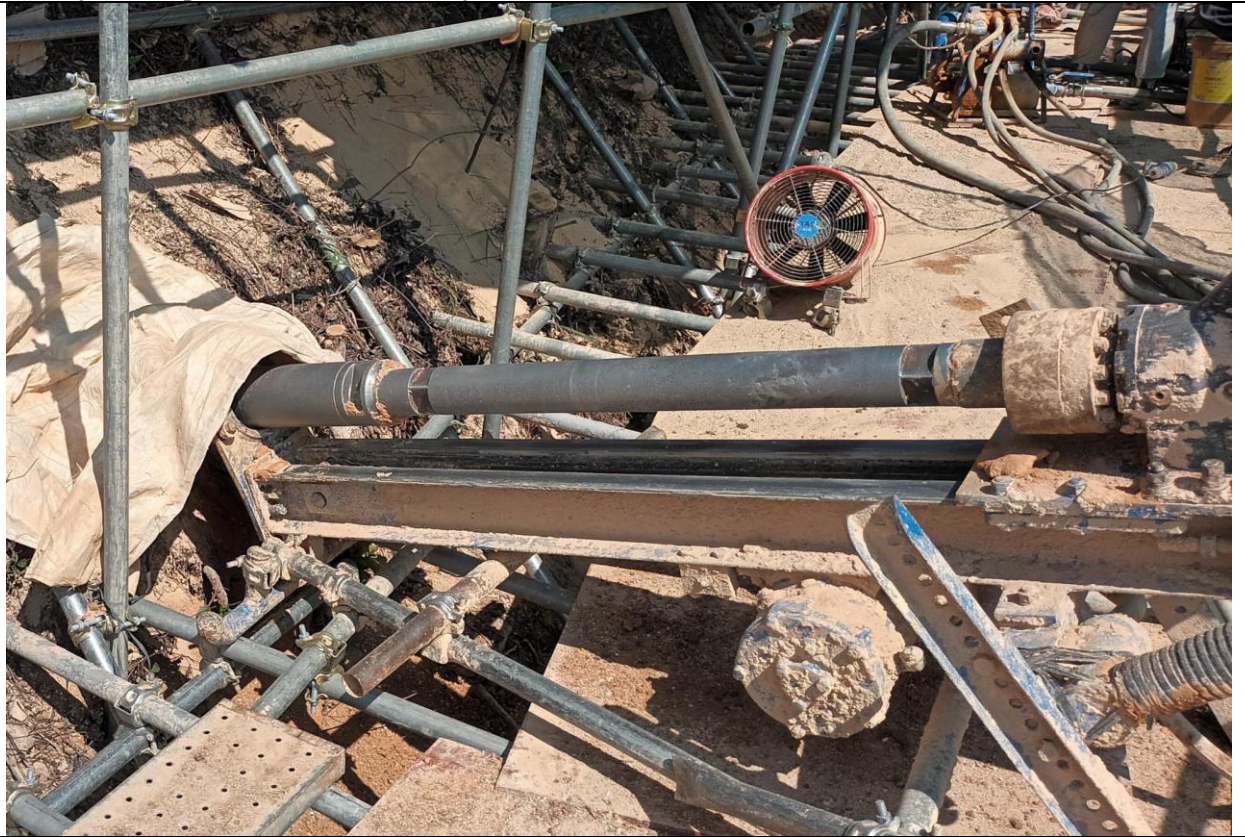
Photo 4: Site photo during soil nail process

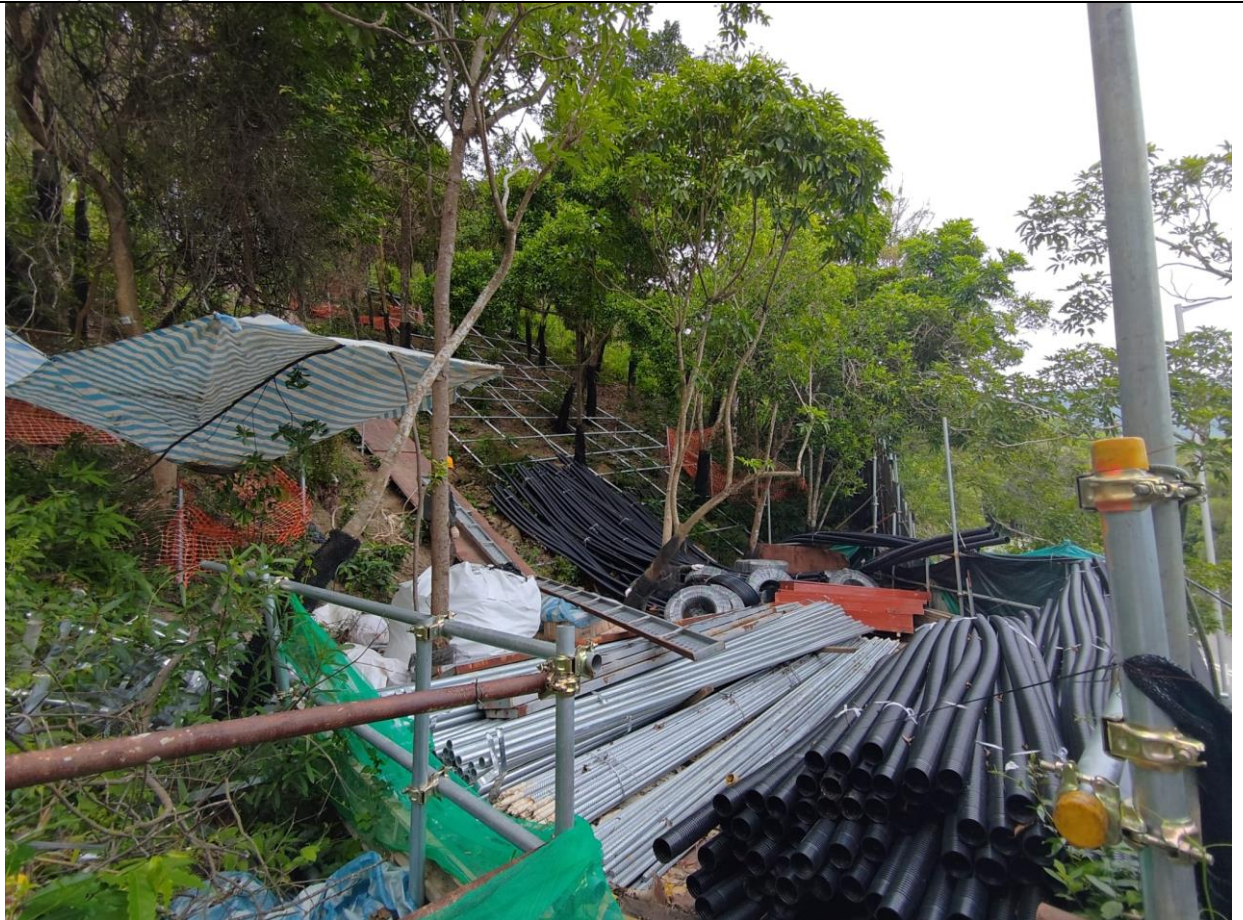
Photo 2: Site photo of Catchment B

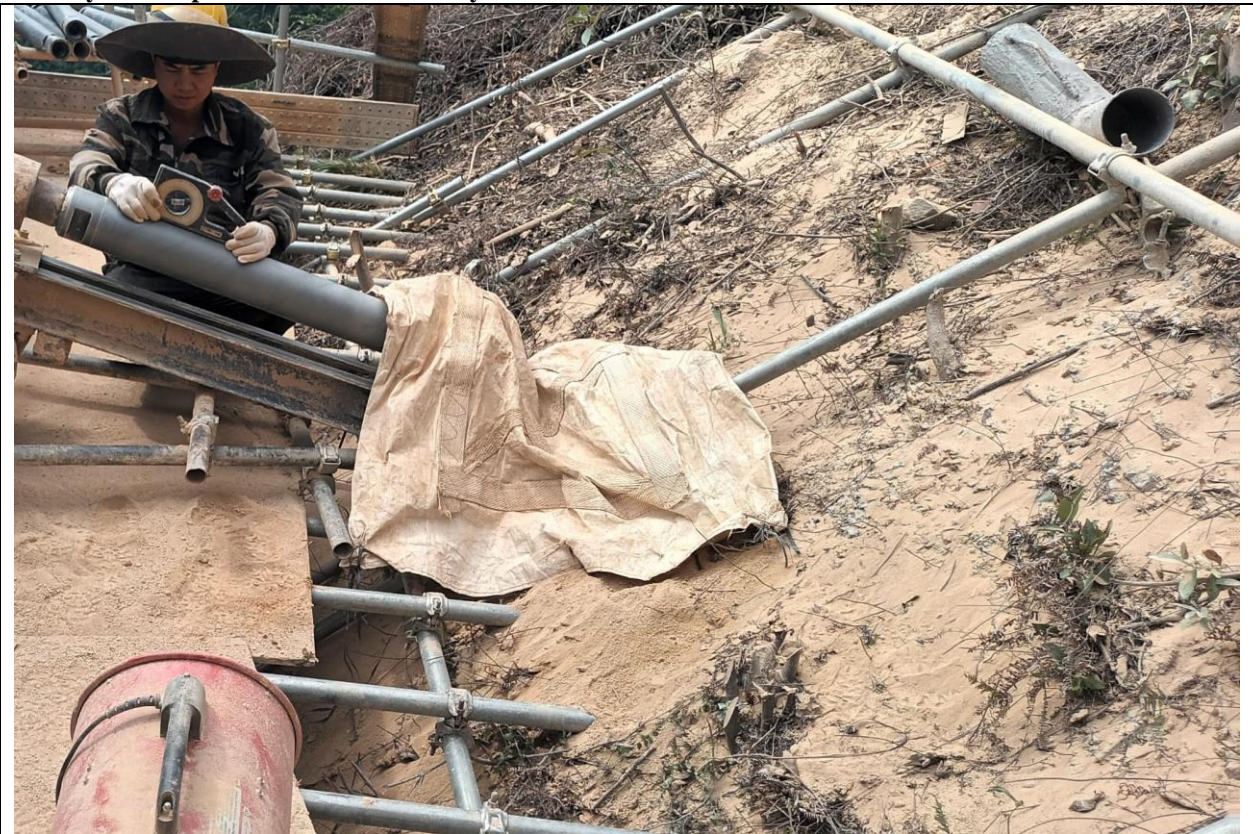
Photo 4: Site photo during soil nail process

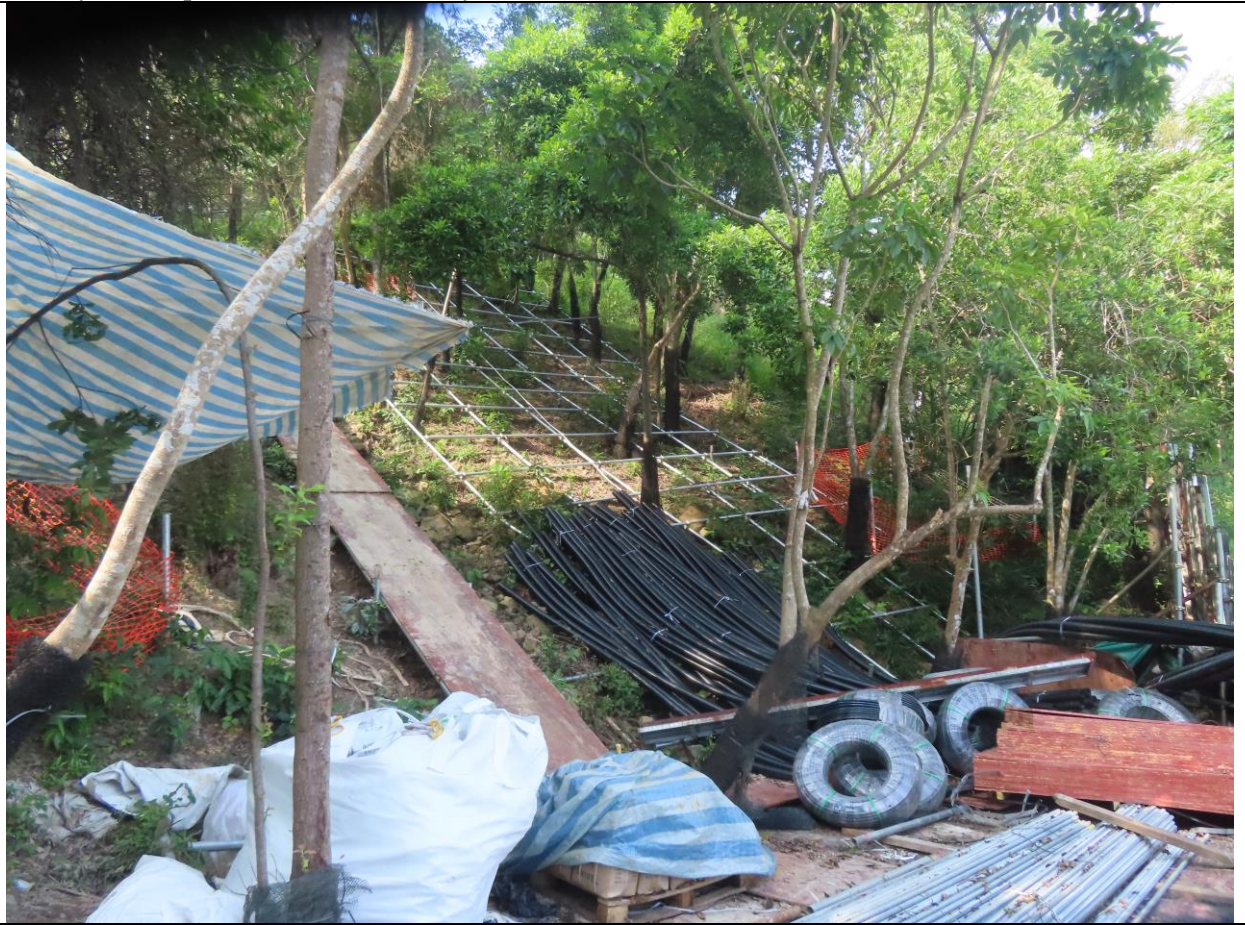
Photo 2: Site photo of Catchment B

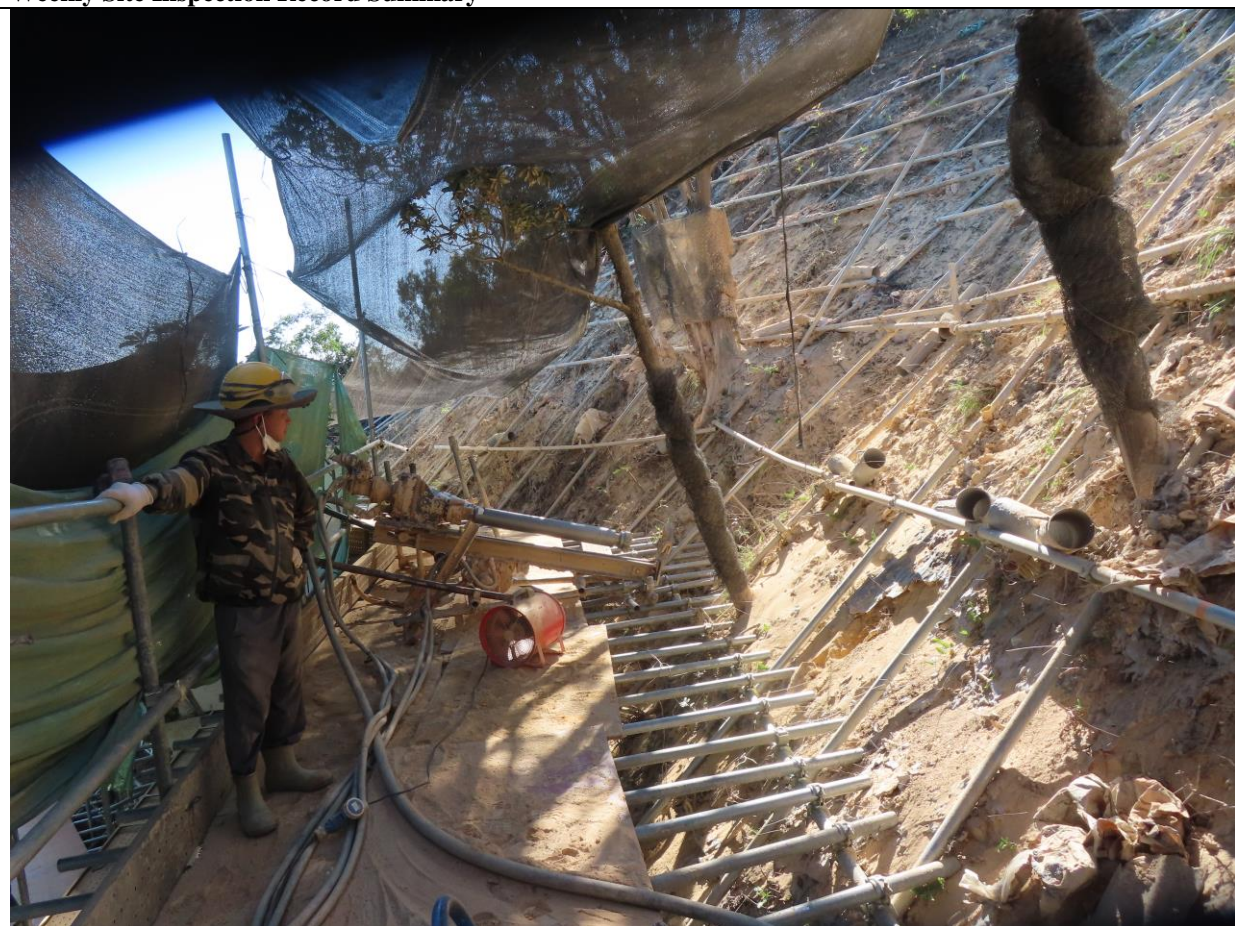
Photo 4: Site photo during soil nail process
