**Shatin to Central Link
Contract 1123 – Exhibition Station and Western Approach Tunnel
Submission of Landscape Plan for Further Environmental Permit No. FEP-13/364/2009/H
and FEP-03/376/2009**

**Shatin to Central Link –
Exhibition Station & Western Approach
Tunnel**

Landscape Plan
for
FEP-13/364/2009/H & FEP-03/376/2009

LS/20426 Contract 1123_H2624 - Exhibition Station and Western Approach Runnel
Initial Tree Survey Report

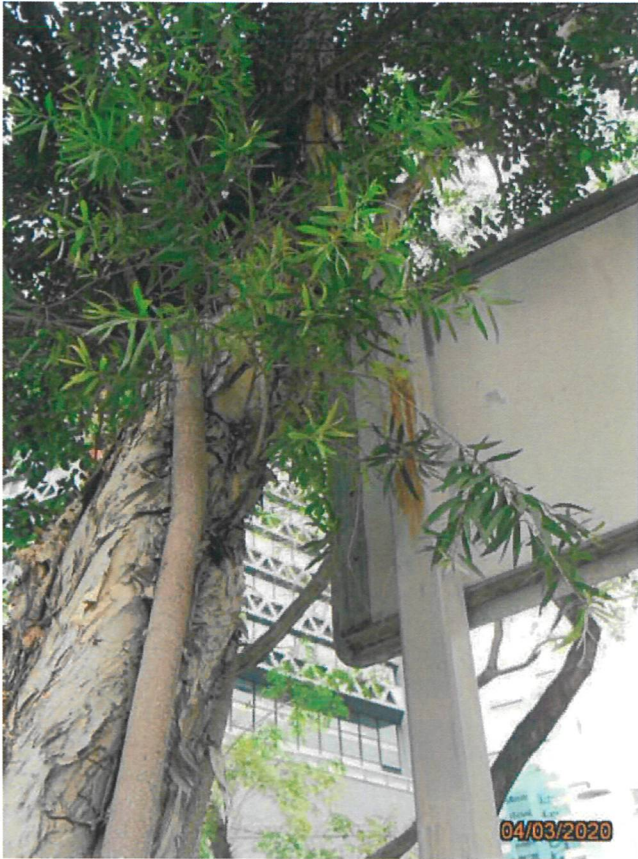
0004 - Conflict with road sign

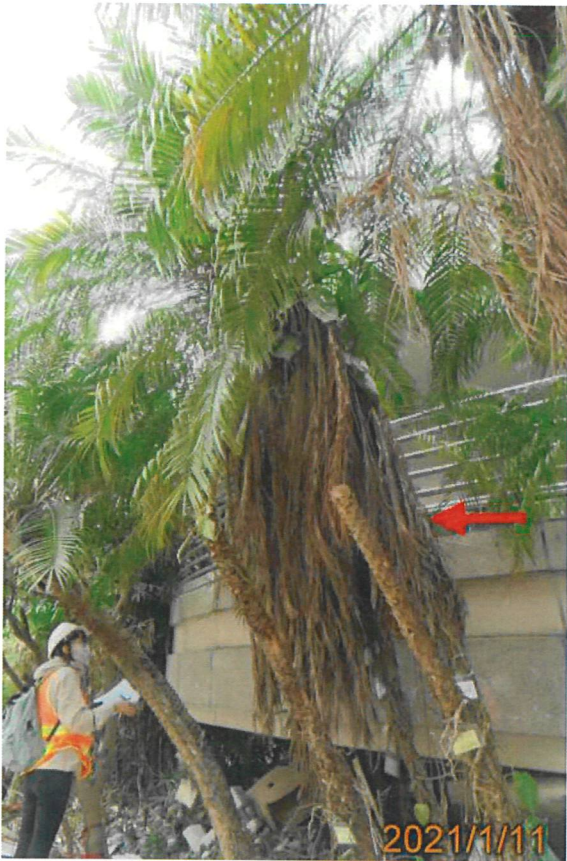
T228 - Climbers on trunk and leaning

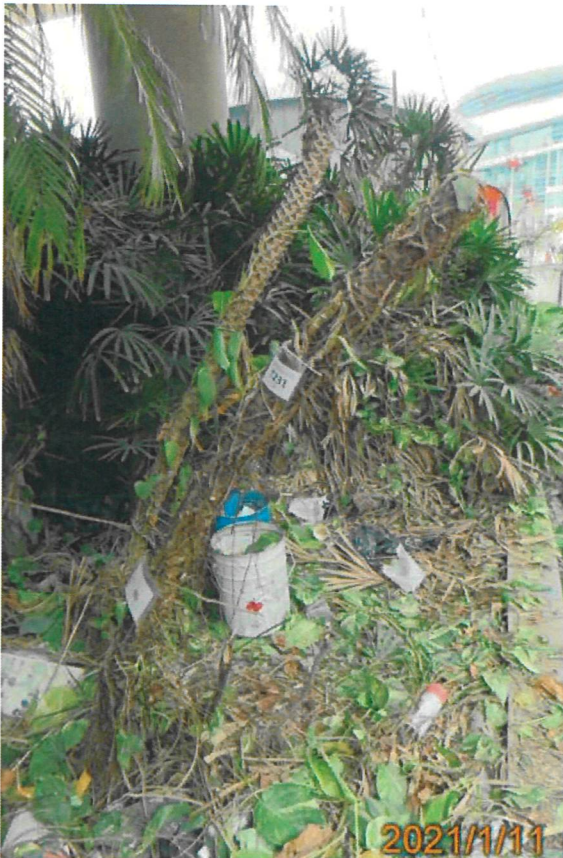
T230 - Overview

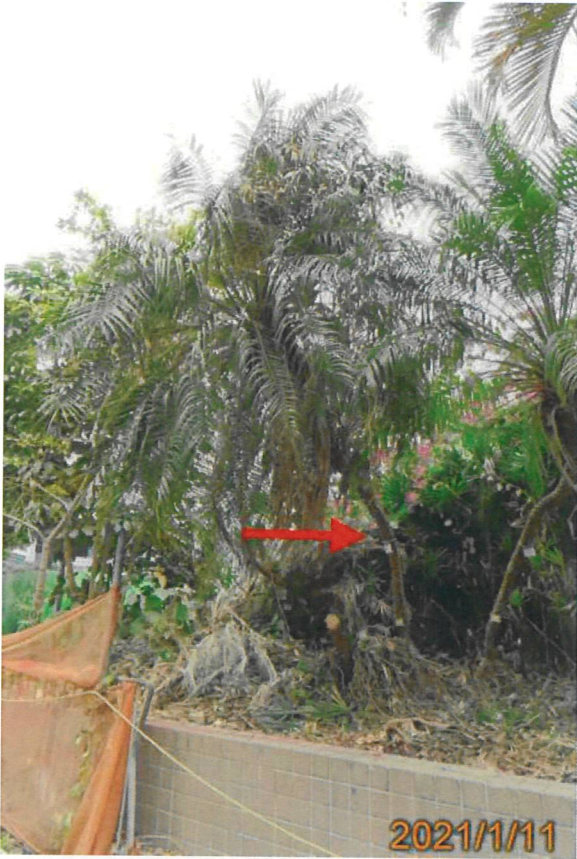
T232 - Overview, leaning and crook trunk
