Kau Sai Chau Golf Academy

Project Profile

January 2014
The Hong Kong Jockey Club

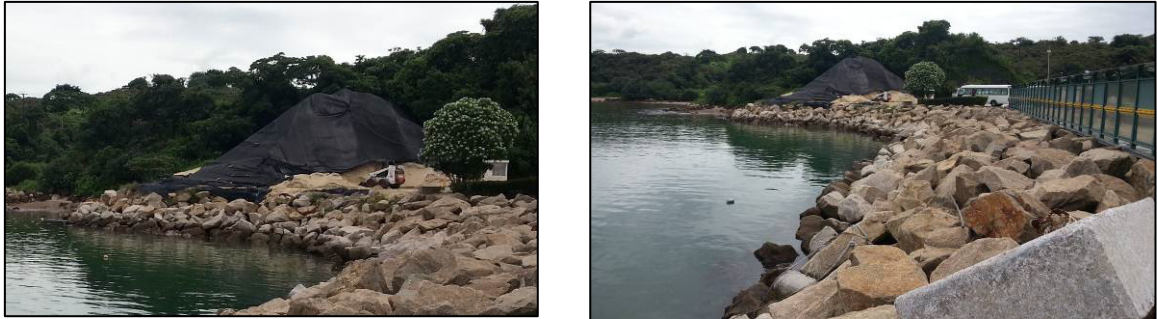
Plate 1: Area for dive survey – Note covered sand stockpile in background where barges unload

A dive survey was carried out in May 2013 on the north side of the existing jetty where barges will unload construction materials and plant. The survey was conducted over a 50 metre radius from the eastern end of the sloping seawall encompassing the north side of the jetty, the seawall north of the barge unloading area and the (sandy) seabed. The proposed barging location is at the landward end of the jetty by the existing sand stockpile.

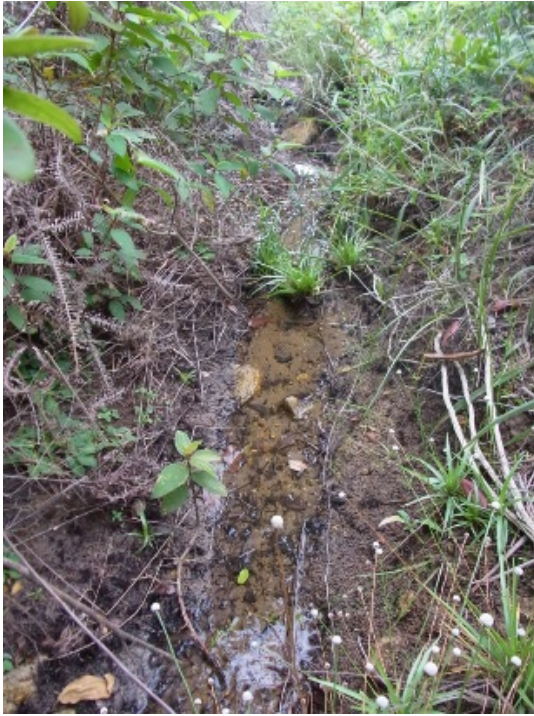
Plate 4 Intermittent flow stream

Freshwater shrimps, crab and mayfly nymph were recorded in some small puddles in the drainage channel within the Project Area (See **Figure 3.3** and **Appendix E.3 Plate 4**). These species were commonly found in Hong Kong. A list of freshwater fauna recorded is shown in Table 4 of **Appendix E**.

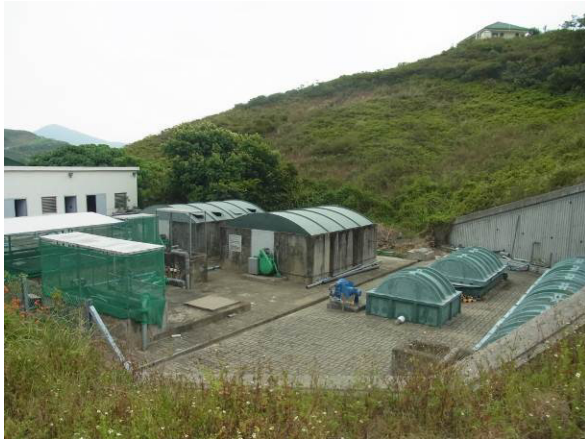
Plate 6 Existing sewage treatment plant to be upgraded
