**Development of a Biodiesel Plant at
Tseung Kwan O Industrial Estate**

**Monthly Environmental Monitoring and
Audit Report for
August 2024**

Monthly Environmental Monitoring and Audit Report No. 101 (August 2024)

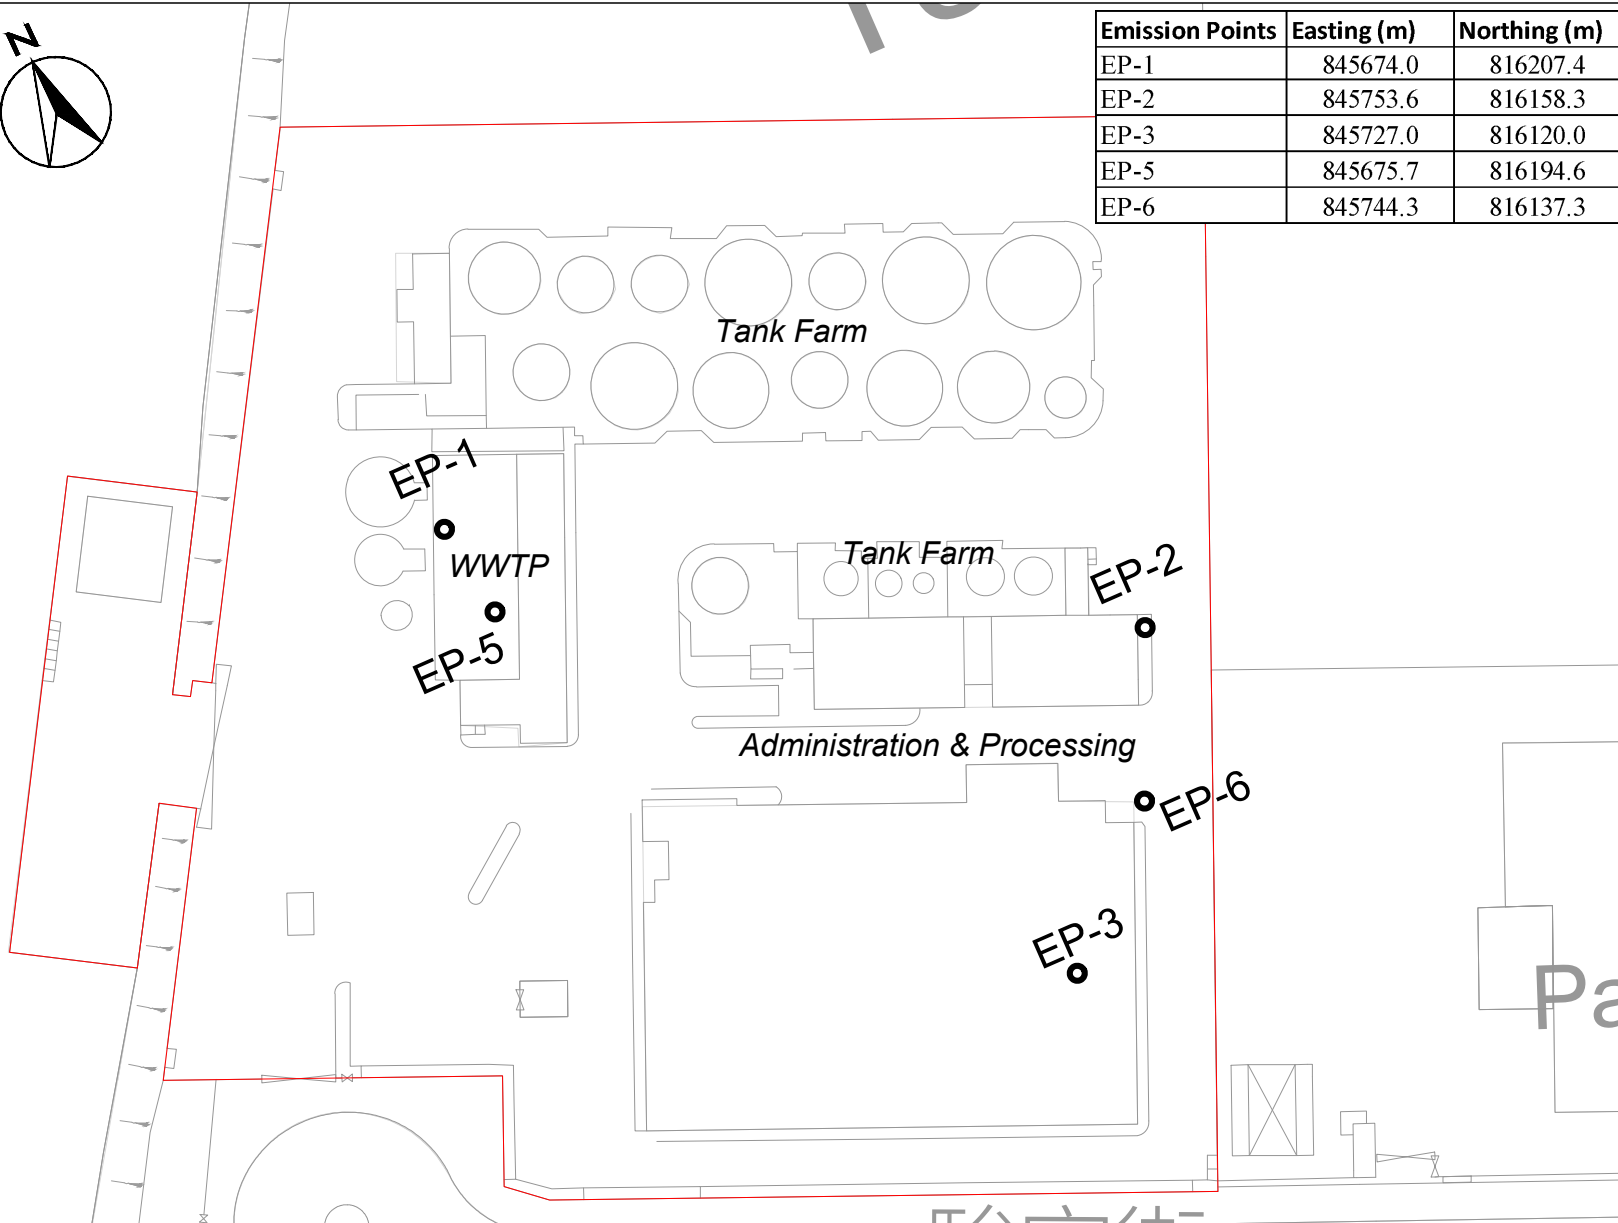
SCALE	1:1000@A4	DATE	13 May 2024
CHECK	KC	DRAWN	EH
JOB No.	MA15052	FIGURE NO.	Figure 2-1
		REV	-

- Site Boundary
- Emission Points

Operation of ASB Biodiesel Plant at Tseung Kwan O
Location Plan of Emission Points in the Plant
