## **Annex 1**

Fault Trees for Tunnel  
Blasting

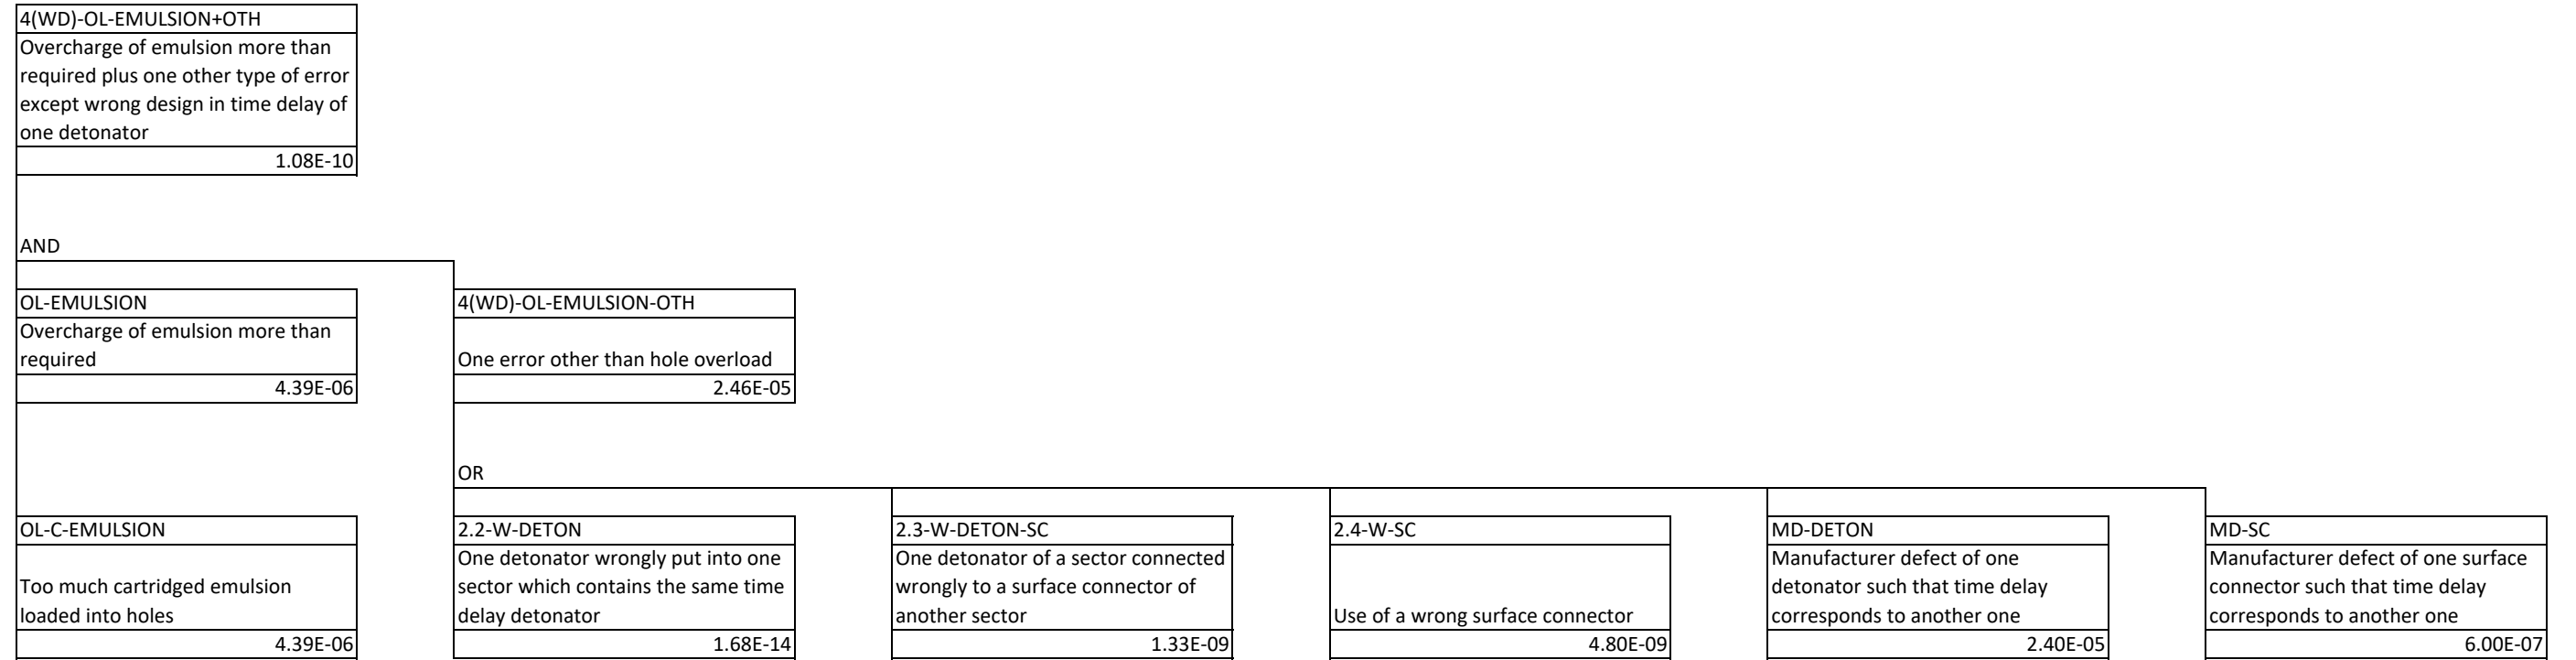
**4(WD)-OL-EMULSION+OTH Overcharge of emulsion more than required plus one other type of error except wrong design in time delay of one detonator**

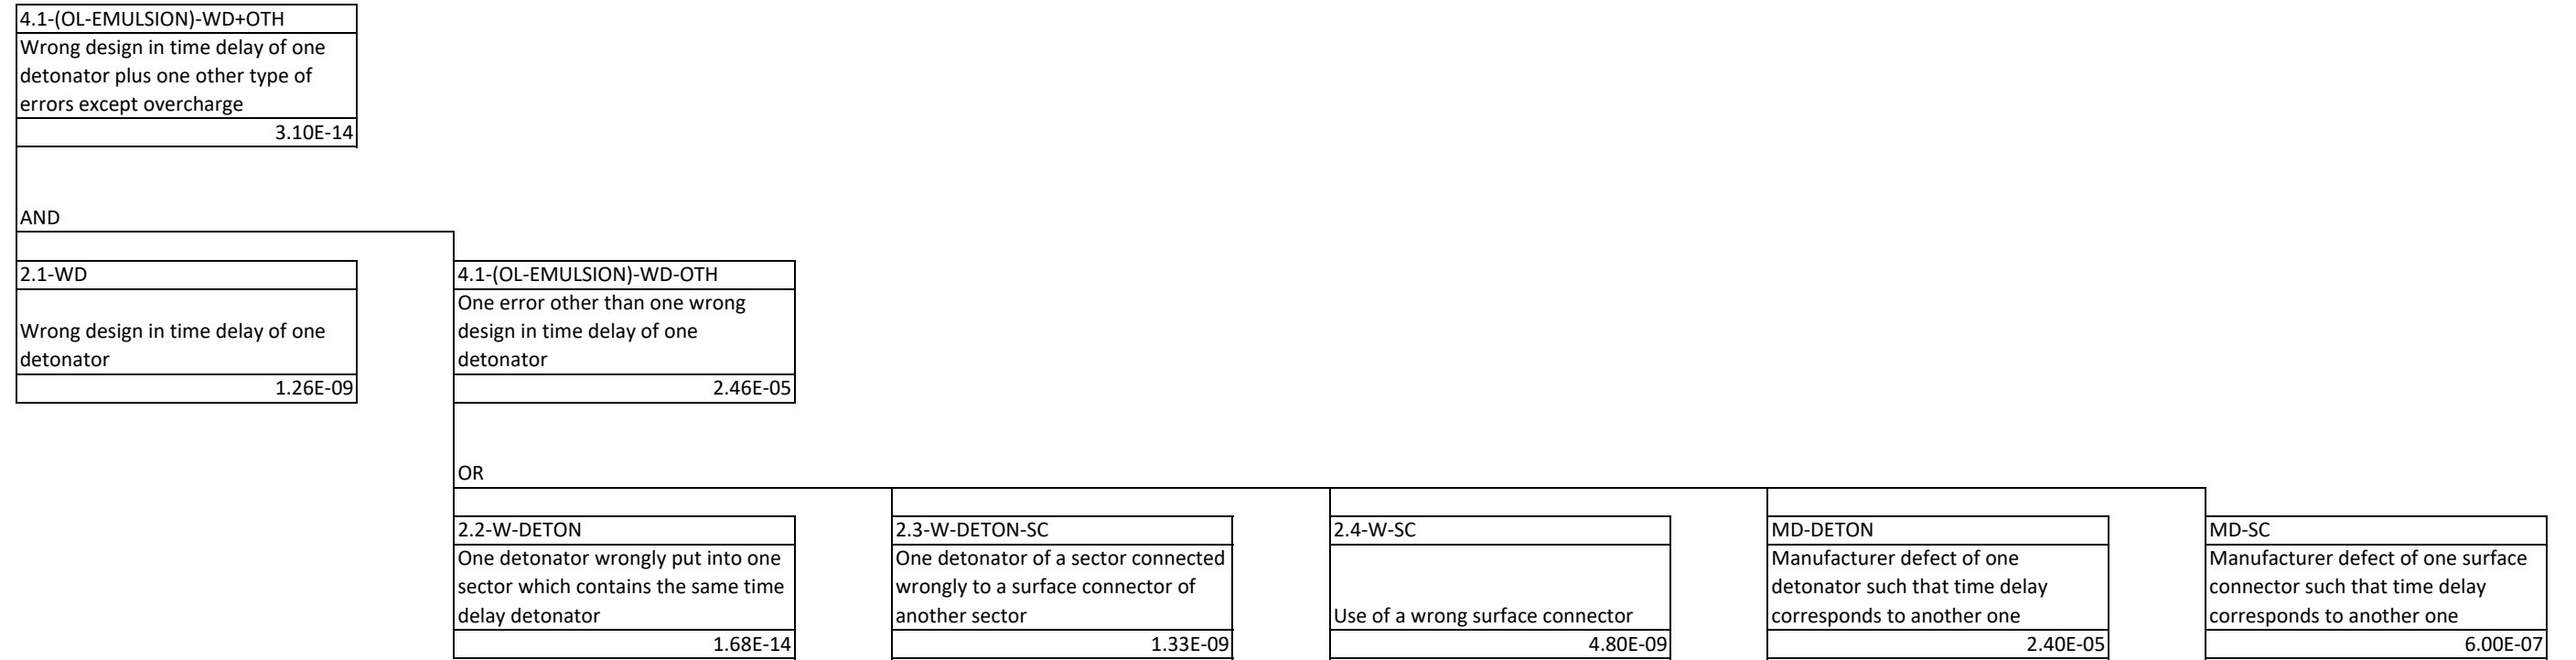
**4.1-(OL-EMULSION)-WD+OTH Wrong design in time delay of one detonator plus one other type of errors except overcharge**

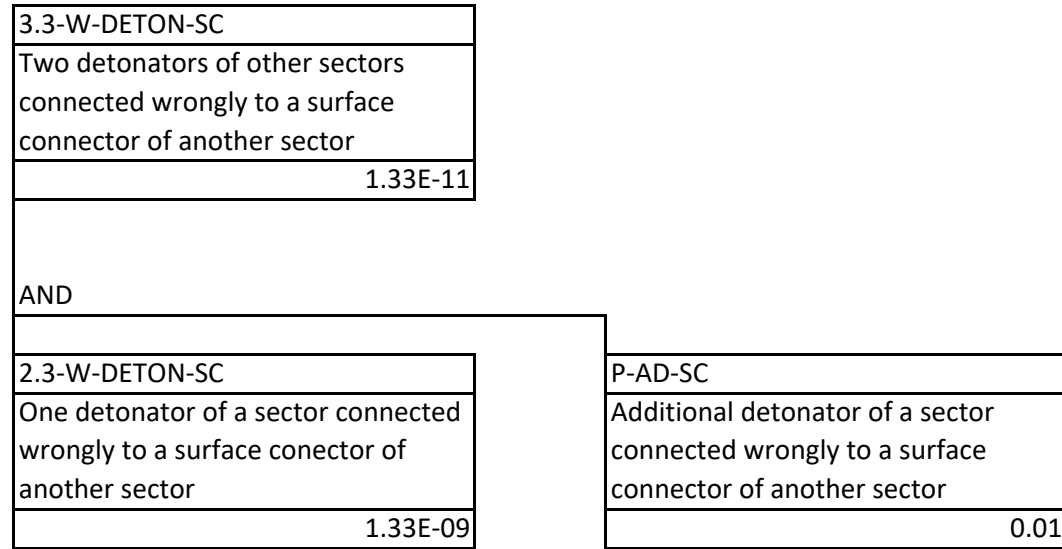
**3.3-W-DETON-SC**

**Two detonators of othe sectors connected wrongly to a surface connector of another sector**

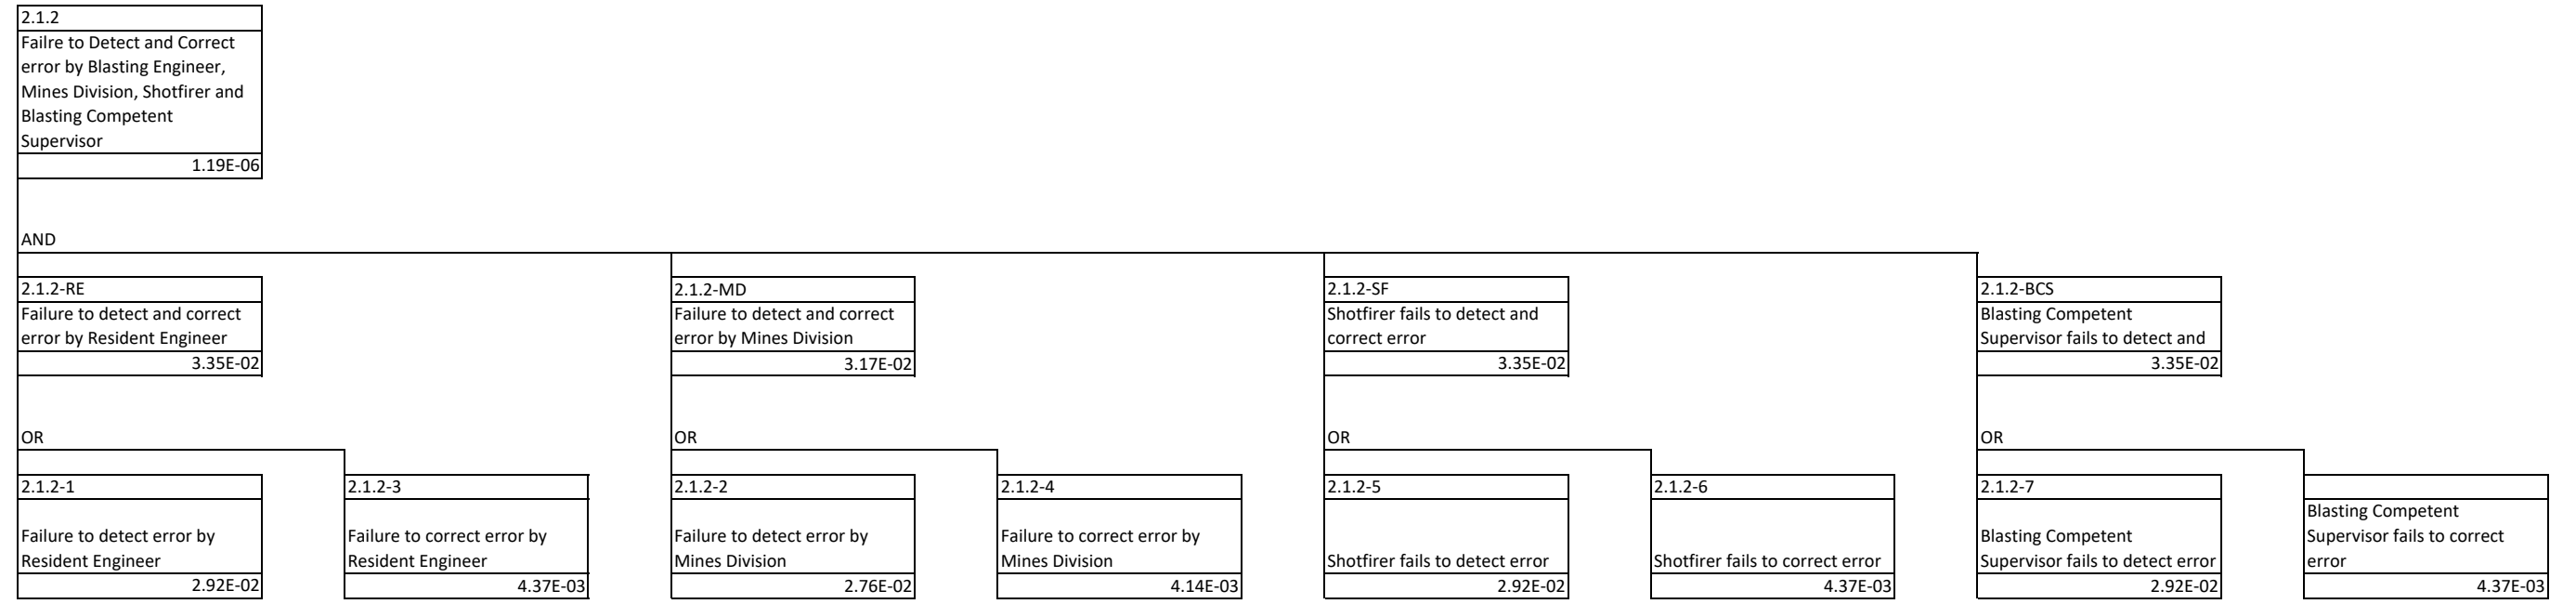
**2.1.2 Failure to detect and correct error by Blasting Engineer, Mines Division, Shotfirer and Blasting Competent Supervisor**

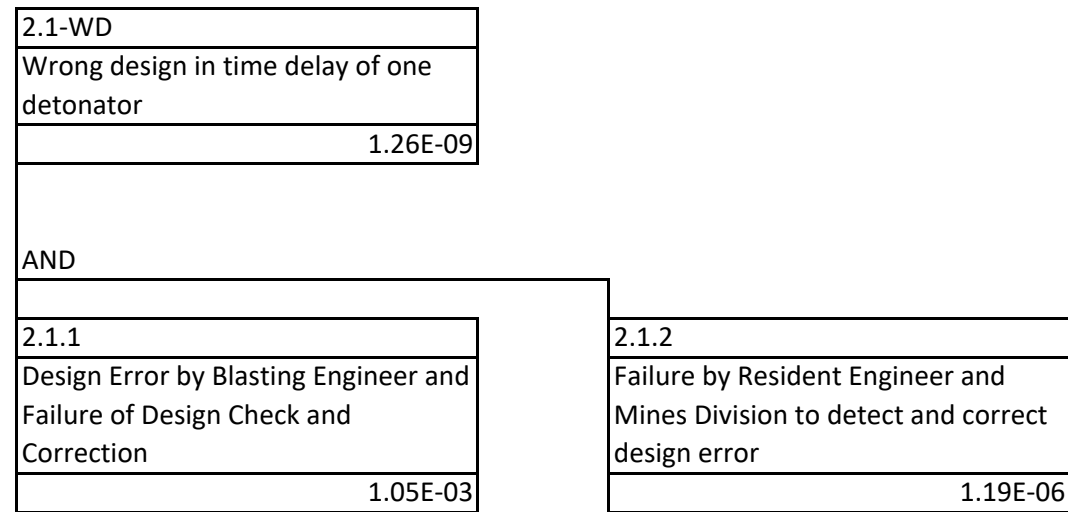
**2.1-WD**

**Wrong design in time delay of one detonator**

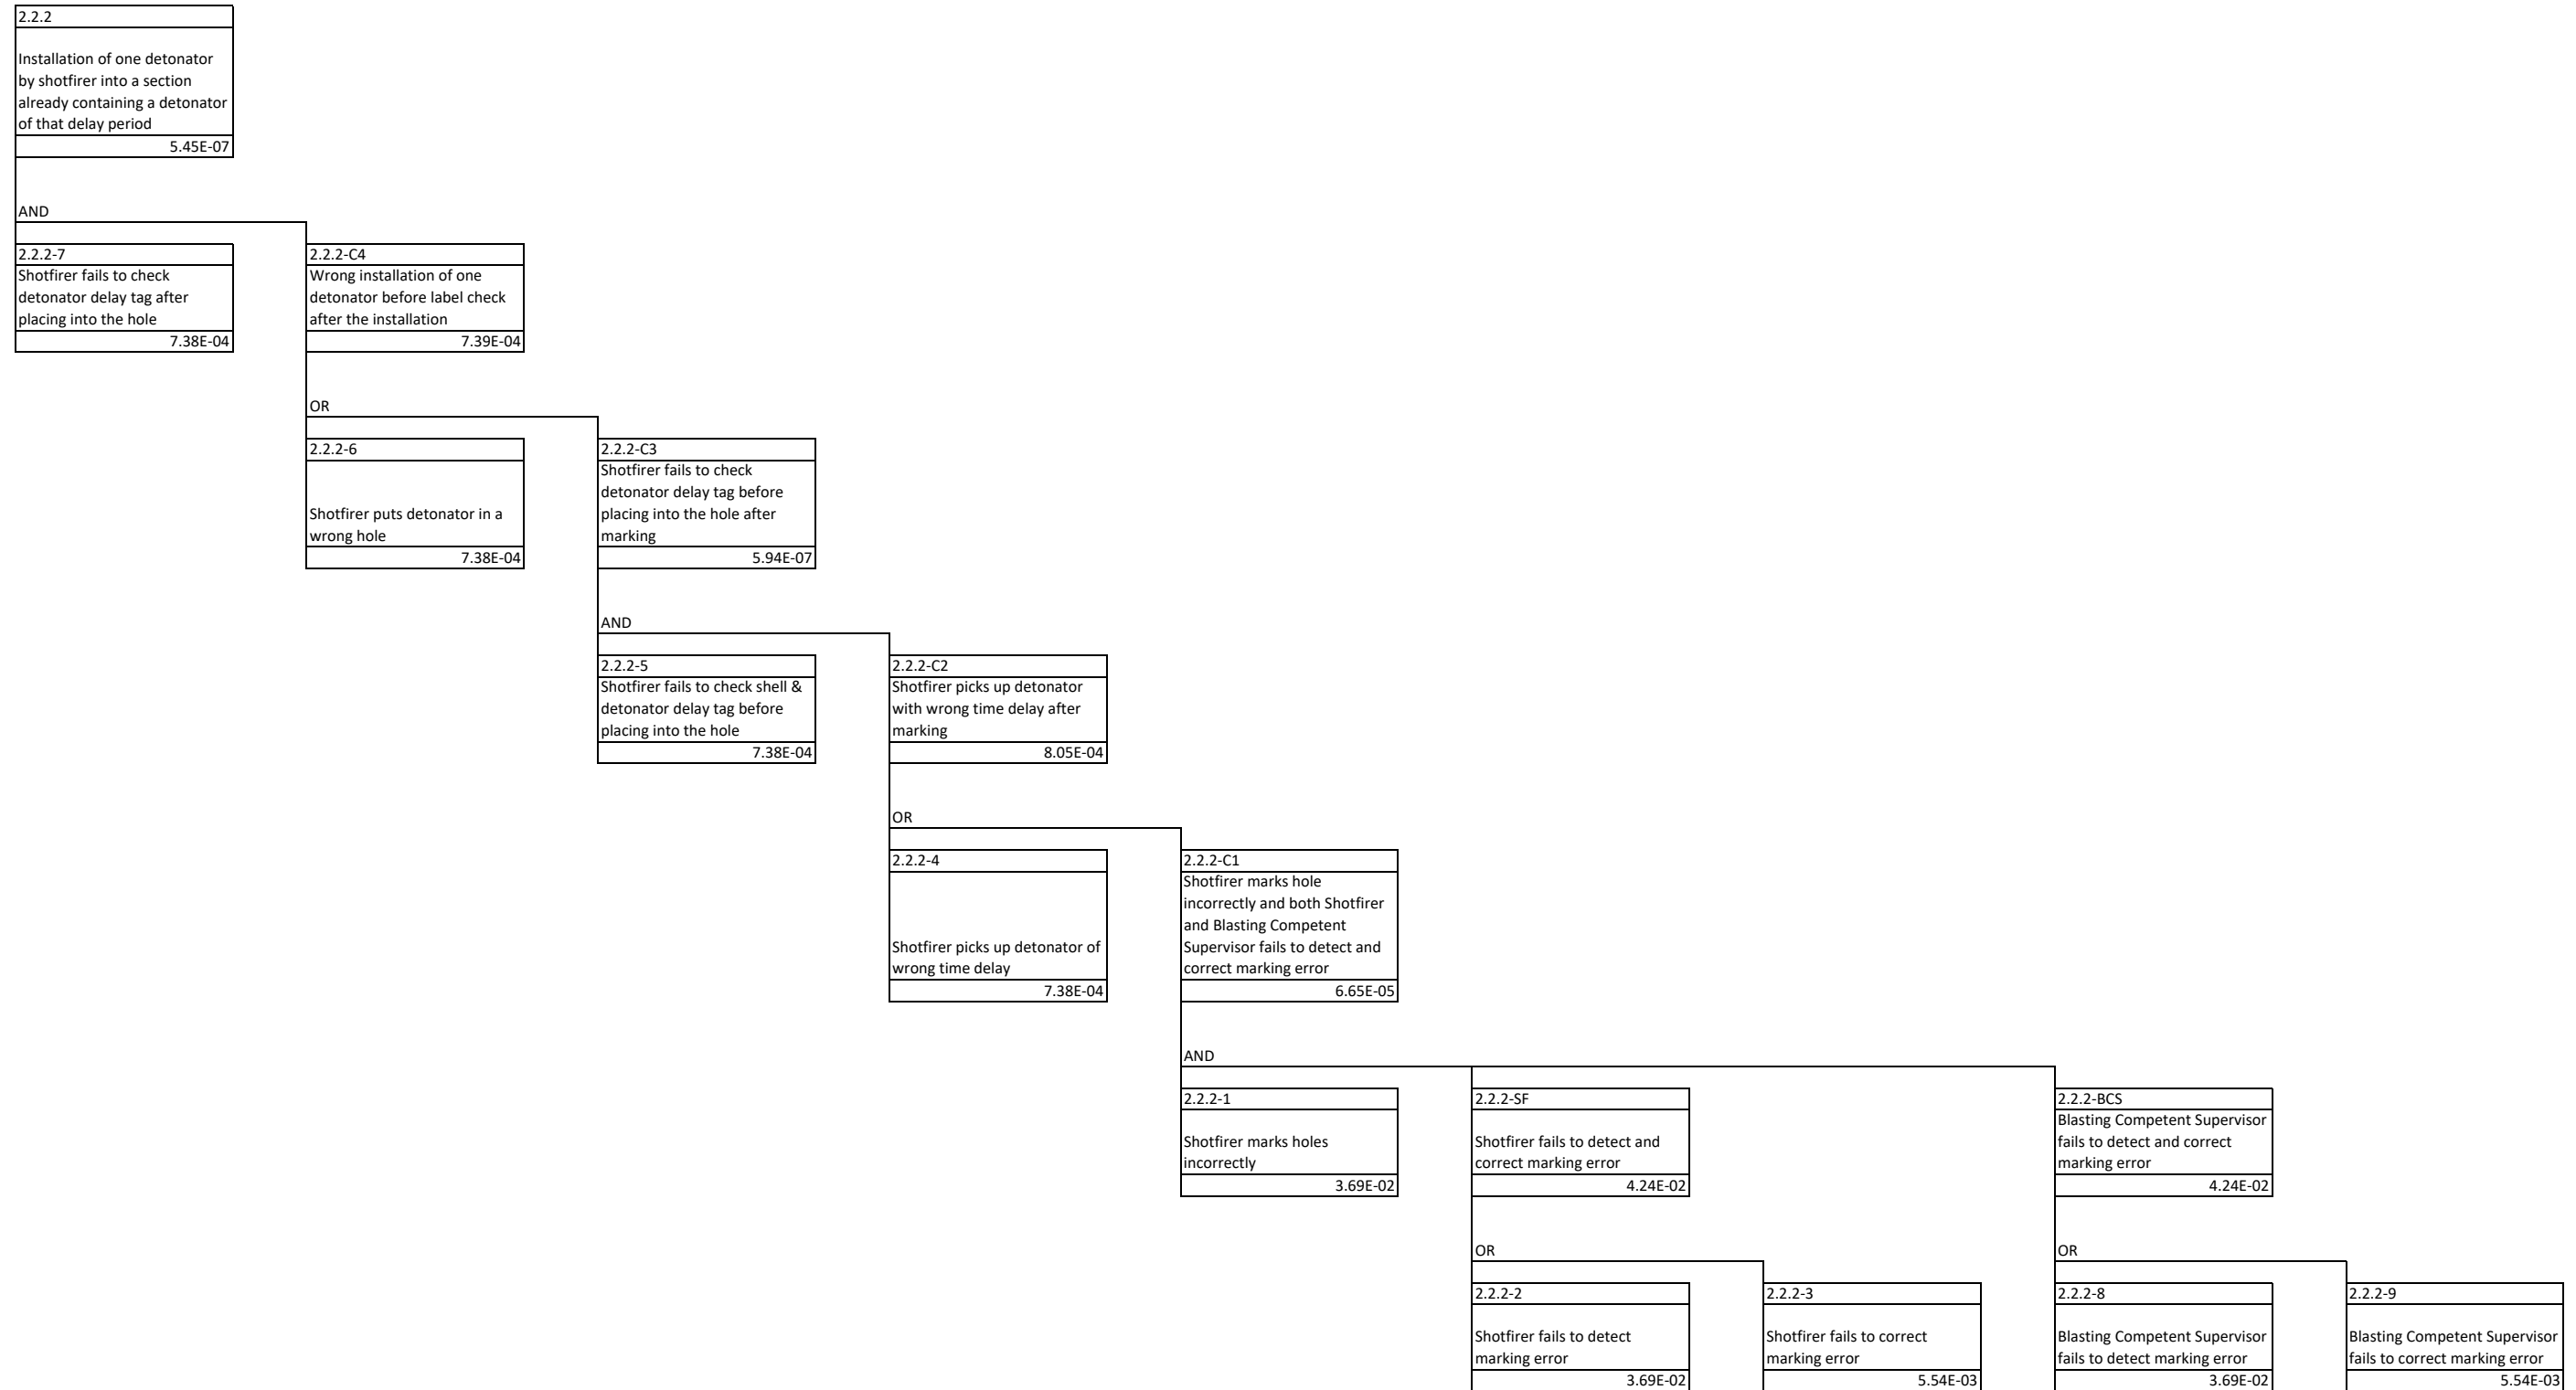
**2.2.2 Installation of one detonator by shotfirer into a section already containing a detonator of that delay period**

2.2.2
Installation of one detonator by Shotfirer into a section already containing a detonator of that delay period
1.31E-04

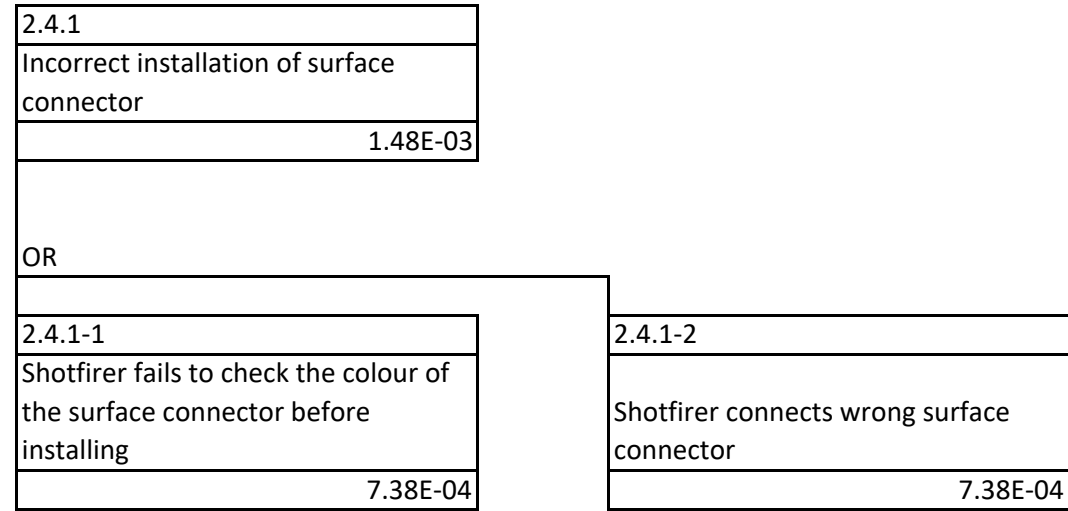
**2.4.1 Incorrect Installation of Surface Connector**

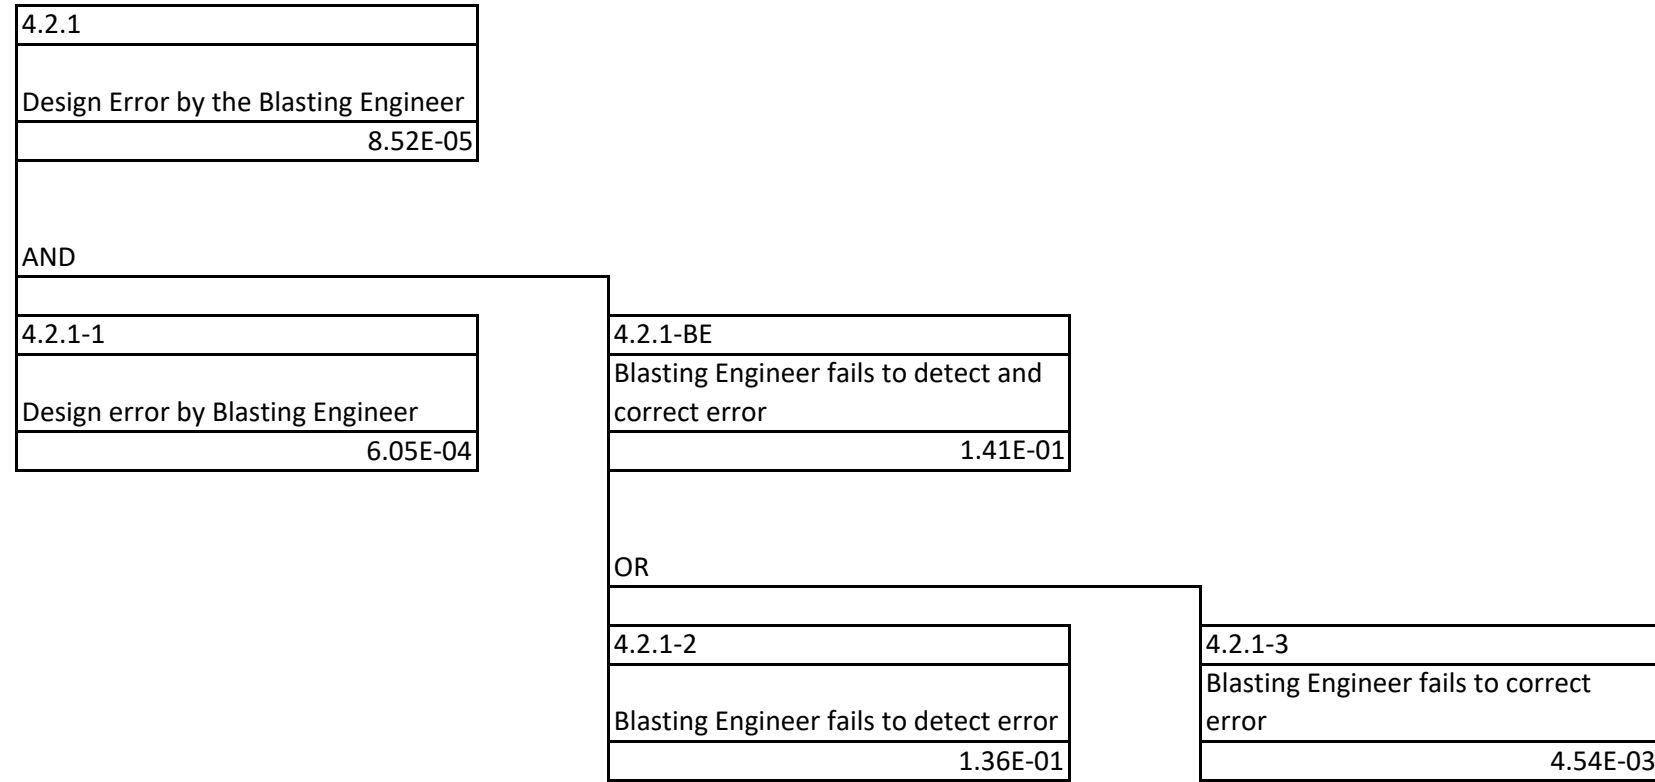
**4.2.1 Design Error by the Blasting Engineer**

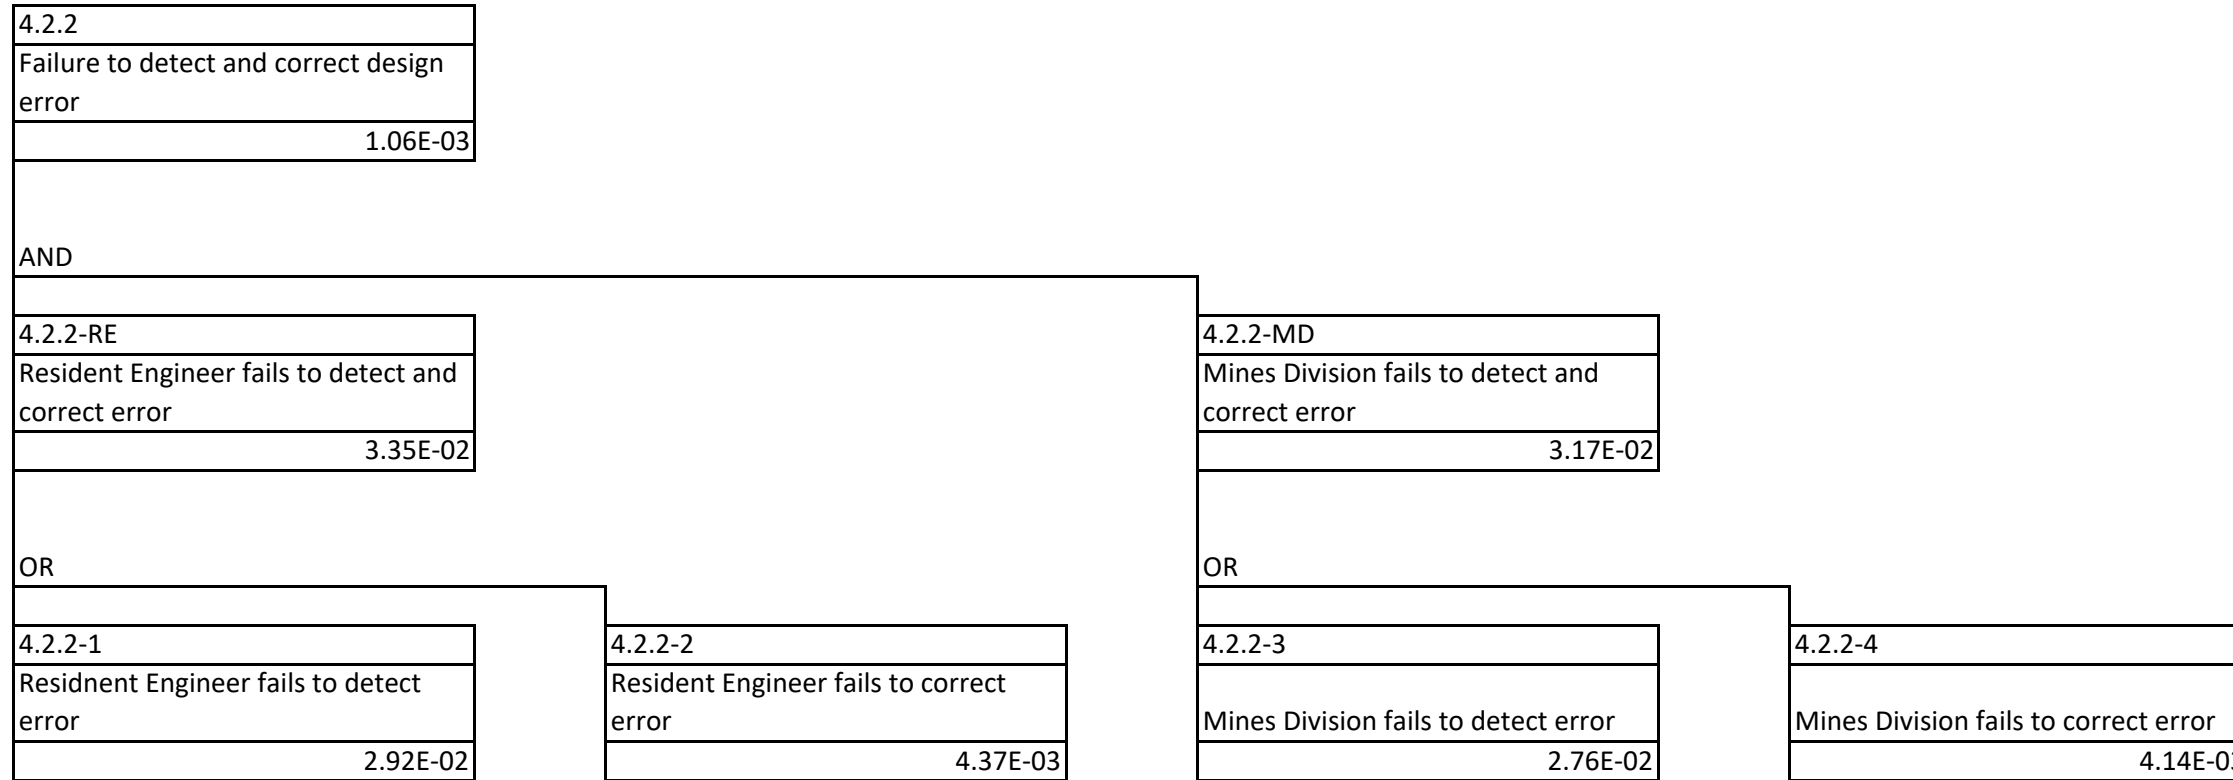
**4.2.2 Failure to detect and correct design error**

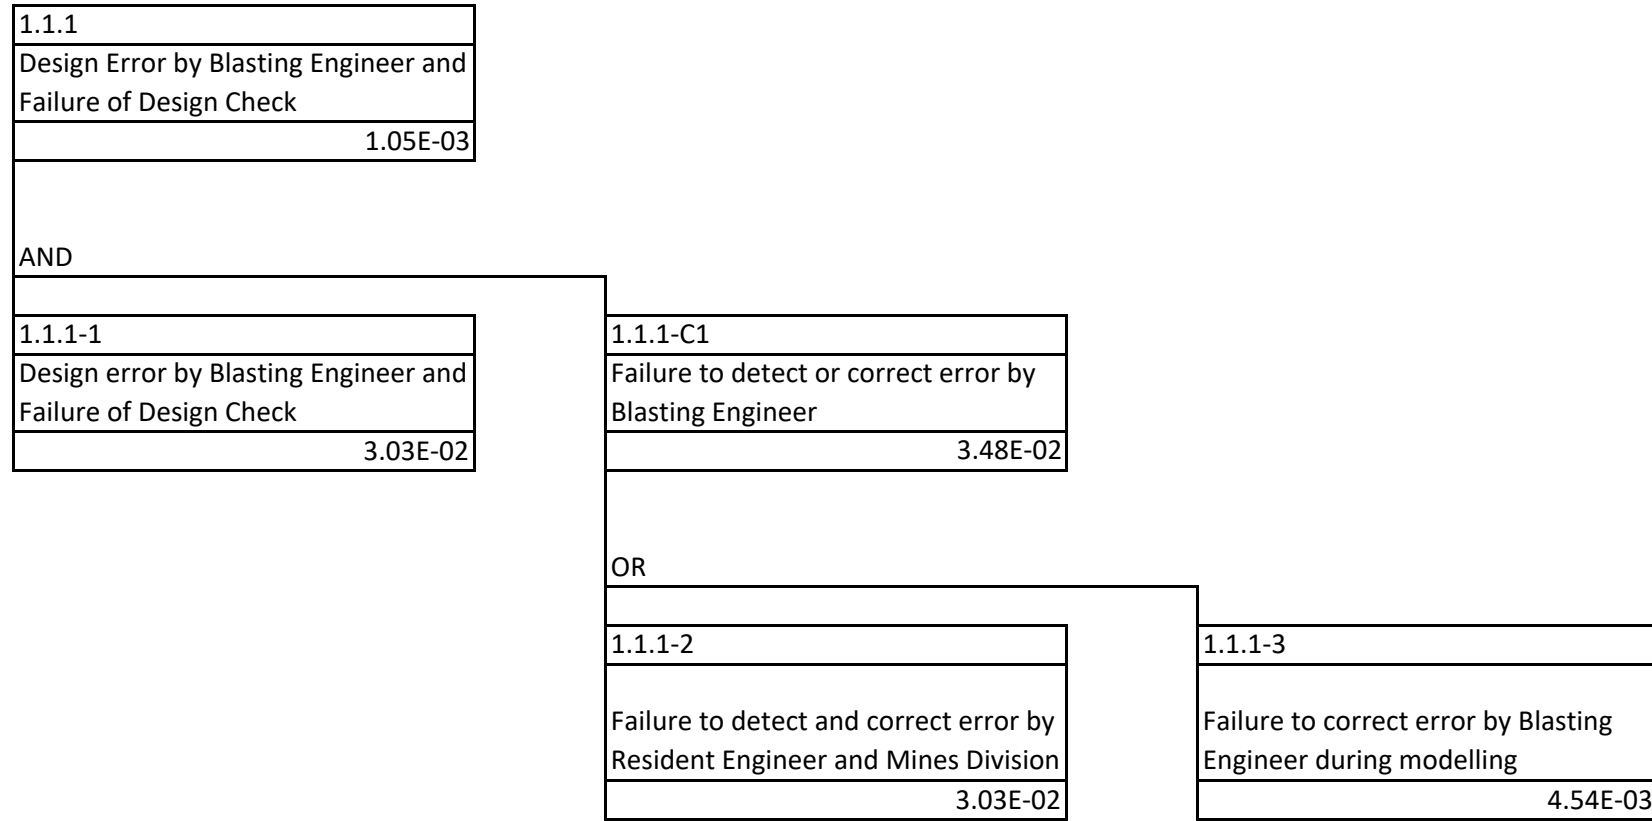
**1.1.1 Design Error by Blasting Engineer and Failure of Design Check**

1.1.1
Design error by Blasting Engineer and Failure of design check
1.05E-03

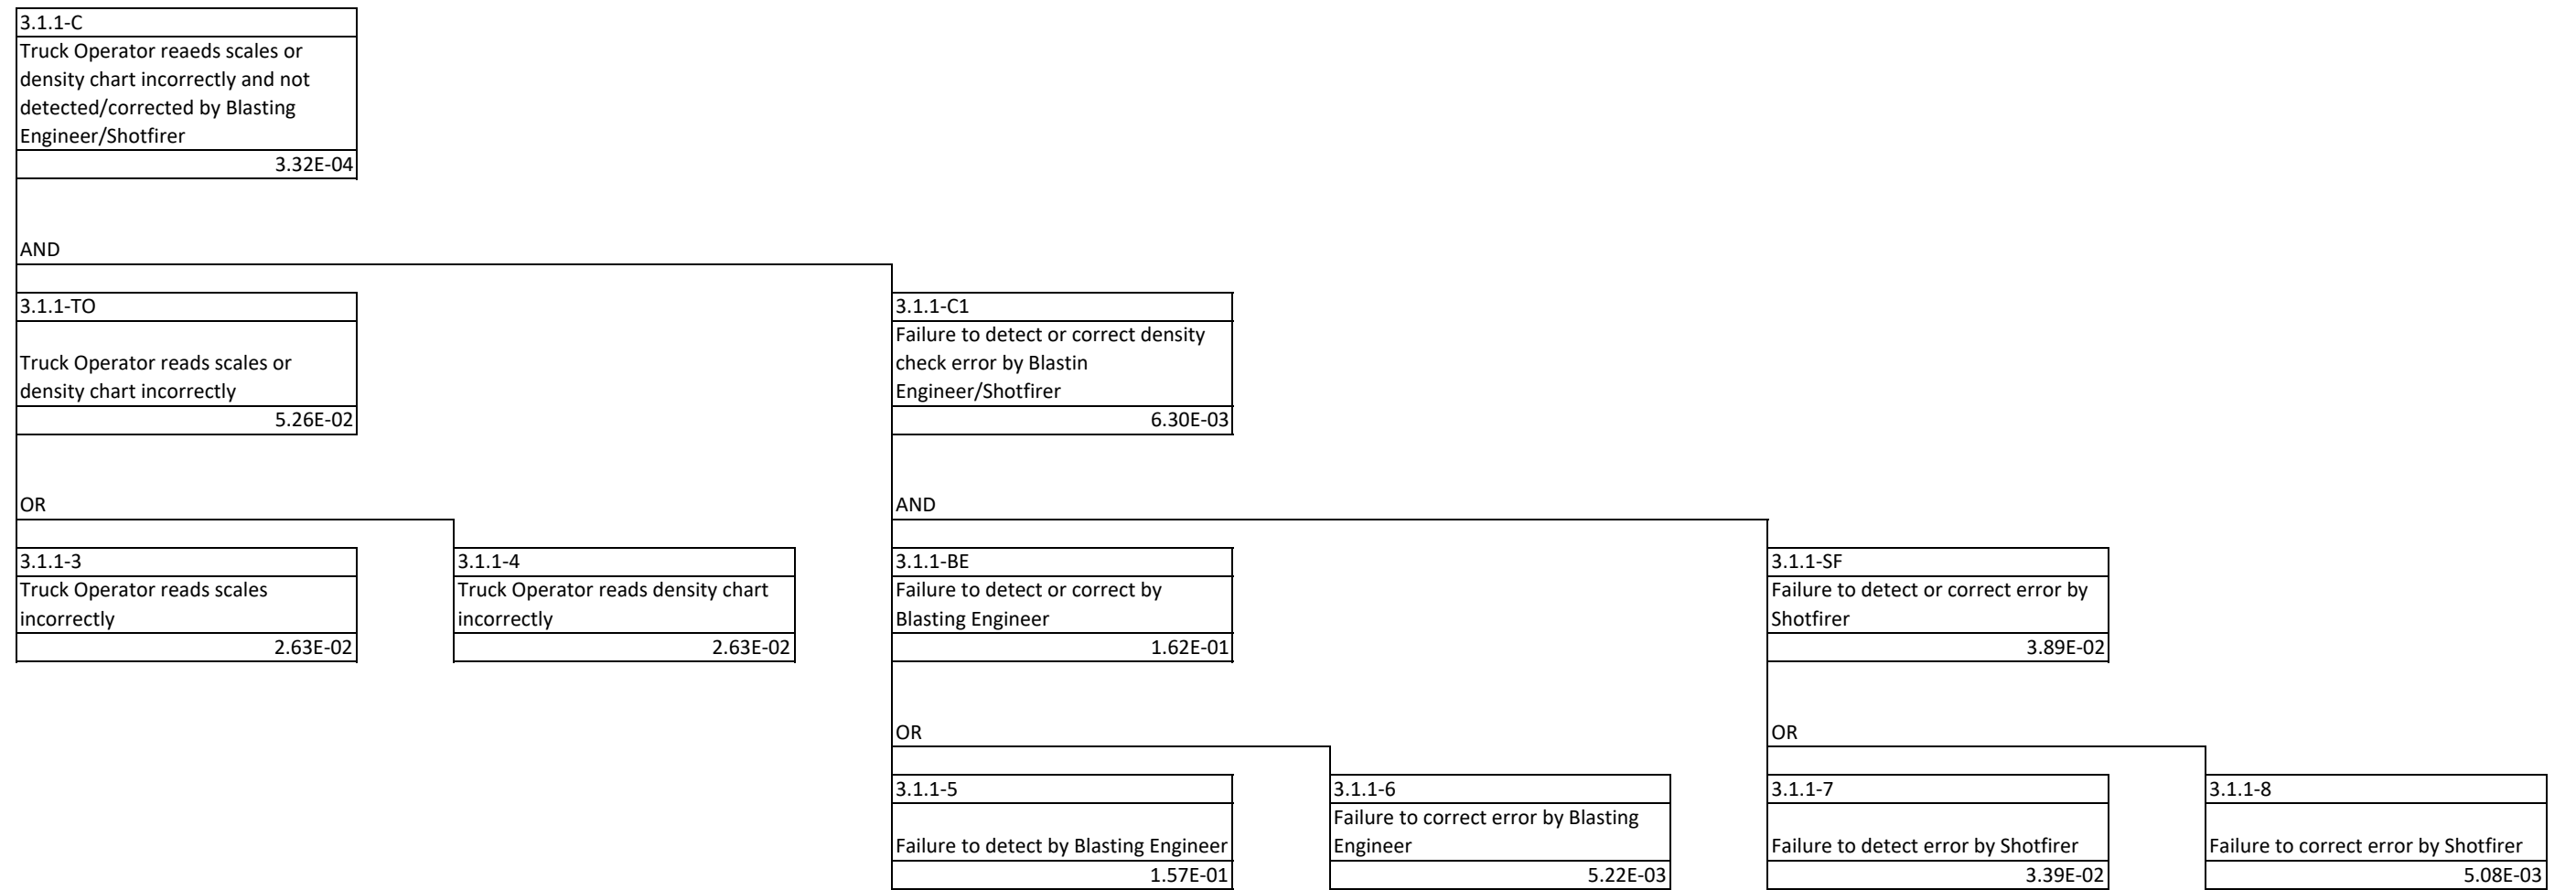
**3.1.1-C Truck Operator reads scales or density chart incorrectly and not detected/corrected by Blasting Engineer/Shotfirer**

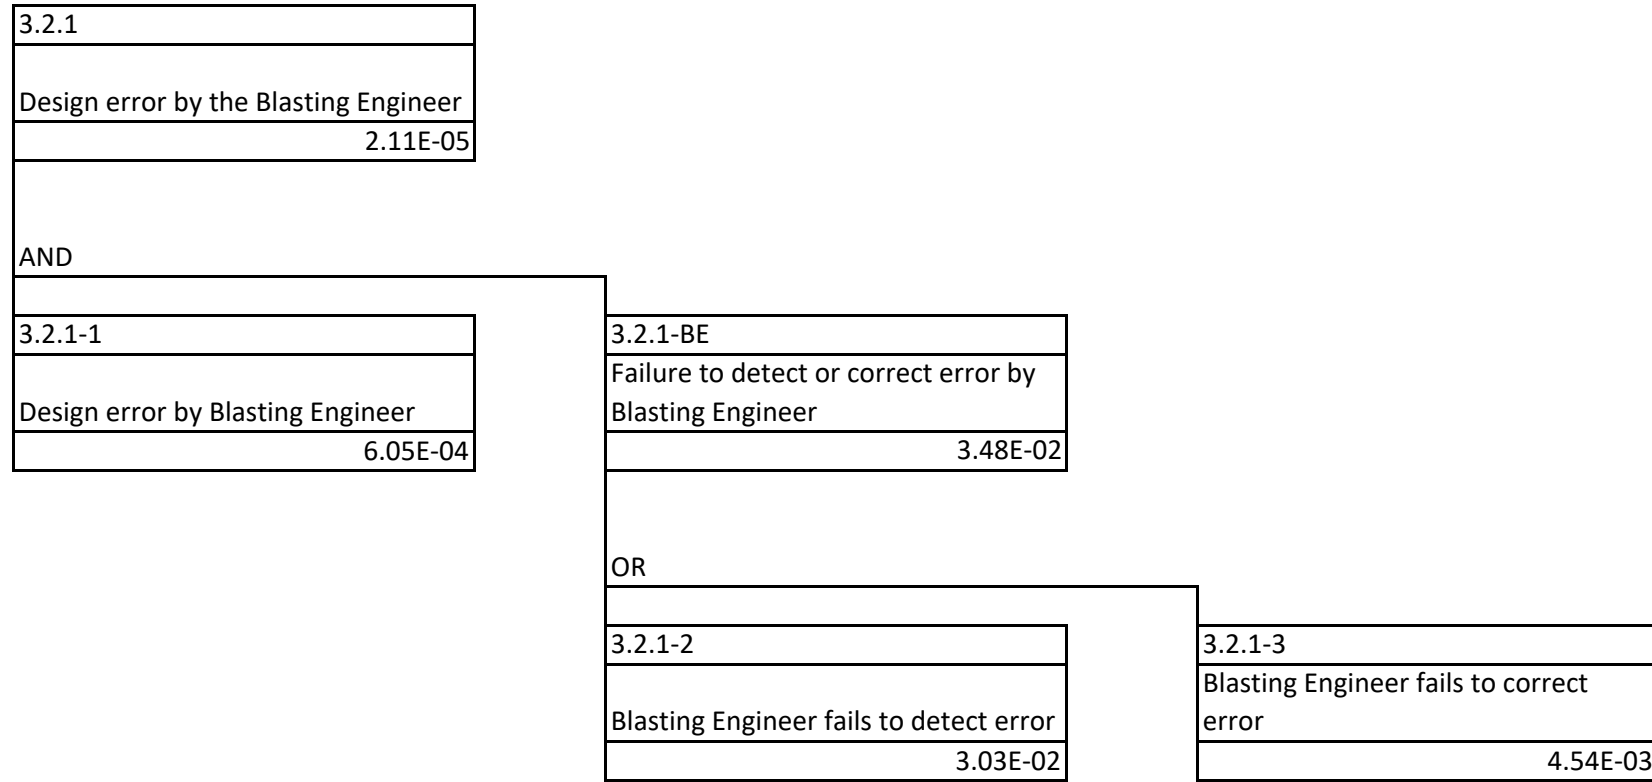
**3.2.1 Design error by the Blasting Engineer**
