China State Construction Engineering (Hong Kong) Ltd.

Contract No. CV/2007/03

**Development at Anderson Road –
Site Formation and Associated
Infrastructure Works****Monthly EM&A Report for
January 2017**

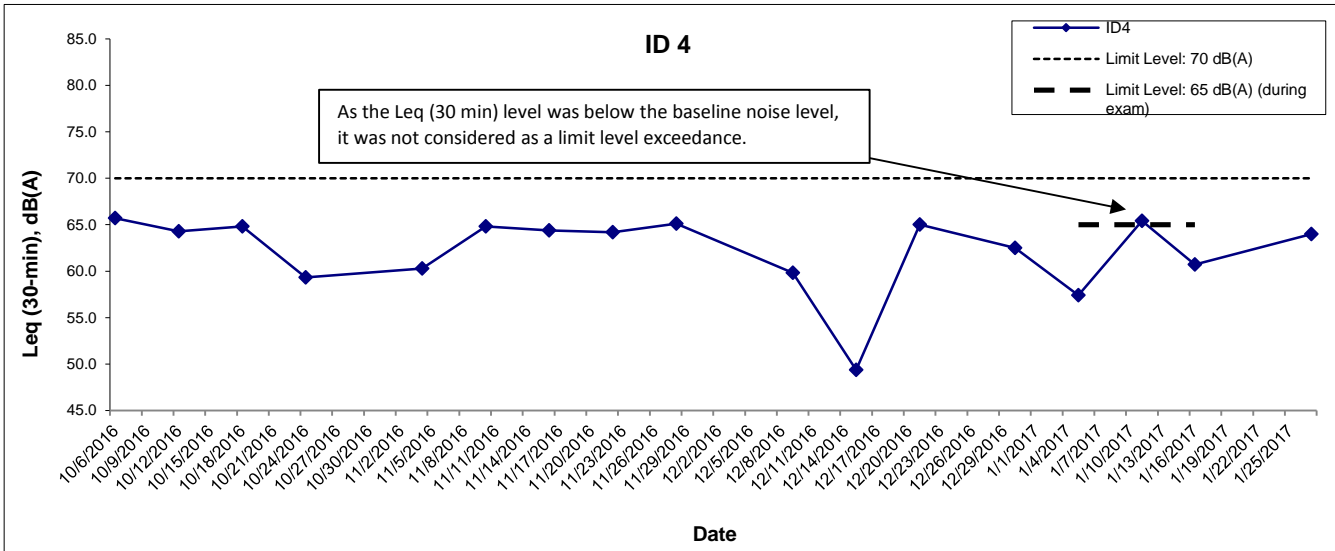
Development at Anderson Road - Site Formation and Associated Infrastructure Works	SCALE	N.T.S.	DATE	Feb-17
	Graphical Presentations of Noise Monitoring Results	CHECK	FYW	DRAWN	DTTW
		JOB NO.	60043155	APPENDIX	G
					-

Date	Weather Condition	Noise Level for 30-min, dB(A) ⁺				Baseline Corrected Level, dB(A)	Baseline Noise Level, dB(A)	Limit Level**, dB(A)	Exceedance (Y/N)
		Time	L90	L10	Leq				
5-Jan-17	Sunny	10:08	60.2	65.0	62.9	61.3	57.8	65	N
11-Jan-17	Sunny	10:20	58.9	67.9	64.6	63.6	57.8	65	N
16-Jan-17	Cloudy	10:00	57.0	61.0	60.0	56.0	57.8	65	N
27-Jan-17	Sunny	9:58	58.0	61.0	59.9	55.7	57.8	70	N
		Min	57.0	61.0		55.7			
		Max	60.2	67.9		63.6			
		Average	--	--		59.4

Date	Weather Condition	Noise Level for 30-min, dB(A) ⁺				Baseline Corrected Level, dB(A)	Baseline Noise Level, dB(A)	Limit Level, dB(A)	Exceedance (Y/N)
		Time	L90	L10	Leq				
5-Jan-17	Sunny	10:58	60.6	65.2	63.7	58.8	62.0	75	N
11-Jan-17	Sunny	11:10	59.4	66.7	63.2	57.0	62.0	75	N
16-Jan-17	Cloudy	10:15	61.0	66.5	65.0	62.0	62.0	75	N
27-Jan-17	Sunny	11:46	58.5	62.5	61.6	61.6	62.0	75	N
		Min	58.5	62.5		57.0			
		Max	61.0	66.7		62.0			
		Average	--	--		59.3

Date	Weather Condition	Noise Level for 30-min, dB(A) ⁺				Baseline Corrected Level, dB(A)	Baseline Noise Level, dB(A)	Limit Level, dB(A)	Exceedance (Y/N)
		Time	L90	L10	Leq				
5-Jan-17	Sunny	13:05	63.1	67.3	65.7	60.6	64.1	75	N
11-Jan-17	Sunny	13:18	59.7	67.8	64.6	55.0	64.1	75	N
16-Jan-17	Cloudy	11:00	62.0	68.5	67.1	64.1	64.1	75	N
27-Jan-17	Sunny	14:02	61.0	63.5	63.0	63.0	64.1	75	N
		Min	59.7	63.5		55.0			
		Max	63.1	68.5		64.1			
		Average	--	--		60.8
