Asia Pacific Gateway (APG) – Tseung Kwan O

Project Profile 工程項目簡介

21 May 2013
2013年5月21日

ERM Document Code: 0174917_APG_PP.doc
環境資源管理顧問有限公司文件編號: 0174917_APG_PP.doc

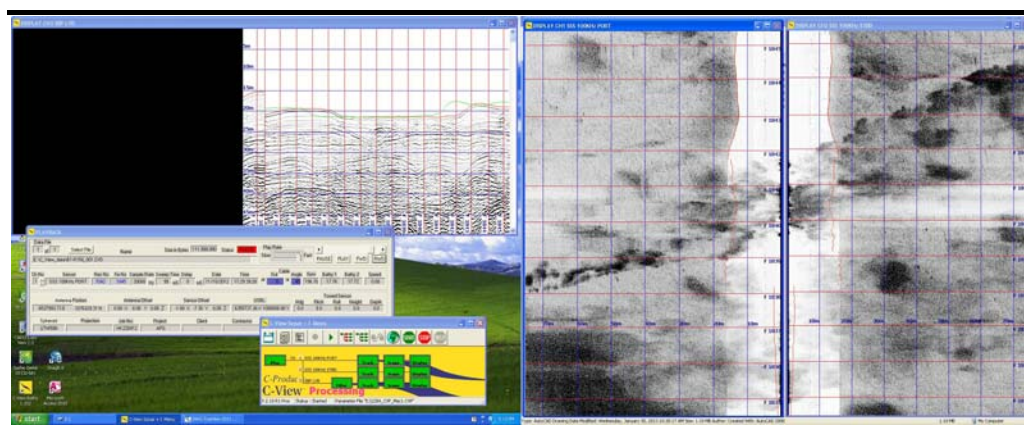
Figure D4.6 *Dumped materials on the seabed in the vicinity of UKHO 65706, but no shipwreck*

No features that could be interpreted as shipwrecks or other underwater cultural heritage sites were observed from a review of the geophysical data in the vicinity of the coordinates for UKHO 65706 and 65708 (and 57736 which is outside of the Study Area), which is consistent with the UKHO information that they are 'dead' sites, i.e. they do not exist (see *Figures D4.6 and D4.7*).

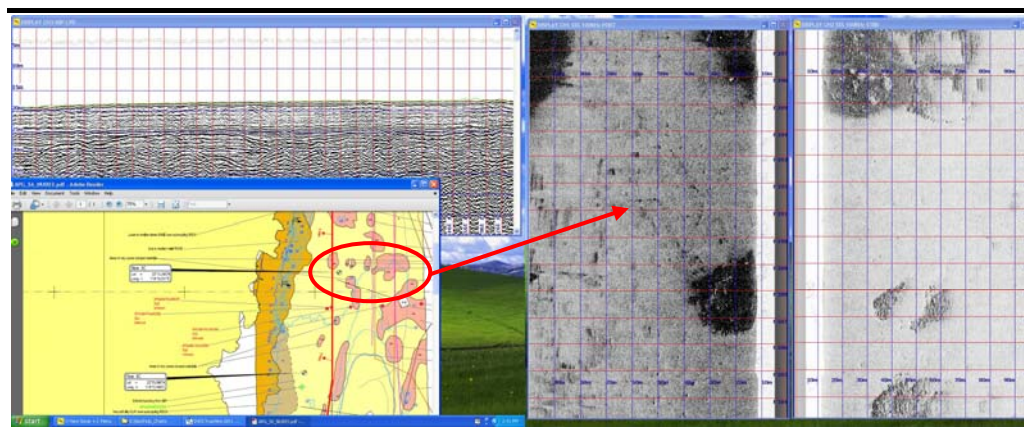
Figure D4.10 *Magnetic contacts 061, 064, 065 associated with dumped materials, and/or associated with modern sub-bottom materials*

Some of the unknown magnetic anomalies located within the Study Area and within a few metres of the proposed cable position were more closely investigated (see *Table 4.3* and *Figure D4.1*) and they were found to be associated with dumped materials (*Figures D4.9* and *4.10*), and of an unknown origin but considered to be of modern in nature or a combination of both, but not considered to be archaeological material.
