Expansion of Hong Kong International Airport into a Three-Runway System

Construction Phase Monthly EM&A
Report No. 105
(For September 2024)

October 2024

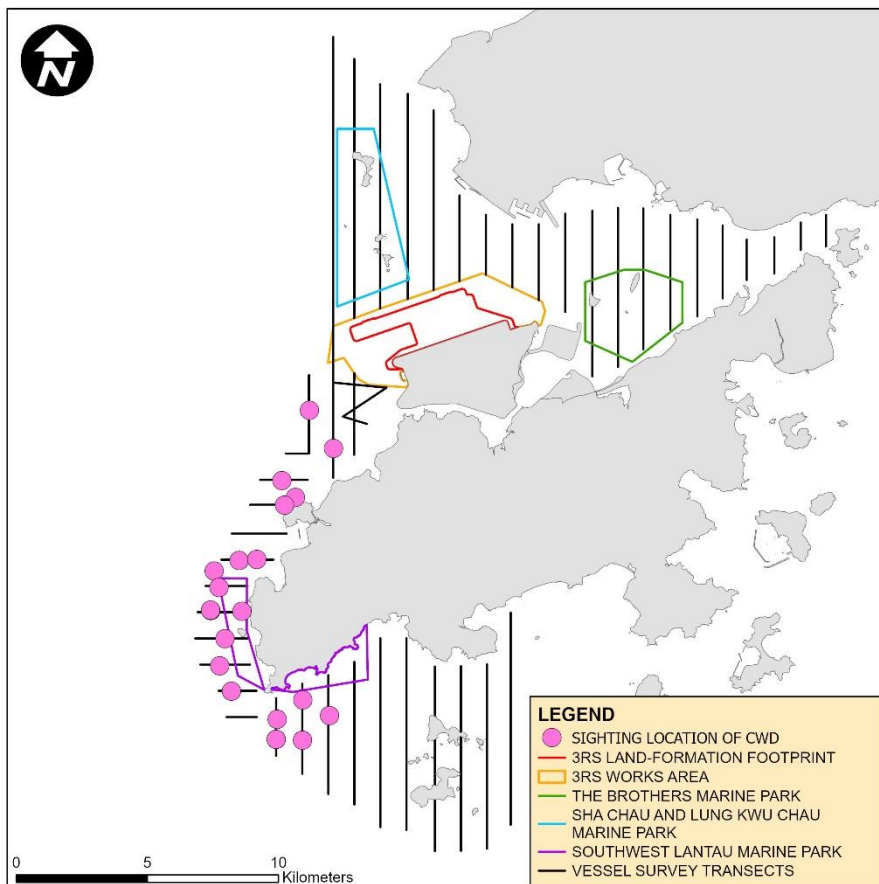
Figure 6.2: Sightings Distribution of Chinese White Dolphins

Distribution of all CWD sightings recorded in the current reporting period is illustrated in **Figure 6.2**. In WL, CWD sightings were mostly scattered in the waters between Tai O and Fan Lau. In SWL, CWD sightings were recorded at the western end. In NWL, there was a CWD sighting recorded near Sham Wat Wan. There was no CWD sighting recorded in NEL during the reporting period.

Remarks: (1) Please note that there is 20 pink circles on the map indicating the sighting locations of CWDs. (2) Marine park excludes land area and the landward boundary generally follows the high water mark along the coastline.

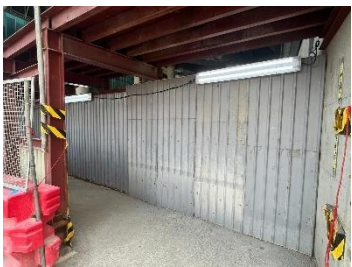
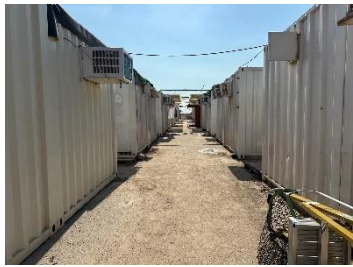
Table 7.2: Examples of Landscape and Visual Mitigation Measures in the Reporting Period

| <p>Erection of site hoardings around works area in unobtrusive colours (CM5)</p> | <p>Avoidance of excessive height and bulk of site buildings (CM6)</p> | <p>Control of night-time lighting using light hooding and minimisation of night working period (CM7)</p> |

| <p>General view of retained tree (CM8)</p> | <p>General view of transplanted trees (CM9)</p> | <p>General view of advanced hydroseeding works (CM10)</p> |

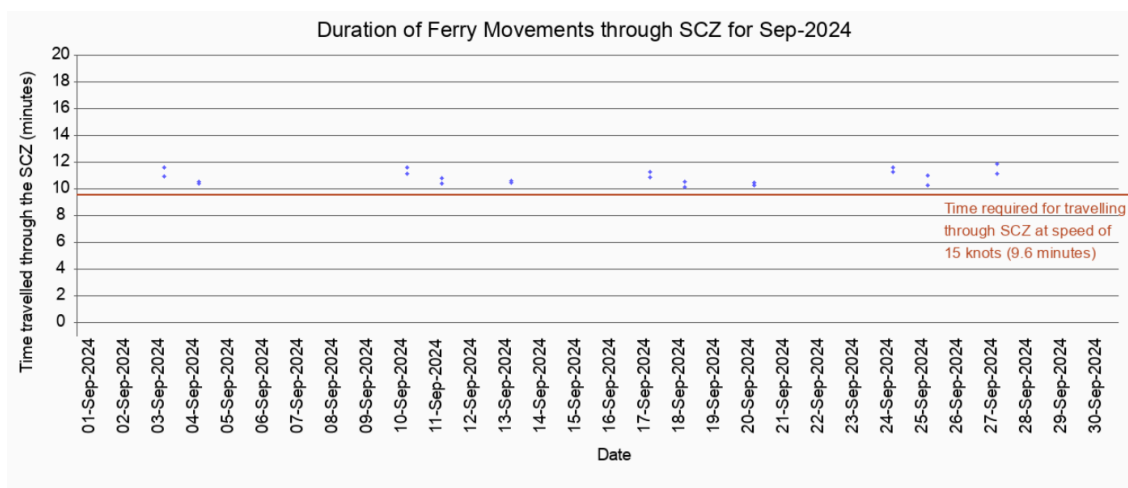
Figure 7.1: Duration of the SkyPier HSFs travelling through the SCZ for September 2024

For September 2024, a total of 22 ferry movements between HKIA SkyPier and Macau were recorded and the data are presented in **Appendix F**. The time spent by the SkyPier HSF travelling through the SCZ in September 2024 was presented in **Figure 7.1**. It will take 9.6 minutes to travel through the SCZ when the SkyPier HSFs adopt the maximum allowable speed of 15 knots within the SCZ. **Figure 7.1** shows that all the SkyPier HSF spent more than 9.6 minutes to travel through the SCZ.

Note: Data above the red line indicated that the time spent by the SkyPier HSFs travelling through the SCZ is more than 9.6 minutes, which is in compliance with the SkyPier Plan.

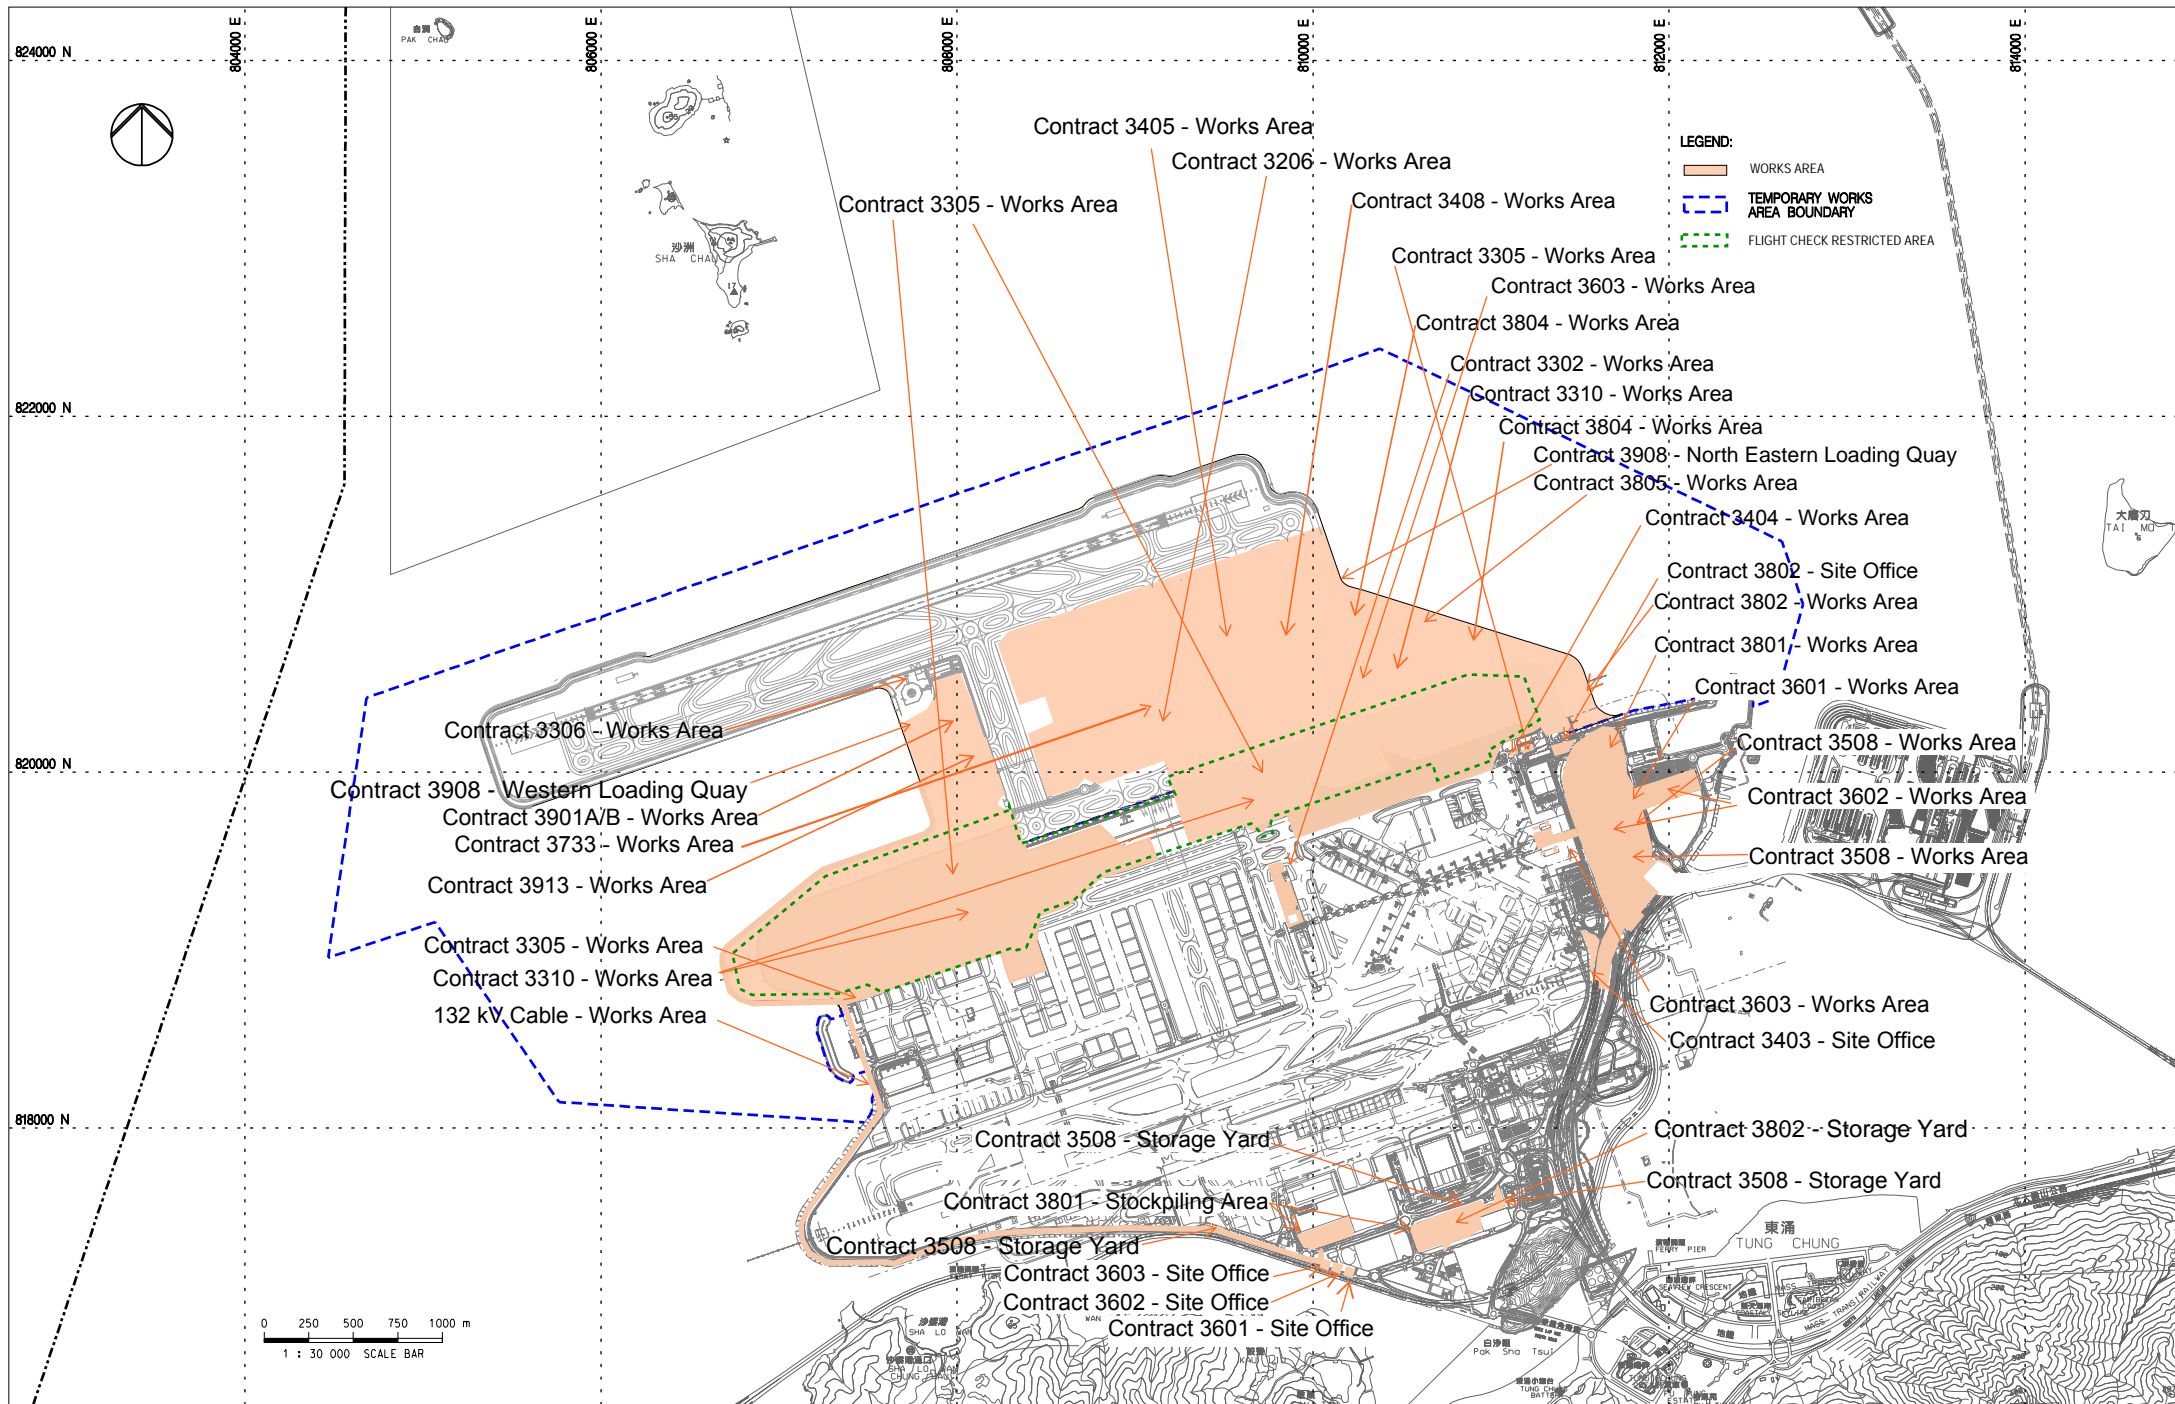
FIGURE 1.1 LOCATIONS OF KEY CONSTRUCTION ACTIVITIES

Note: The locations are for indicative purpose. The actual construction work locations are in accordance with the construction work programme.
