Expansion of Hong Kong International Airport into a Three-Runway System

Construction Phase Quarterly EM&A Report
No.33 (1 January to 31 March 2024)

May 2024

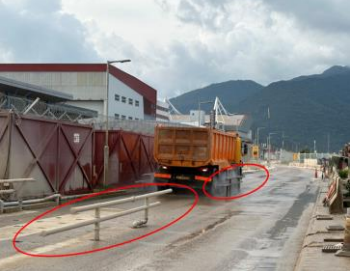
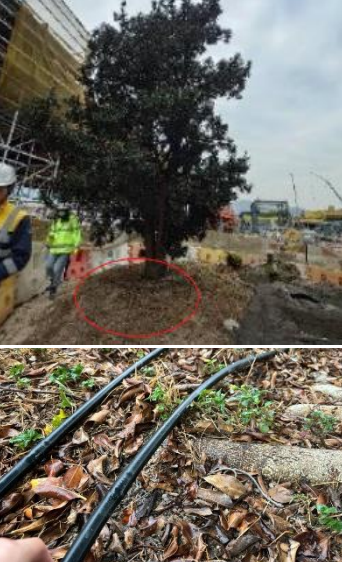
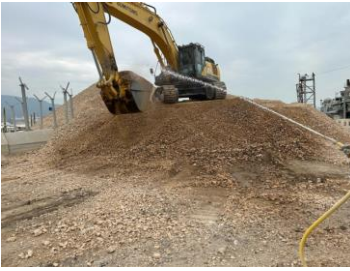
<p>Installed automatic wheel washing facilities in series</p>	<p>Automatic drip irrigation system</p>	<p>Provision of water spray at the stockpiling area</p>

1. Three automatic wheel washing facilities were installed in series by the contractor to ensure the vehicle was washed thoroughly, and all dusty materials from its underneath and wheels were removed before leaving the construction site.
2. Automatic drip irrigation system was provided by the contractor to maintain good health condition of the trees.
3. Water spraying was provided at the stockpiling area for dust suppression purposes.

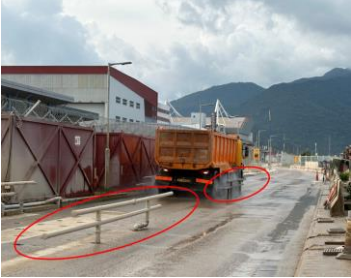
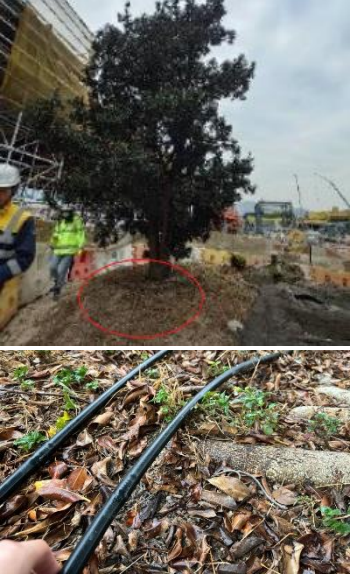
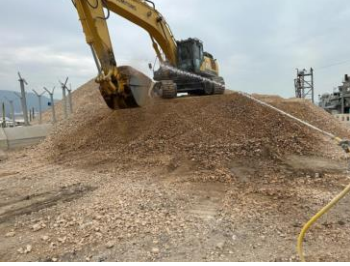
1. Three automatic wheel washing facilities were installed in series by the contractor ensure the vehicle was washed thoroughly, and all dusty materials from its underneath and wheels were removed before leaving the construction site.
2. Automatic drip irrigation system was provided by the contractor to maintain good health condition of the trees.
3. Water spraying was provided at the stockpiling area for dust suppression purposes.

<p>Installed automatic wheel washing facilities in series</p>	<p>Automatic drip irrigation system</p>	<p>Provision of water spray at the stockpiling area</p>

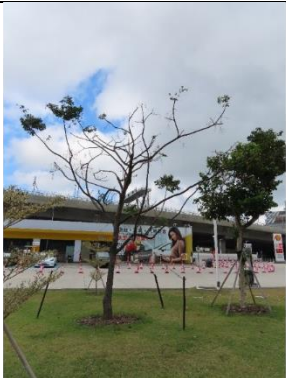
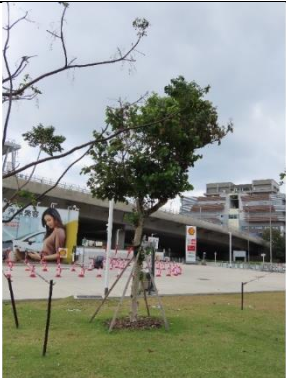
CT276	CT1253

Table 2.15: Photos of the Existing Transplanted Trees Inspected in the Reporting Period
