**CONTRACT NO. 1/WSD/19 & 6/WSD/21**

IN-SITU REPROVISIONING OF SHA TIN WATER TREATMENT WORKS (SOUTH WORKS) – WATER TREATMENT WORKS AND **ANCILLARY FACILITIES Environmental Permit EP-494/2015**

In-Situ Reprovisioning of Sha Tin Water Treatment Works (South Works) – Water Treatment Works and Ancillary Facilities
Environmental Permit EP-494/2015
Submission of 103<sup>rd</sup> monthly EM&A Report

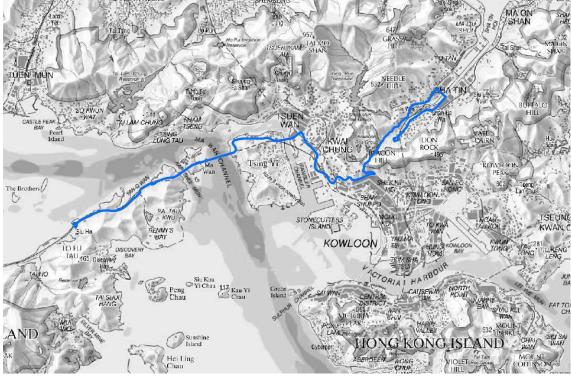
Figure 1: Chlorine Transport Route to Sha Tin Water Treatment Works

2.7.1 Chlorine is delivered to Sha Tin WTW in batches of up to 6×1-tonne drums. The transport route from Sham Shui Kok dock on North Lantau is shown in Figure 1. The route passes along the North Lantau Expressway, around the northern edge of Tsing Yi, through Tsuen Wan and along Tai Po Road (Piper's Hill) to Sha Tin (Table 2-15).

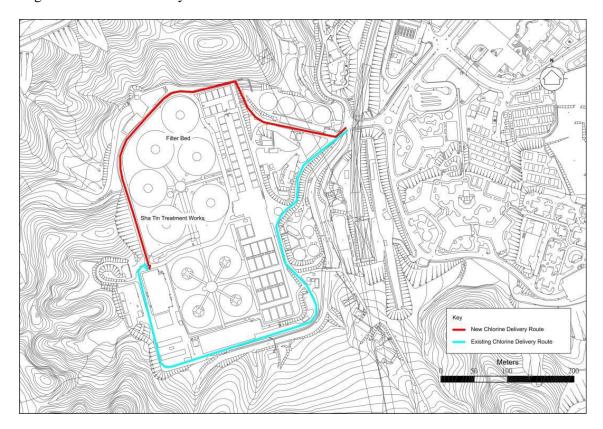
Figure 2: Chlorine Delivery Route at Sha Tin WTW

- 2.7.2 Unloading takes place inside the Chlorination House, with the doors closed, in a designated truck unloading bay. The movement of drums within the storage area and 'drive-through' unloading bay is carried out using a hoist/monorail system with a purpose-built lifting beam. Prior to usage, the drums are stored on cradles within the chlorine storage area.
- 2.7.3 The on-site chlorine delivery route is shown in **Figure 2**.

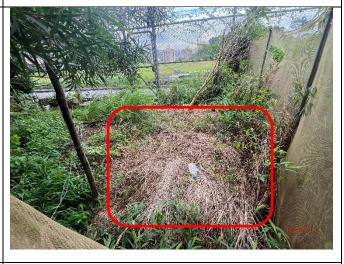
Photo 5. Ornamental plants were found around the second patch of *Cibotium barometz*

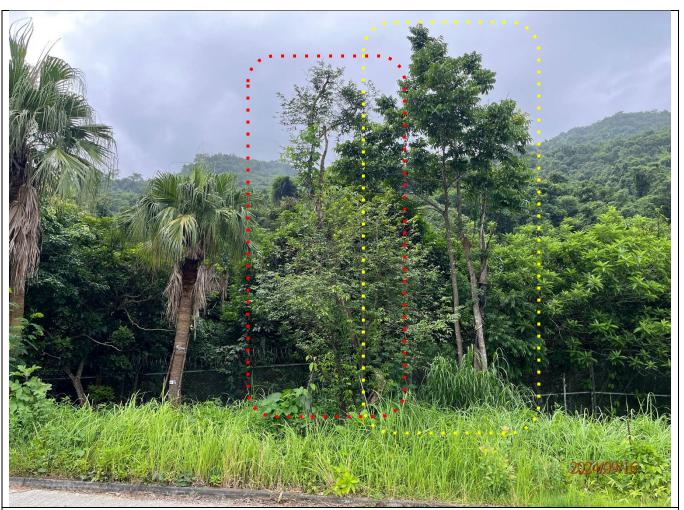
Photo 6. Rubbish was found within the protection zone of the second patch of *Cibotium barometz*

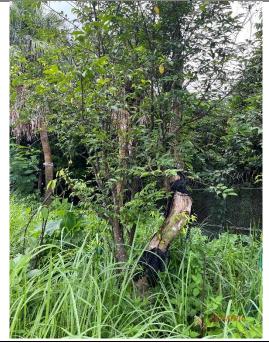
- 2.5.1 The condition of TA572 was observed in fair health despite in poor form. TA327 was in fair condition; while already dead TA326 collapsed under Signal No. 10 typhoon Mangkhut in September 2018. Tree guying cables have been installed to provide external support to the two remaining transplanted trees. Weeding has been completed in this area

Photo 7. Transplanted Incense Tree (*Aquilaria sinensis*) – TA327 (red); and Ailanthus (*Ailanthus fordii*) – TA572 (yellow). Weeds grew vigorously around the two trees.

- 2.5.6 Weeding by hand held tools within protection zone of Cibotium barometz is in progress.
- 2.5.7 Root ball of TA572 and TA327 tree should be kept moisture especially during dry and non-raining day.

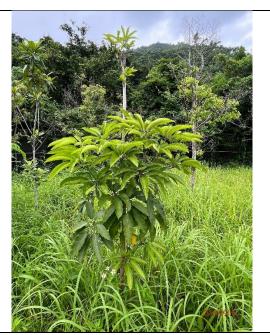
- 2.5.4 New small sprouts keep emerging from the two *Desmos chinensis* that have been reported dead previously. Construction materials was also found too close to the planter. An eye-catching protective fence shall be set up as a protection zone. No construction materials shall be placed near/ within the protection zone.

Photo 10. No construction material or equipment should put near the *Desmos chinensis*. Rubbish should be cleared.

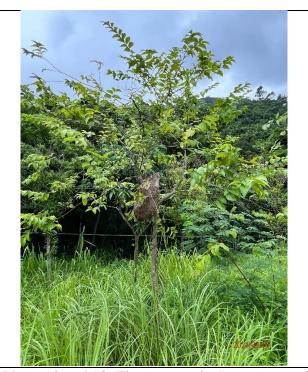
Photo 11. *Schefflera heptaphylla* as compensatory planting of TA326.

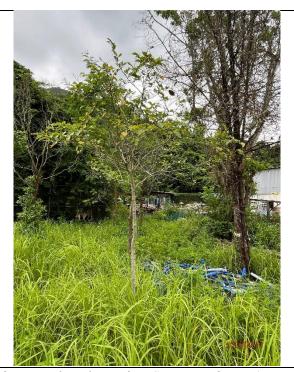
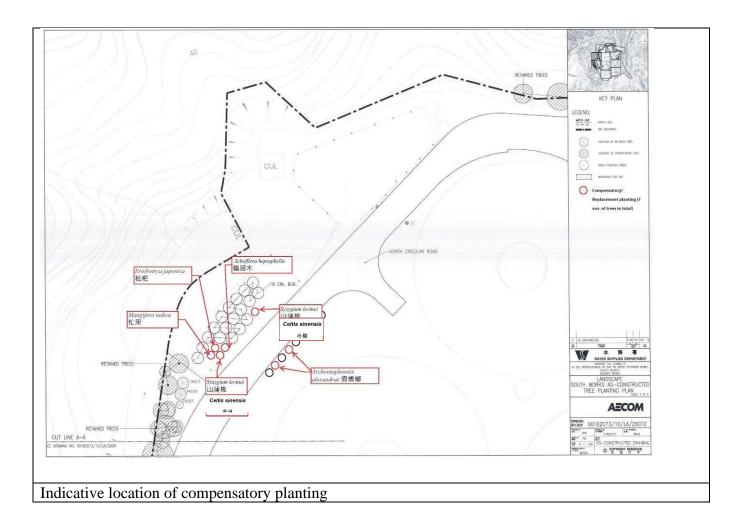
- 2.5.2 Compensatory planting of TA326 has been completed on 25 March 2020 by planting two Syzygium levinei and one Schefflera heptaphylla. However, the two native Syzygium levinei were mis-planted by two exotic Syzygium jambos, which have been replaced by another native tree species Celtis sinensis on 31 May 2021. Weeding was completed in this area.

Photo 12 and 13. The two exotic *Syzygium jambos* (mis-treated as the native *Syzygium levinei*) were replaced by another native tree species *Celtis sinensis* (due to market availability) as compensatory planting of TA326. Note: *Celtis sinensis* is a deciduous species. Weeds grew vigorously around two trees.

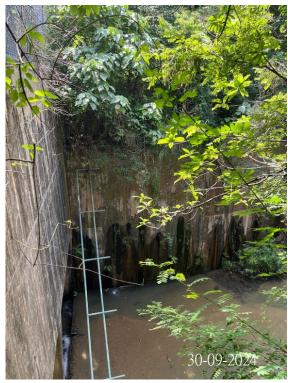
Photo 2 (M1)

- 2) According to the field observation from the Environmental Team (ET) on 30 September 2024, no polluted discharge was made from construction site to Impact Monitoring Station M1 (Photo 2). The condition of water at Impact Station M1 was in order and no discharge from construction was observed (Photo 2).
