CONTRACT NO. 1/WSD/19 & 6/WSD/21

IN-SITU REPROVISIONING OF SHA TIN WATER TREATMENT WORKS (SOUTH WORKS) – WATER TREATMENT WORKS AND **ANCILLARY FACILITIES Environmental Permit EP-494/2015**

- (a) Three hard copies,
- (b) Two copies of the 99th monthly Environmental Monitoring and Audit (EM&A) Report (Rev.0). (Register No.: AEIAR-187/2015)

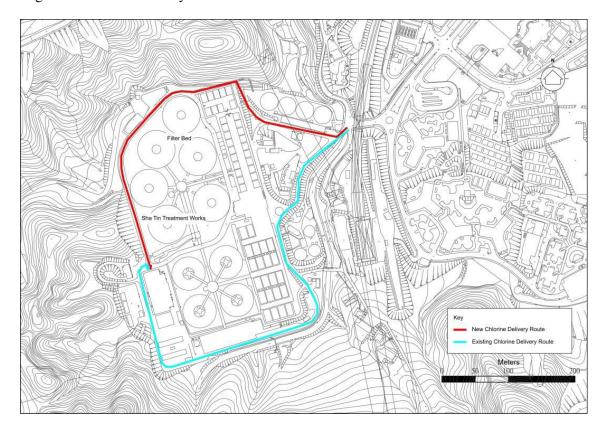
Figure 2: Chlorine Delivery Route at Sha Tin WTW

- 2.7.2 Unloading takes place inside the Chlorination House, with the doors closed, in a designated truck unloading bay. The movement of drums within the storage area and 'drive-through' unloading bay is carried out using a hoist/monorail system with a purpose-built lifting beam. Prior to usage, the drums are stored on cradles within the chlorine storage area.
- 2.7.3 The on-site chlorine delivery route is shown in **Figure 2**.

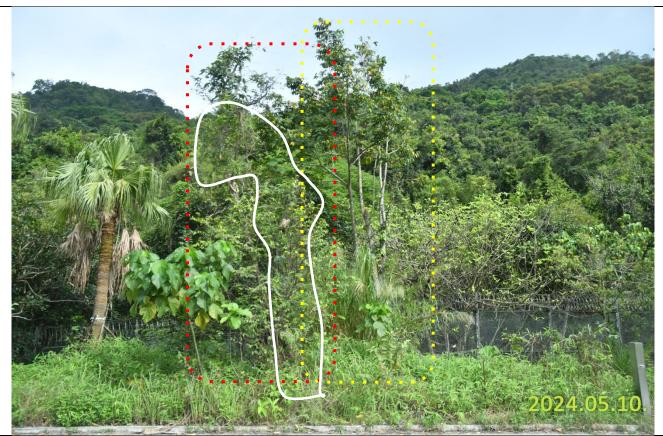
Photo 5 & 6. Weeds and climbers were observed occupying growing space of *Cibotium barometz* at the second patch (in red), which may deplete their health/ growth condition.

- 2.5.6 Weeding by hand held tools within protection zone of Cibotium barometz is urgently needed.
- 2.5.7 Root ball of TA572 and TA327 tree should be kept moisture especially during dry and non-raining day.

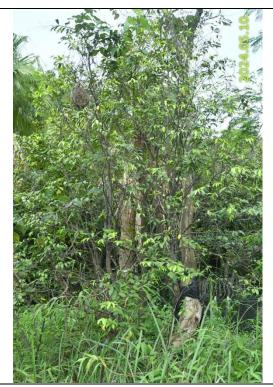
Photo 7. Transplanted Incense Tree (*Aquilaria sinensis*) – TA327 (red); and Ailanthus (*Ailanthus fordii*) – TA572 (yellow). Climber (white) should be removed, including the roots, to relieve the

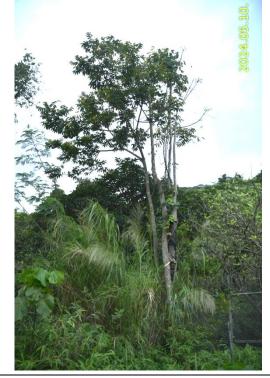
Photo 8. Sprouts at lower trunk of TA327 (*Aquilaria sinensis*). Climber should be removed, including the roots, to relieve the canopy

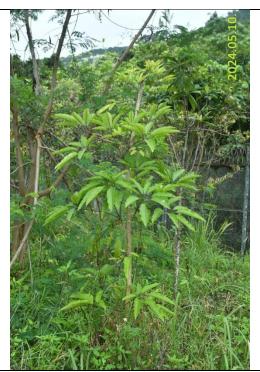
Photo 9. TA572 (*Ailanthus fordii*) was found vigorous and in generally good condition. Surrounding weeds/ grass should be removed

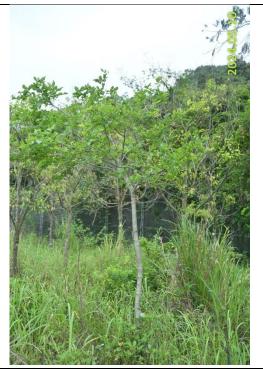
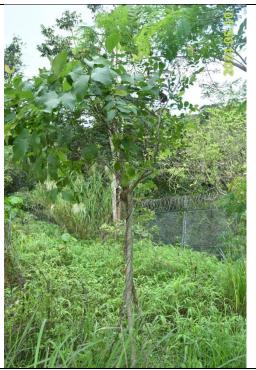
Photo 10. New sprouts of the *Desmos chinensis* grew well in this rainy month (red). No materials or equipment should put near the plant.

Photo 11. *Schefflera heptaphylla* as compensatory planting of TA326.

Photo 12 and 13. The two exotic *Syzygium jambos* (mis-treated as the native *Syzygium levinei*) are replaced by another native tree *Celtis sinensis* (due to market availability) as compensatory planting of TA326. Note: *Celtis sinensis* is a deciduous species.

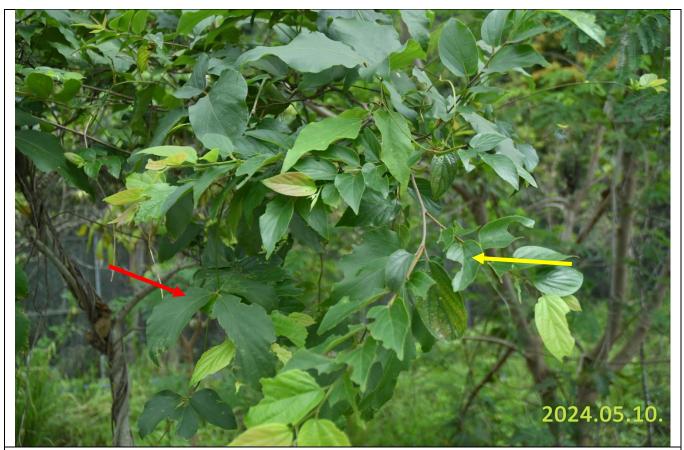
Fast-growing climber was observed in one of the *Celtis sinensis* (right; compared to the left). The climber should be removed immediately otherwise it will affect the health of the tree. Root removal is necessary when recolonization of weeds is fast after recent routine maintenance work.

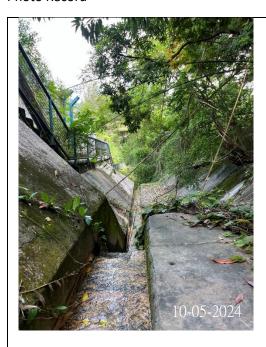
Photo 1 (M3)

- 1) According to the field observation from the Environmental Team (ET) on 10 May 2024, no polluted discharge was made from construction site to the Impact Monitoring Station M3 (Photo 1). In general, the condition of water at Impact Station M3 was in order and no discharge from construction was observed (Photo 1). The water quality monitoring locations and contract site area are illustrated in Figure 1.
- 2) Weekly site inspection by the Contractor and ET was conducted on 14 May 2024 to audit the site environmental performance. The finding of the inspection was summarized below:
