**ENVIRONMENTAL TEAM FOR  
DEVELOPMENT OF  
ANDERSON ROAD QUARRY SITE -  
ROAD IMPROVEMENT WORKS**

**UNDER ENVIRONMENTAL PERMIT NO. EP-513/2016**

**MONTHLY ENVIRONMENTAL MONITORING & AUDIT REPORT**

**JULY 2024**

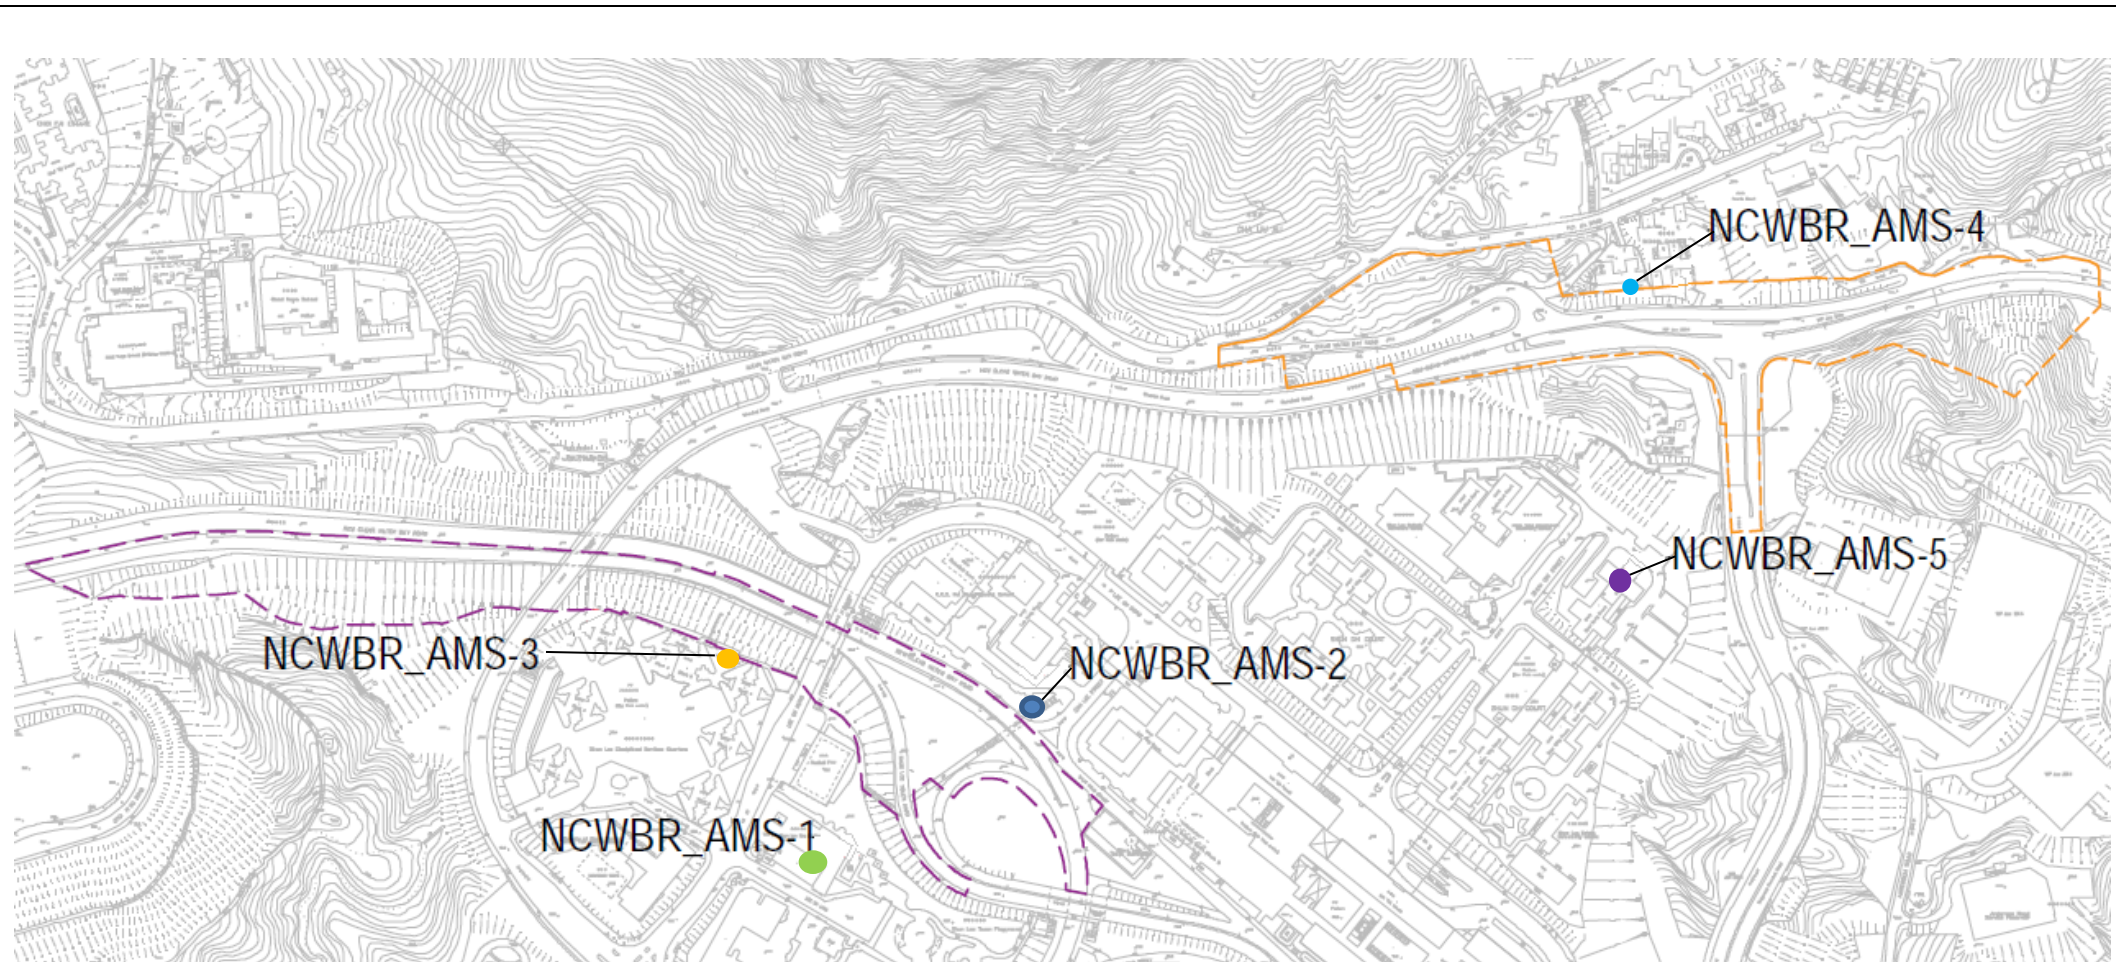
Figure 4.3  
Location of Air Quality Monitoring Station  
(for Road Improvement Work 1 & 2)

Monitoring Station ID	EIA ID	Location
<b>NCWBR RIW</b>		
NCWBR_AMS-1	ASLF-1	Shun Lee Fire Station
NCWBR_AMS-2	ASLE-21	Shun Lee Estate Lee Hang House
NCWBR_AMS-3	ASLD-10	Shun Lee Disciplined Services Quarters (Block 6)
NCWBR_AMS-4	AFNS-3	Sienna Garden
NCWBR_AMS-5	ASCC-05	Shun Chi Court Shun Fung House

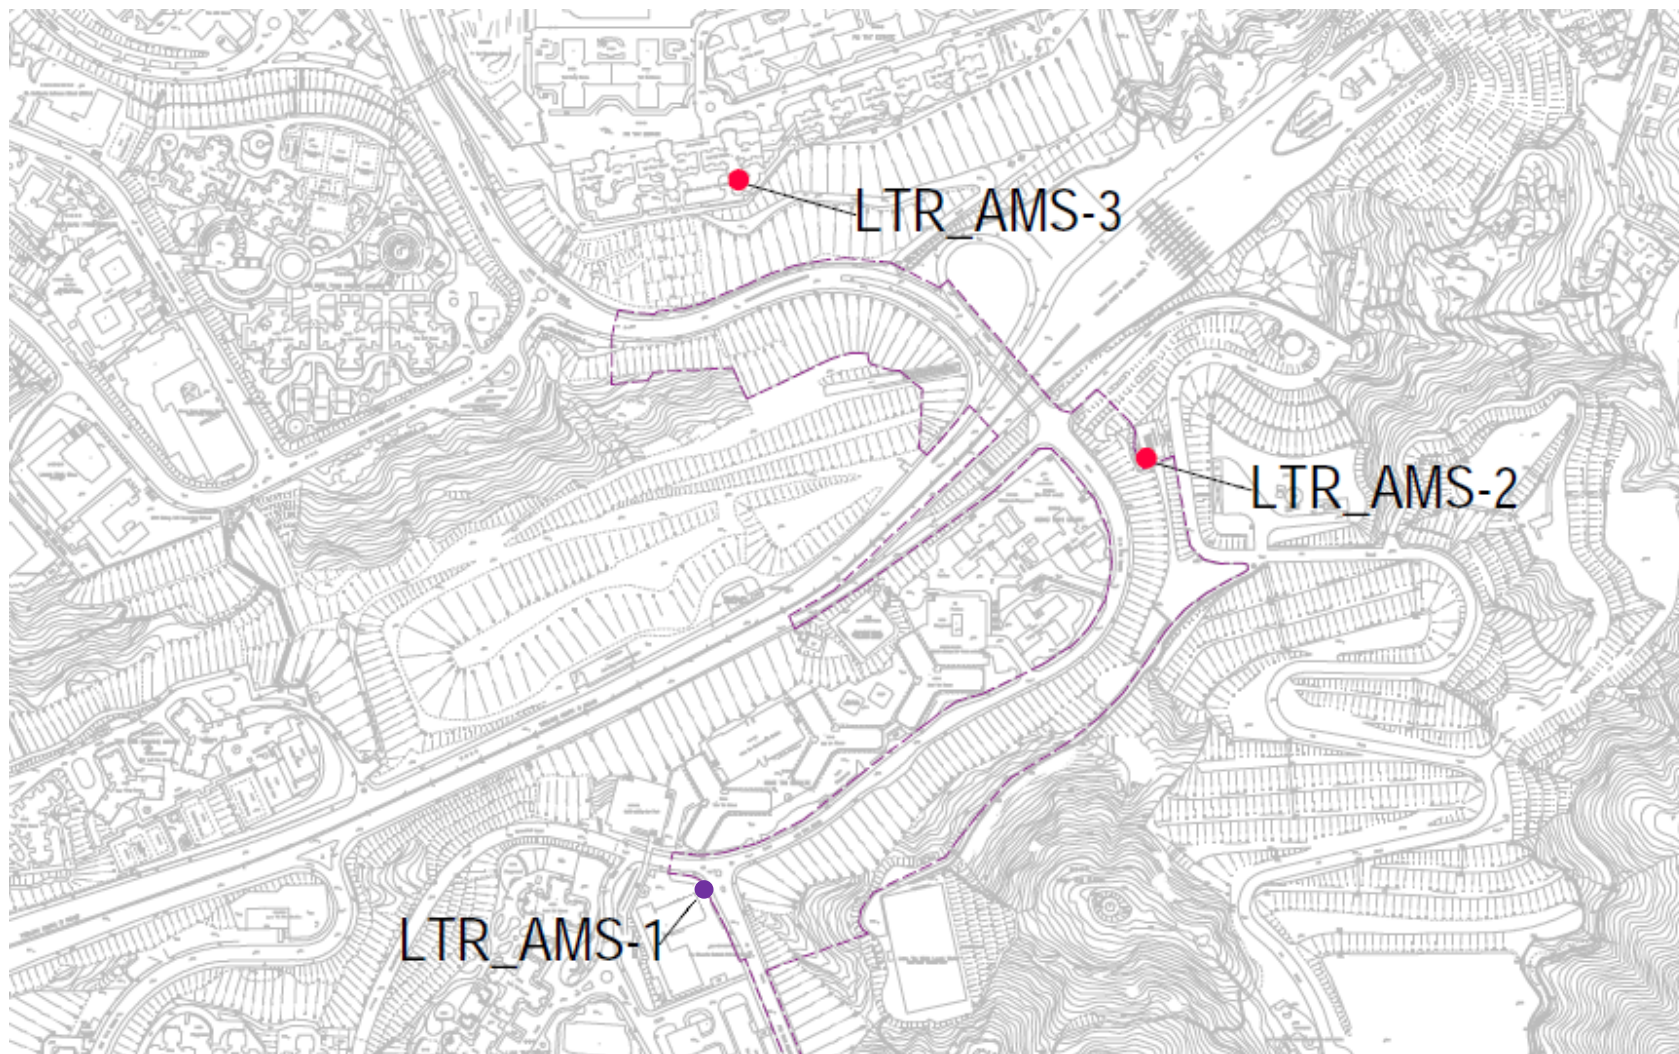
Figure 4.4  
Location of Air Quality Monitoring Station  
(for Road Improvement Work 3)

Monitoring Station ID	EIA ID	Location
<b>LTR RIW</b>		
LTR_AMS-1	ASECP-2	St Edward's Catholic Primary School
LTR_AMS-2	AEPD-01	Environmental Protection Department's Restored Landfill Site Office
LTR_AMS-3	APTE-14	Po Tat Estate Tat Kai House

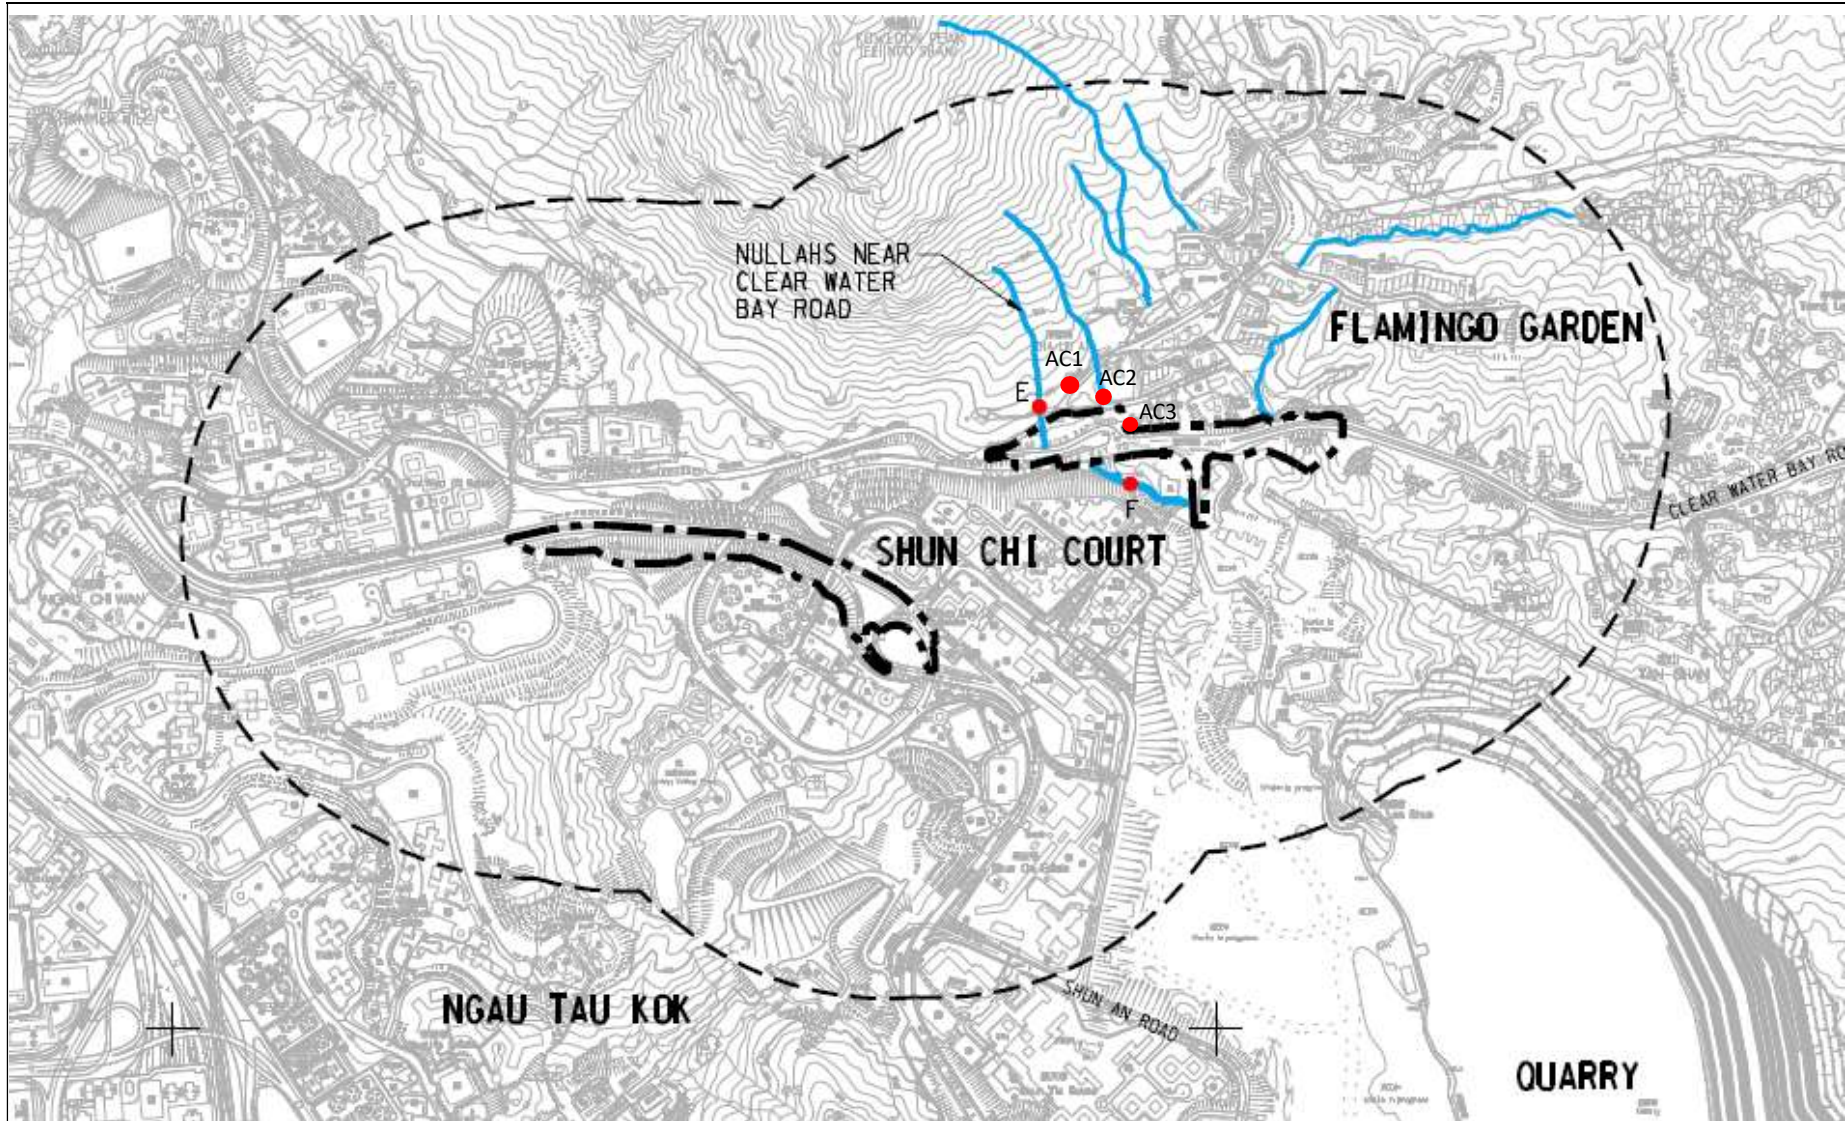
Figure 4.5  
Location of Water Quality Monitoring Station  
(for Road Improvement Work 1 & 2)

Inland Water	Stations	Description
Channelized nullah across the Project site	E	Upstream Control Station
	F	Downstream Impact Station
	AC1	Upstream Reference Station
	AC2	Upstream Reference Station
	AC3	Upstream Reference Station

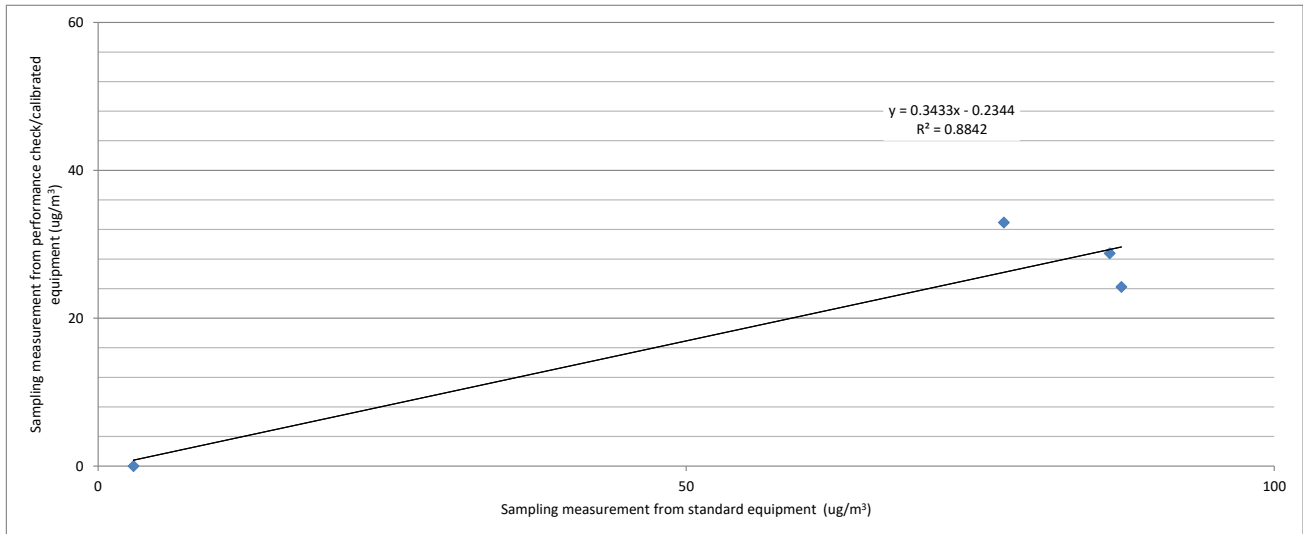
Linear Regression of Y on X

Slope (K- factor) : 2.6000
Correlation Coefficient : 0.9403
Validity of Performance Check / Calibration Record : 6/5/2025

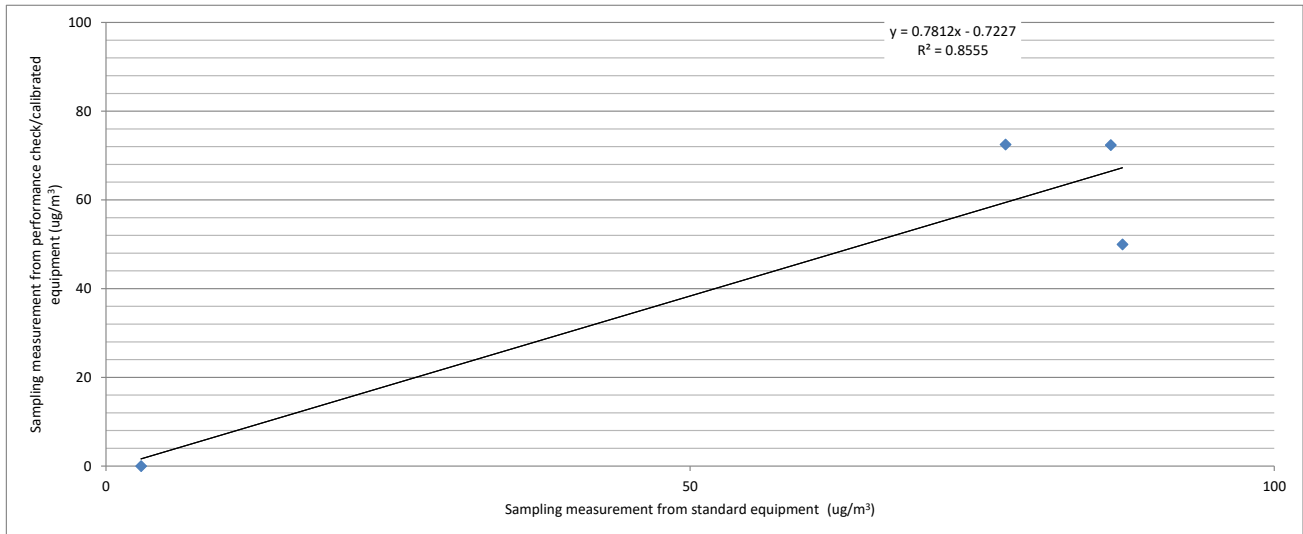
Linear Regression of Y on X

Slope (K- factor) : 1.1000
Correlation Coefficient : 0.9249
Validity of Performance Check / Calibration Record : 6/5/2025

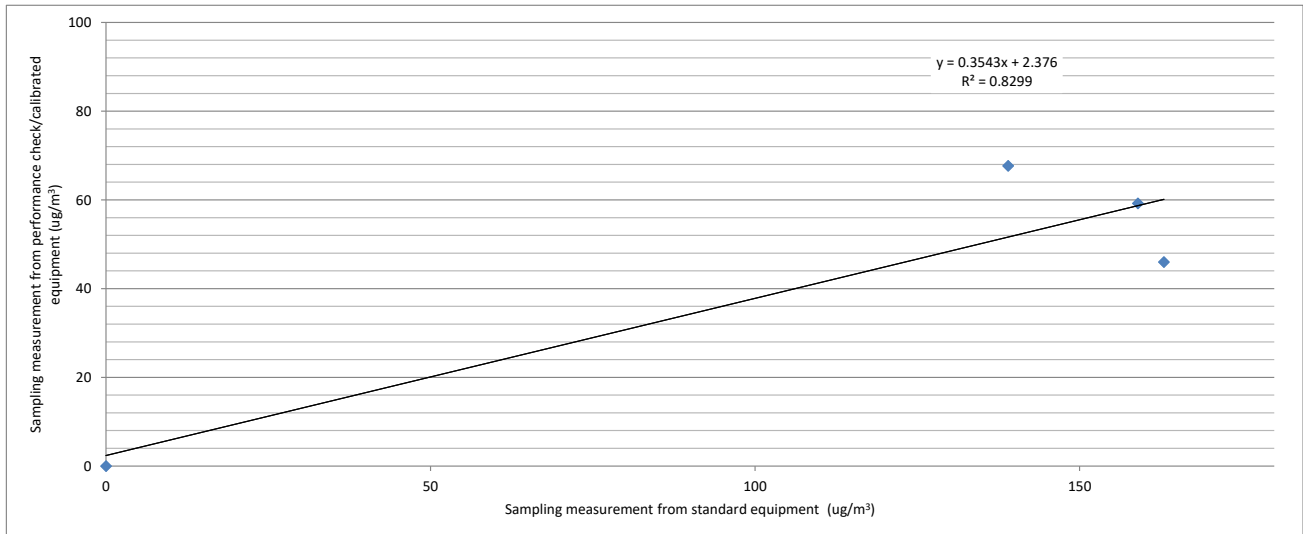
Linear Regression of Y on X

Slope (K- factor) : 2.4000
Correlation Coefficient : 0.9110
Validity of Performance Check / Calibration Record : 17/4/2025

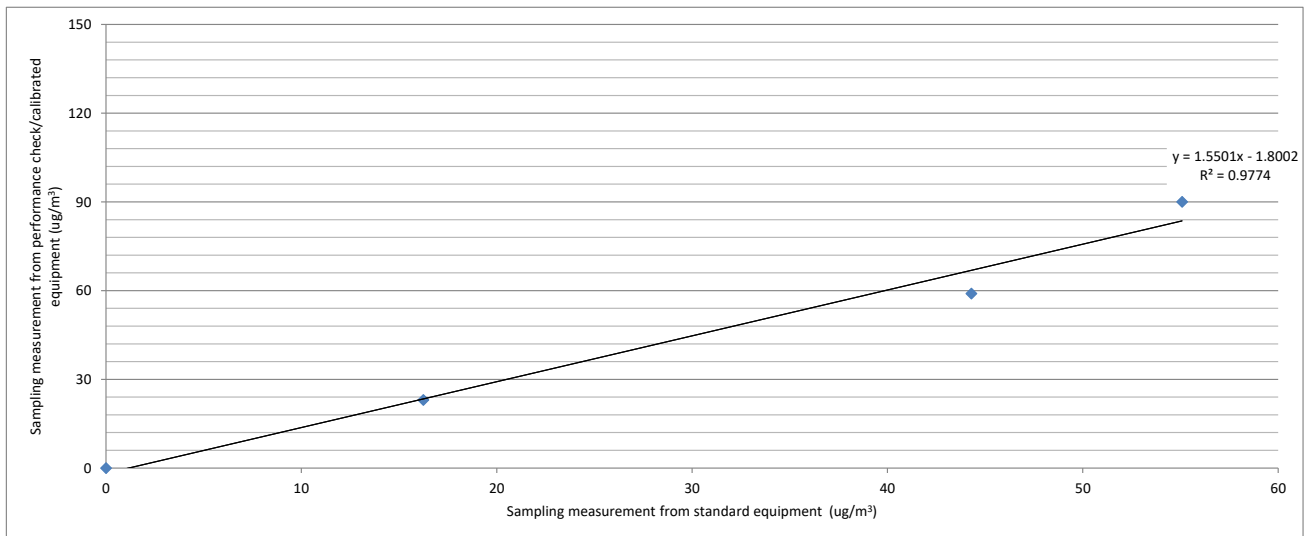
Linear Regression of Y on X

Slope (K- factor) : 1.6000
Correlation Coefficient : 0.9887
Validity of Performance Check / Calibration Record : 17/8/2024

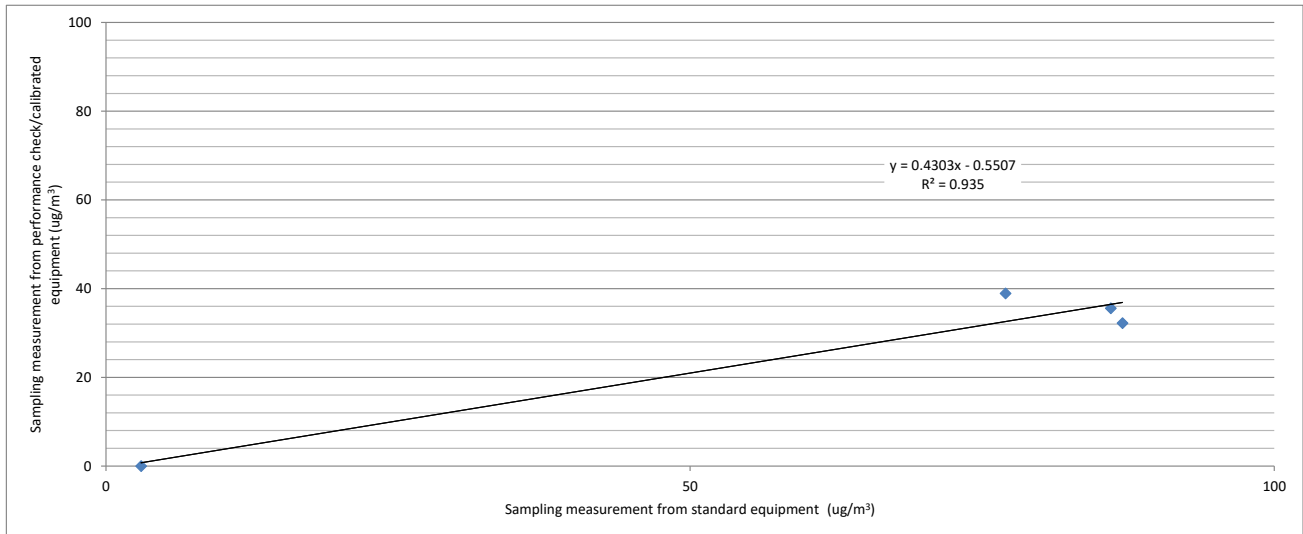
Linear Regression of Y on X

Slope (K- factor) : 2.2000
Correlation Coefficient : 0.9670
Validity of Performance Check / Calibration Record : 6/5/2025

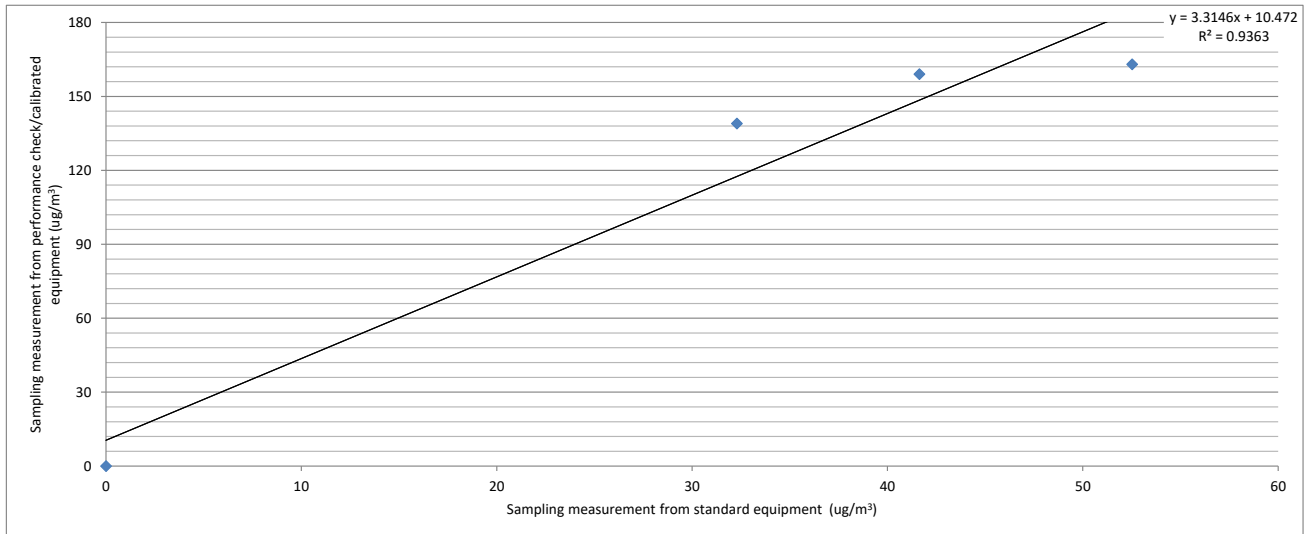
Linear Regression of Y on X

Slope (K- factor) : 3.4000
Correlation Coefficient : 0.9676
Validity of Performance Check / Calibration Record : 17/4/2025

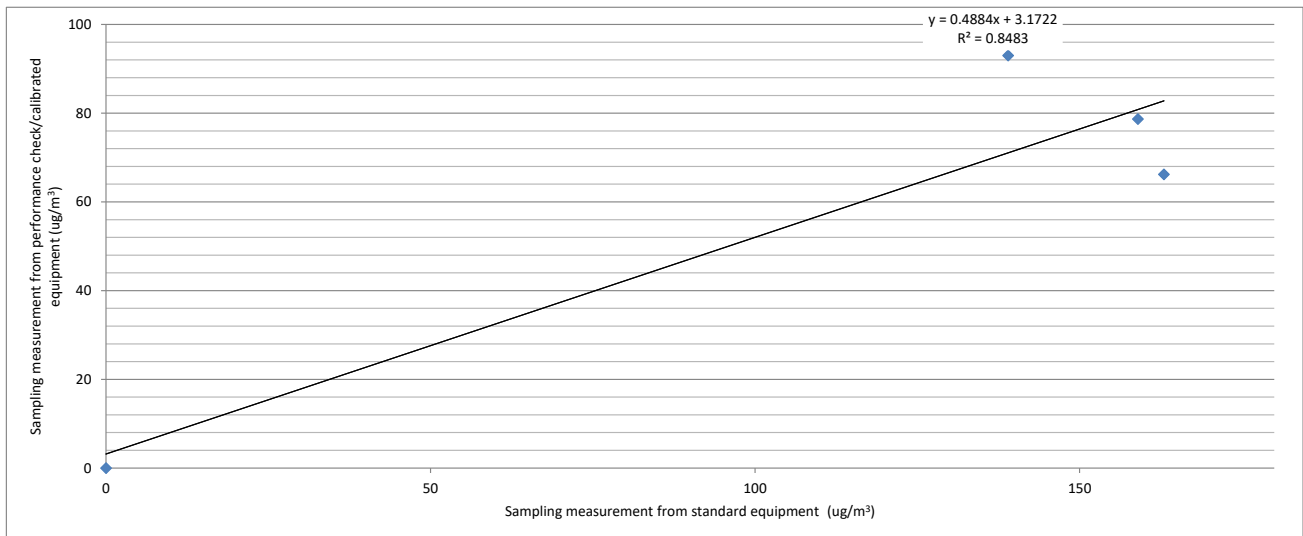
Linear Regression of Y on X

Slope (K- factor) : 1.8000
Correlation Coefficient : 0.9210
Validity of Performance Check / Calibration Record : 17/4/2025

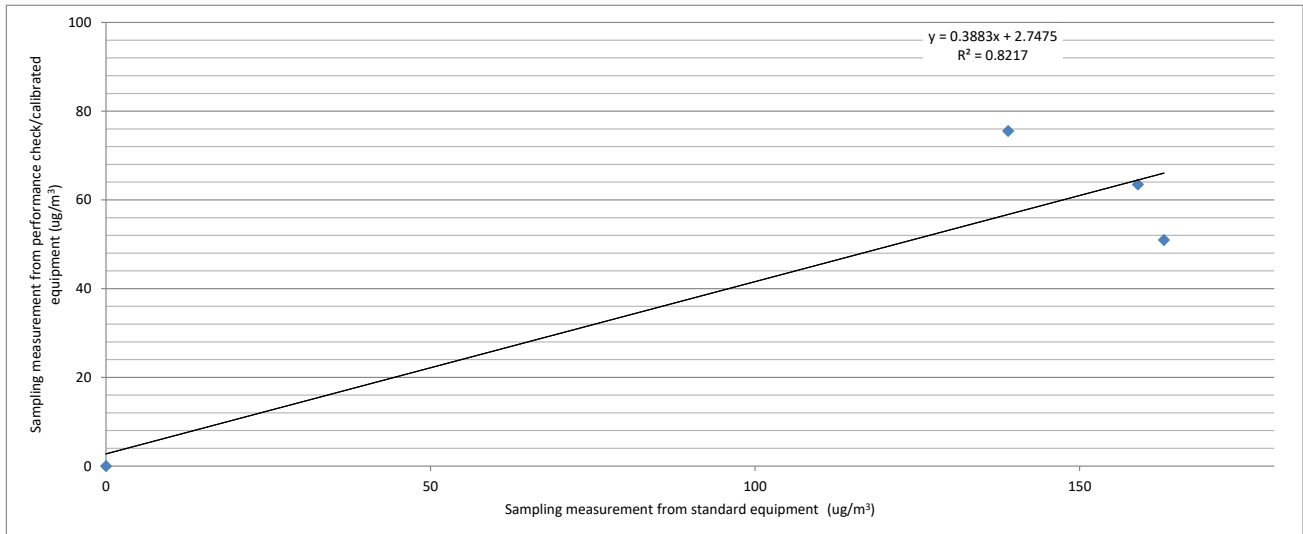
Linear Regression of Y on X

Slope (K- factor) : 2.2000
Correlation Coefficient : 0.9065
Validity of Performance Check / Calibration Record : 17/4/2025

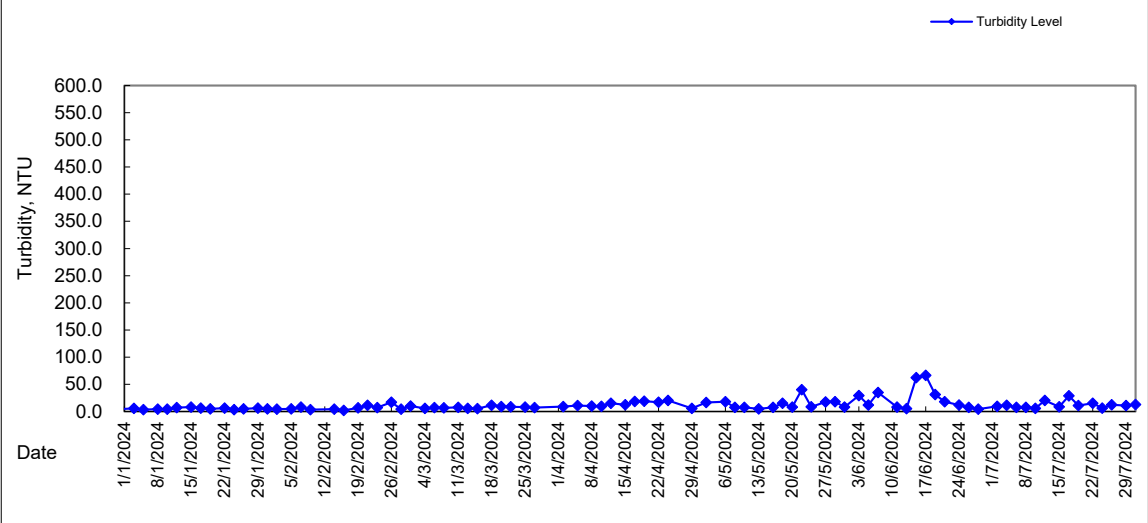
Station H - Ma You Tong Stream (Upstream Control Station) - Turbidity

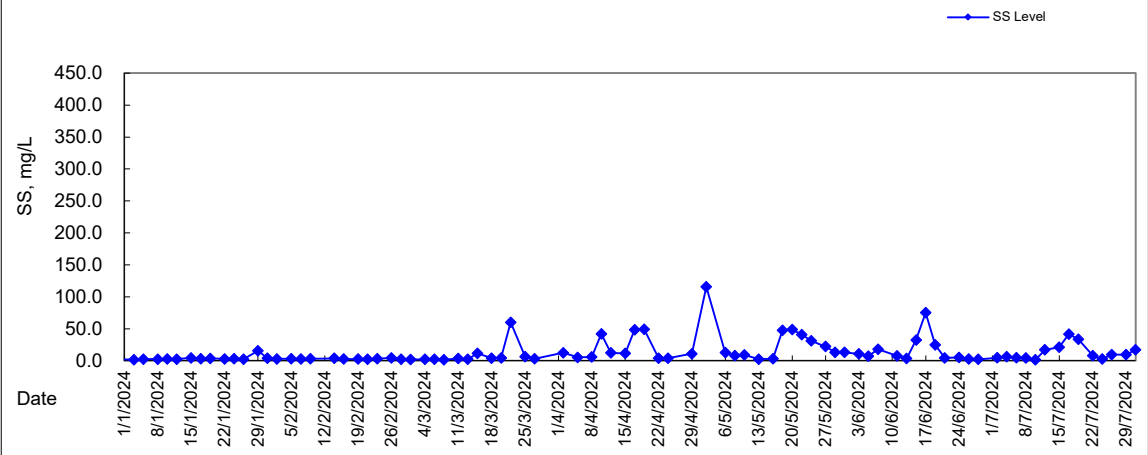
Station H - Ma You Tong Stream (Upstream Control Station) - Suspended Solid
