Agreement No. CE 60/2017 (EP)

Environmental Team for Tung Chung New Town Extension (East) -Design and Construction

Monthly Environmental Monitoring & Audit Report for February 2019

March 2019

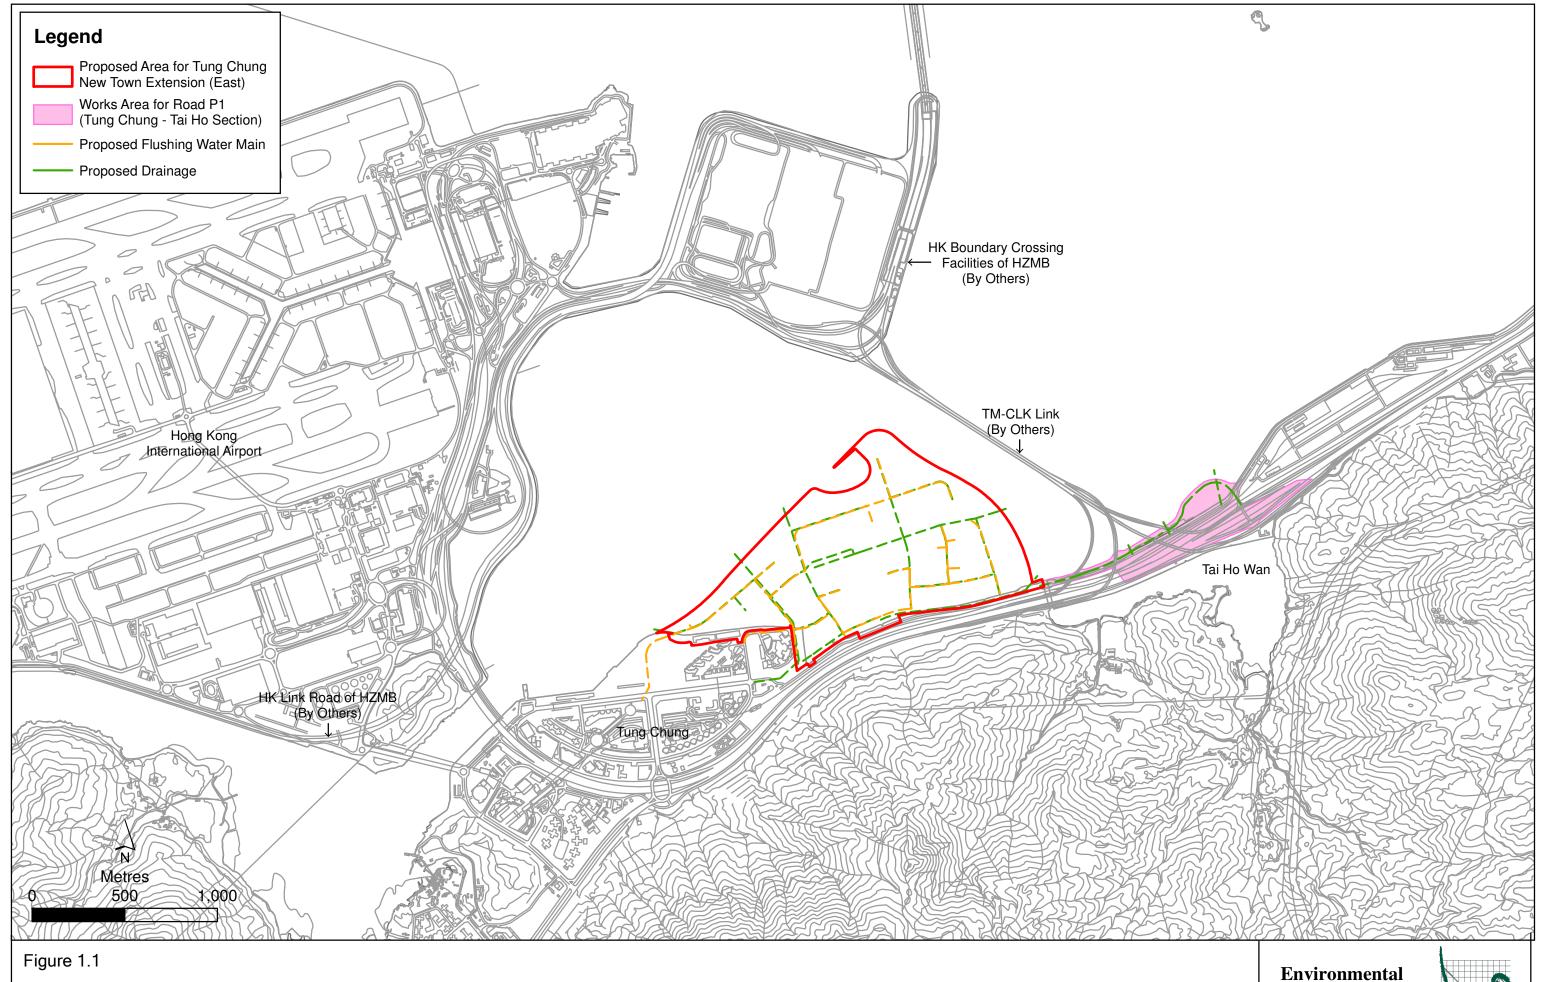
Location of the Tung Chung New Town Extensions (East) and its Associated Infrastructure Works

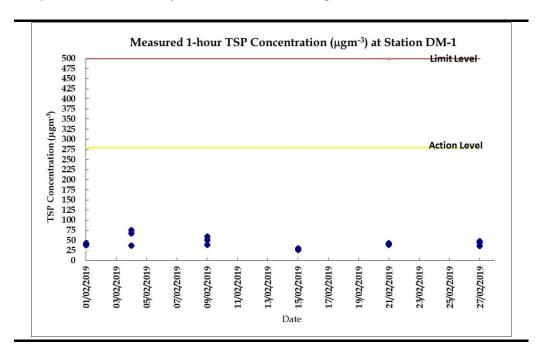
Figure D3 Graphical Presentation for 1-hr TSP Monitoring at Station DM-1

Date	Start Time	Finish Time	Weather	1-hour TSP (μg/m³)
01-02-2019	13:05	14:05	Cloudy	43
01-02-2019	14:05	15:05	Cloudy	40
01-02-2019	15:05	16:05	Cloudy	38
04-02-2019	14:36	15:36	Sunny	67
04-02-2019	15:36	16:36	Sunny	75
04-02-2019	16:36	17:36	Sunny	37
09-02-2019	13:35	14:35	Sunny	39
09-02-2019	14:35	15:35	Sunny	51
09-02-2019	15:35	16:35	Sunny	59
15-02-2019	13:06	14:06	Sunny	30
15-02-2019	14:06	15:06	Sunny	27
15-02-2019	15:06	16:06	Sunny	26
21-02-2019	13:09	14:09	Sunny	42
21-02-2019	14:09	15:09	Sunny	39
21-02-2019	15:09	16:09	Sunny	43
27-02-2019	8:11	9:11	Sunny	48
27-02-2019	9:11	10:11	Sunny	44
27-02-2019	10:11	11:11	Sunny	36

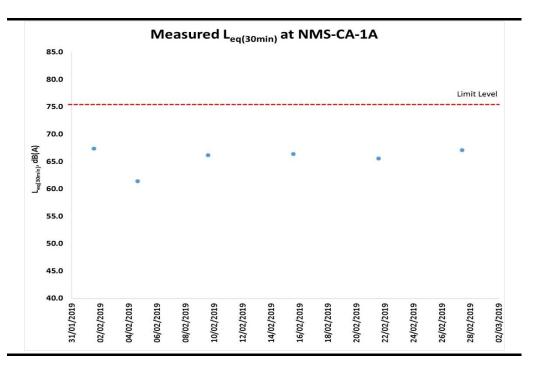
Figure E3.1 Graphical Presentation for Noise Monitoring at Station NMS-CA-1A

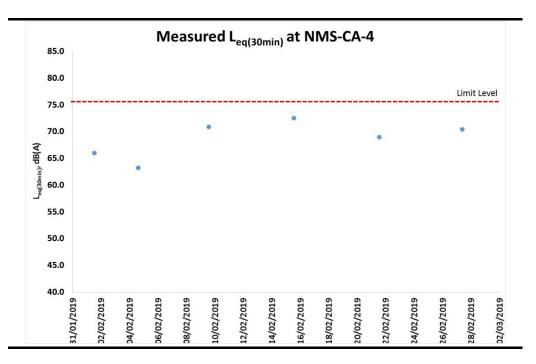
Figure E3.2 Graphical Presentation for Noise Monitoring at Station NMS-CA-4

Date & Time	L _{eq (5min)}	L ₁₀	L ₉₀	L _{eq (30min)}
01-02-2019 13:05	66.5	70.2	60.5	
01-02-2019 13:10	63.9	67.4	60.0	
01-02-2019 13:15	65.8	69.0	60.7	66.0
01-02-2019 13:20	66.6	70.3	60.2	00.0
01-02-2019 13:25	65.4	69.0	59.7	
01-02-2019 13:30	67.0	71.1	59.7	
04-02-2019 14:38	60.7	61.9	59.3	
04-02-2019 14:43	63.7	67.4	59.2	
04-02-2019 14:48	62.9	64.7	59.1	63.2
04-02-2019 14:53	62.1	63.9	60.7	03.2
04-02-2019 14:58	63.0	64.6	60.7	
04-02-2019 15:03	65.4	69.5	59.8	
09-02-2019 13:39	68.8	70.1	67.4	
09-02-2019 13:44	69.2	70.3	68.1	
09-02-2019 13:49	70.4	72.3	67.8	70.9
09-02-2019 13:54	70.6	71.7	69.2	70.9
09-02-2019 13:59	71.9	73.3	70.3	
09-02-2019 14:04	73.0	74.9	70.3	
15-02-2019 13:05	73.6	74.7	72.4	
15-02-2019 13:10	73.3	74.4	71.9	
15-02-2019 13:15	73.3	74.6	71.9	72.5
15-02-2019 13:20	72.8	74.2	71.3	12.5
15-02-2019 13:25	72.4	73.8	70.0	
15-02-2019 13:30	67.1	69.9	62.4	
21-02-2019 13:12	68.6	70.6	66.1	
21-02-2019 13:17	69.3	71.4	66.3

21-02-2019 13:22	68.9	71.1	64.1	68.9
21-02-2019 13:27	68.0	71.0	63.0	00.9
21-02-2019 13:32	69.7	72.7	64.2	
21-02-2019 13:37	68.9	72.0	63.0	
27-02-2019 9:39	69.4	71.3	66.6	
27-02-2019 9:44	71.4	73.5	68.6	
27-02-2019 9:49	71.8	73.5	69.7	70.4
27-02-2019 9:54	69.9	71.3	67.9	
27-02-2019 9:59	69.9	71.2	67.3	
27-02-2019 10:04	69.5	71.6	65.8

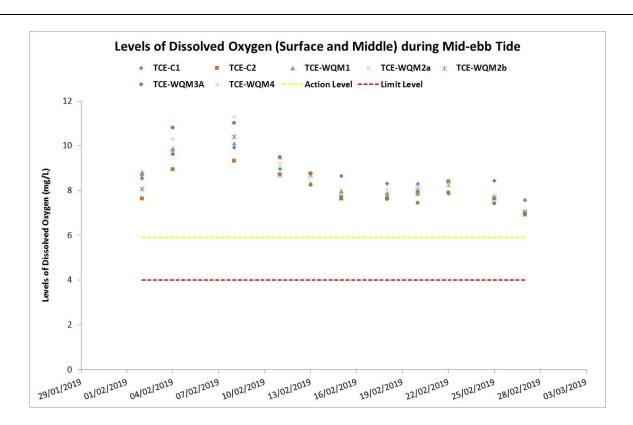
Figure 1: Levels of Dissolved Oxygen (Surface and Middle) (mg/L) recorded at Mid-ebb Tide during the Water Quality Monitoring between 1 and 28 February 2019

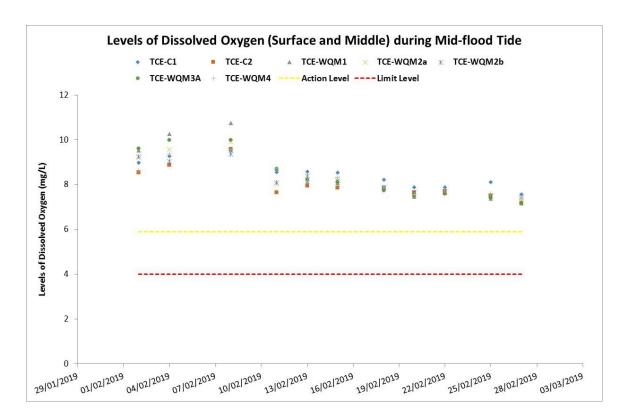
Figure 2: Levels of Dissolved Oxygen (Surface and Middle) (mg/L) recorded at Mid-flood Tide during the Water Quality Monitoring between 1 and 28 February 2019

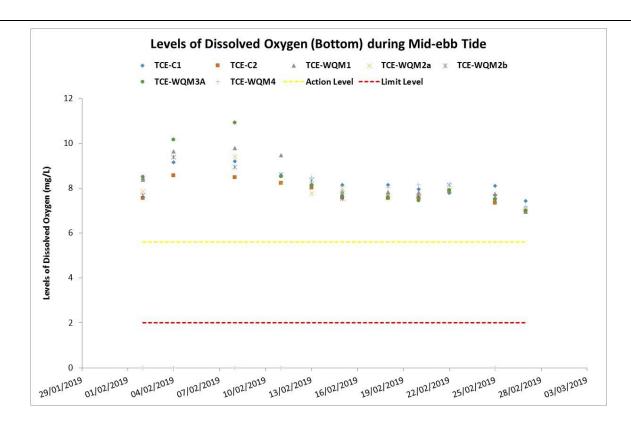
Figure 3: Levels of Dissolved Oxygen (Bottom) (mg/L) recorded at Mid-ebb Tide during the Water Quality Monitoring between 1 and 28 February 2019

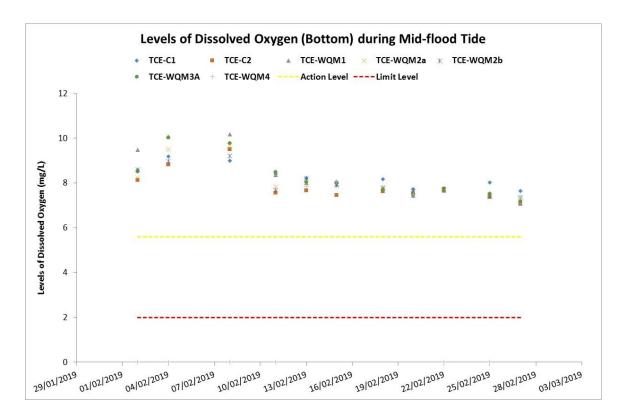
Figure 4: Levels of Dissolved Oxygen (Bottom) (mg/L) recorded at Mid-flood Tide during the Water Quality Monitoring between 1 and 28 February 2019

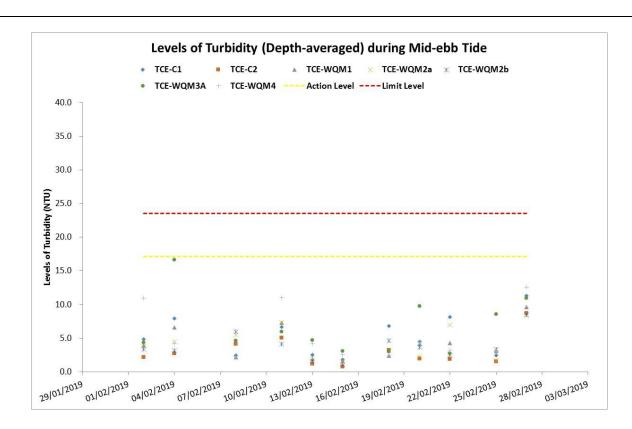
Figure 5: Levels of Turbidity (Depth-averaged) (NTU) recorded at Mid-ebb Tide during the Water Quality Monitoring between 1 and 28 February 2019

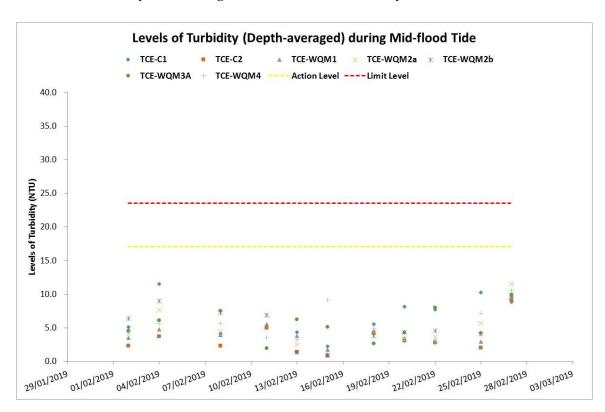
Figure 6: Levels of Turbidity (Depth-averaged) (NTU) recorded at Mid-flood Tide during the Water Quality Monitoring between 1 and 28 February 2019

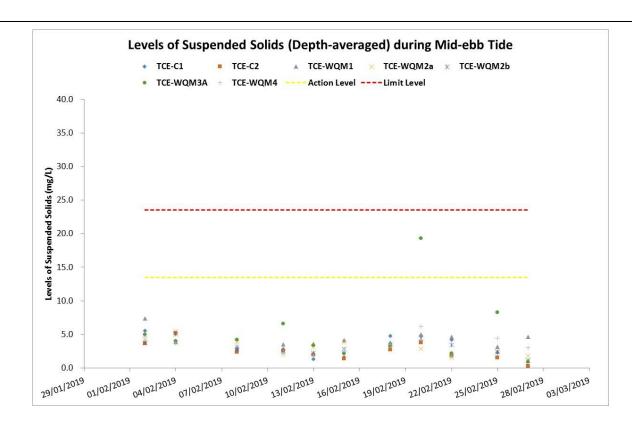
Figure 7: Levels of Suspended Solids (Depth-averaged) (mg/L) recorded at Mid-ebb Tide during the Water Quality Monitoring between 1 and 28 February 2019

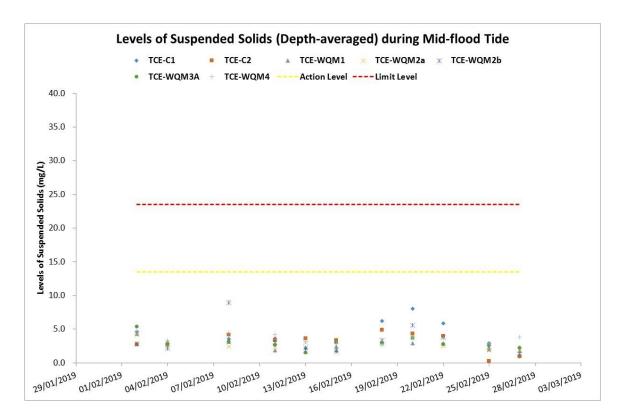
Figure 8: Levels of Suspended Solids (Depth-averaged) (mg/L) recorded at Mid-flood Tide during the Water Quality Monitoring between 1 and 28 February 2019
