**Agreement No. CE 30/2018 (EP)  
Environmental Team for Kai Tak Sports Park –  
Design and Construction**

Quarterly EM&A Report (Jan 2024 – Mar 2024)

April 2024

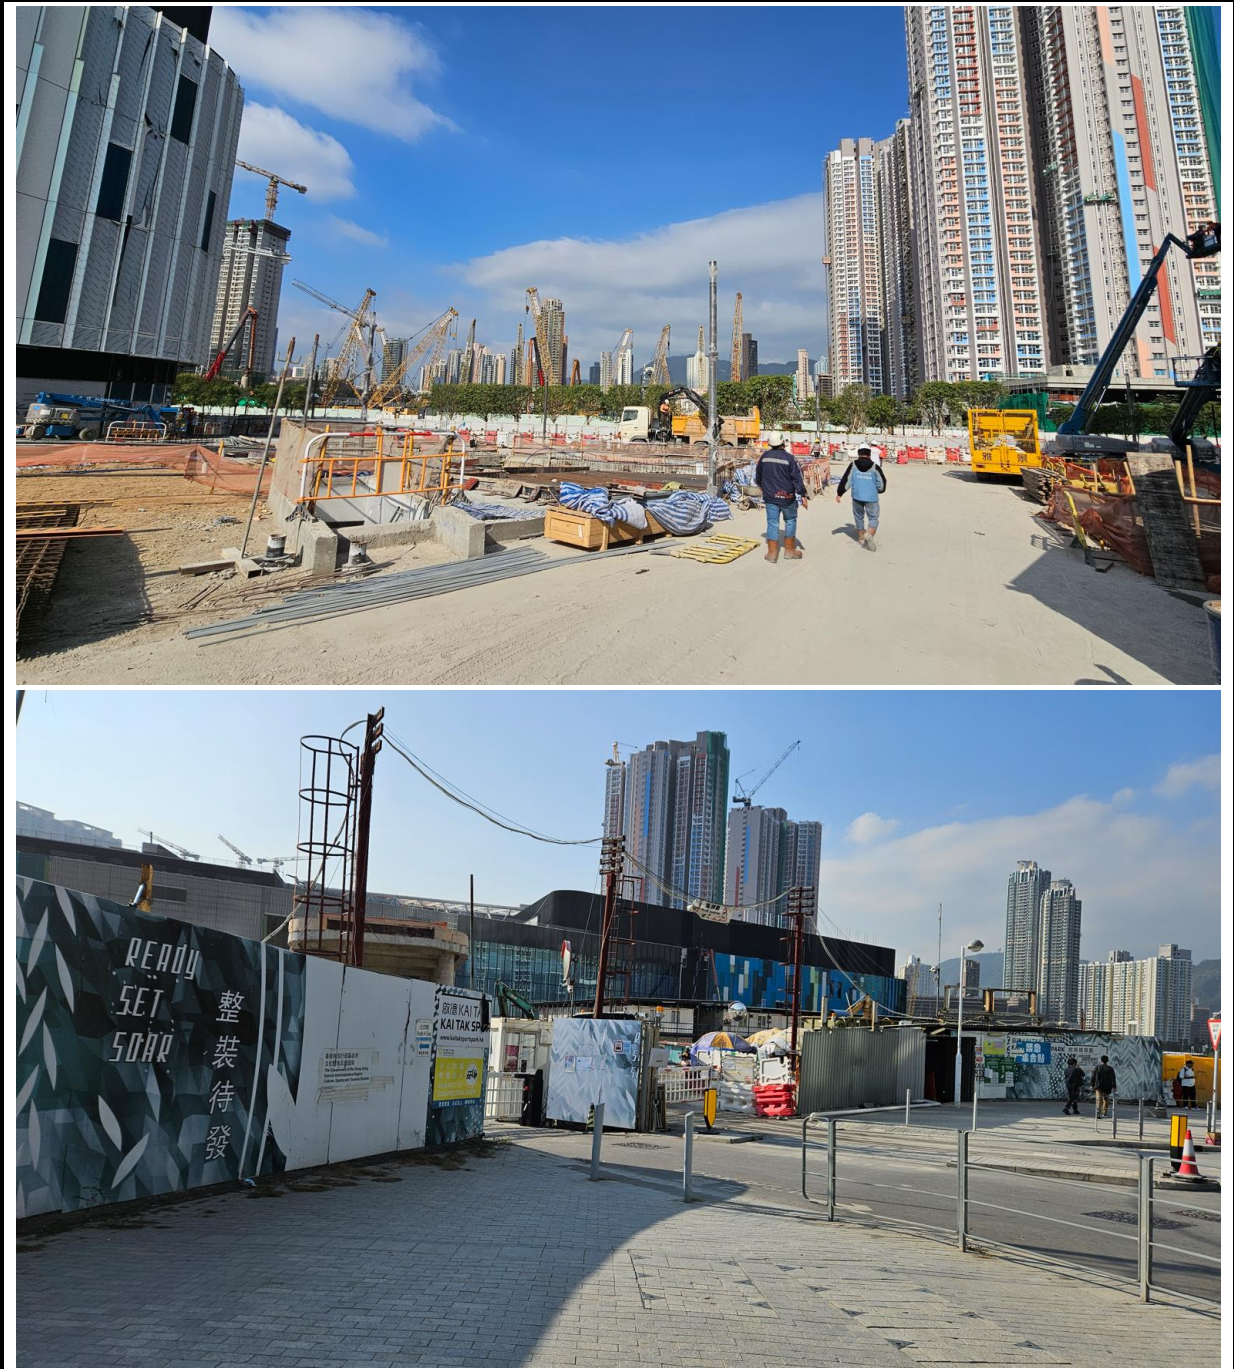
**Photo 1a and 1b:** Regular site inspection with contractor on 3 January 2024.

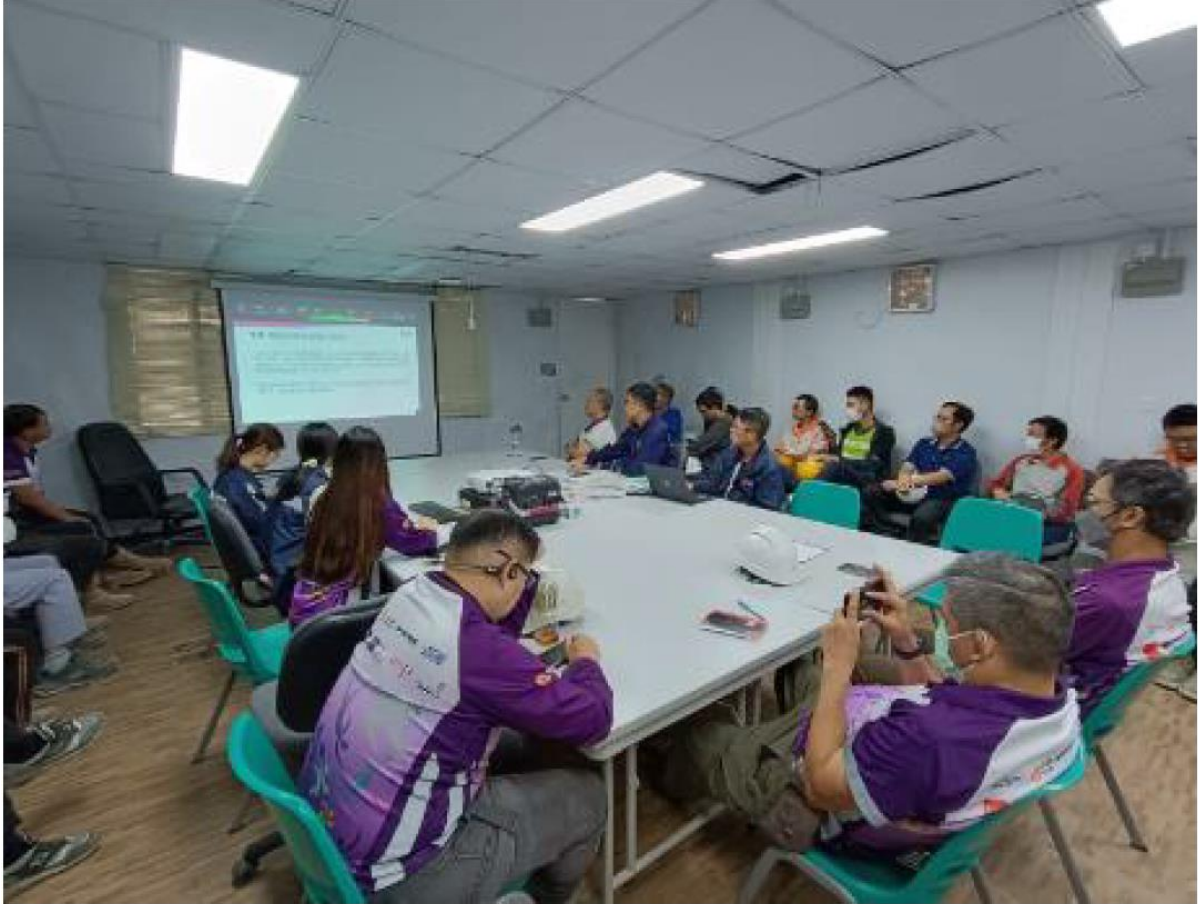
**Photo 2:** Subcontractors had been reminded to switch off all powered mechanical equipment every day after finish working during subcontractor meetings.

RECOMMENDATIONS / MITIGATION MEASURES / ACTIONS			
Environmental mitigation measures have been maintained as follow:			
1. All subcontractors had been reminded to switch off all powered mechanical equipment every day after finish working during subcontractor meetings. (Photo 2).			
2. A memo to subcontractors has been issued with the latest Construction Noise Permit requirement. (Photo 3).			
3. Technician night shift team conduct patrol at the site area every day to ensure all unnecessary construction equipment are off. (Photo 4a and 4b)			
4. Implementation of construction noise mitigation measures recommended in EIA’s Environmental Mitigation Implementation Schedule.			
Prepared by:	Sunny Chan	Title:	Environmental Team Leader
Signature:

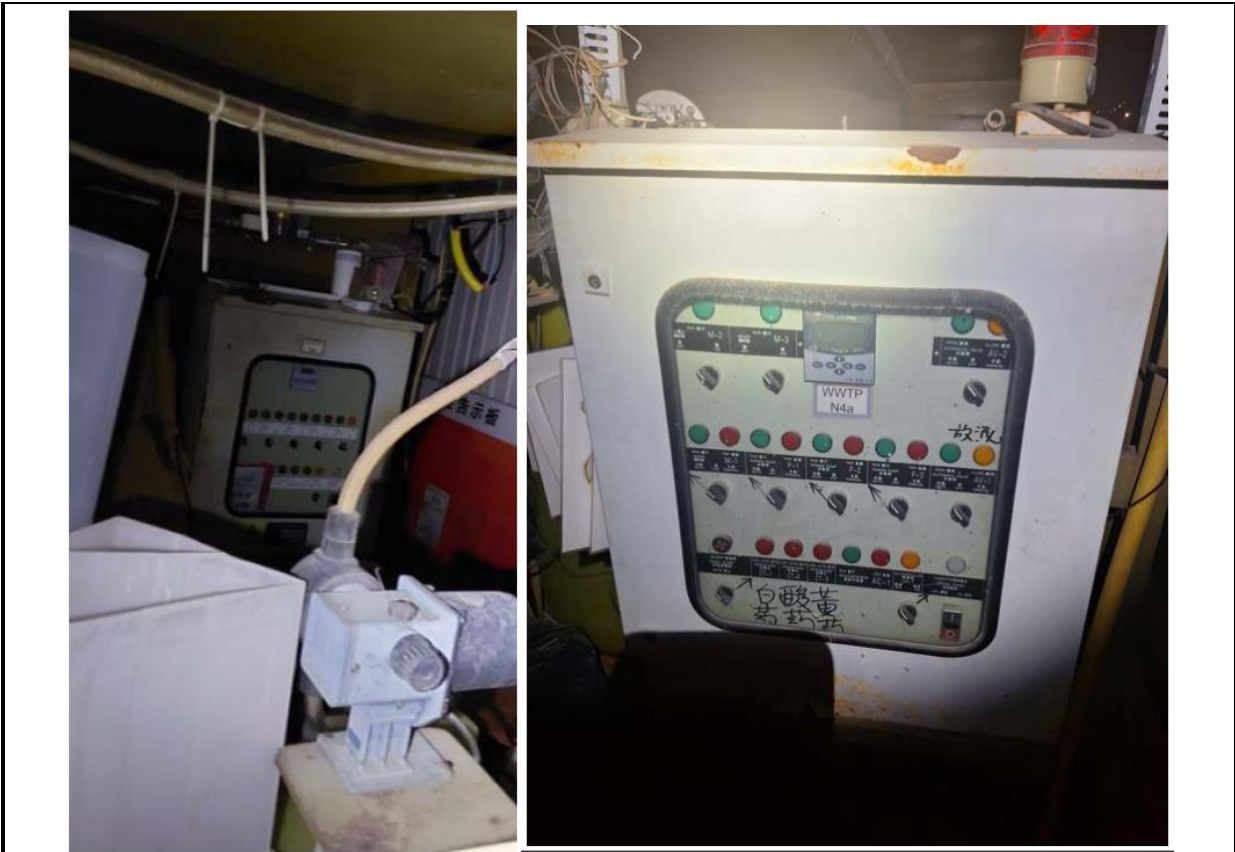
**Photo 4a and 4b:** Technician night shift team conduct patrol at the site area every day to ensure all unnecessary construction equipment are off.

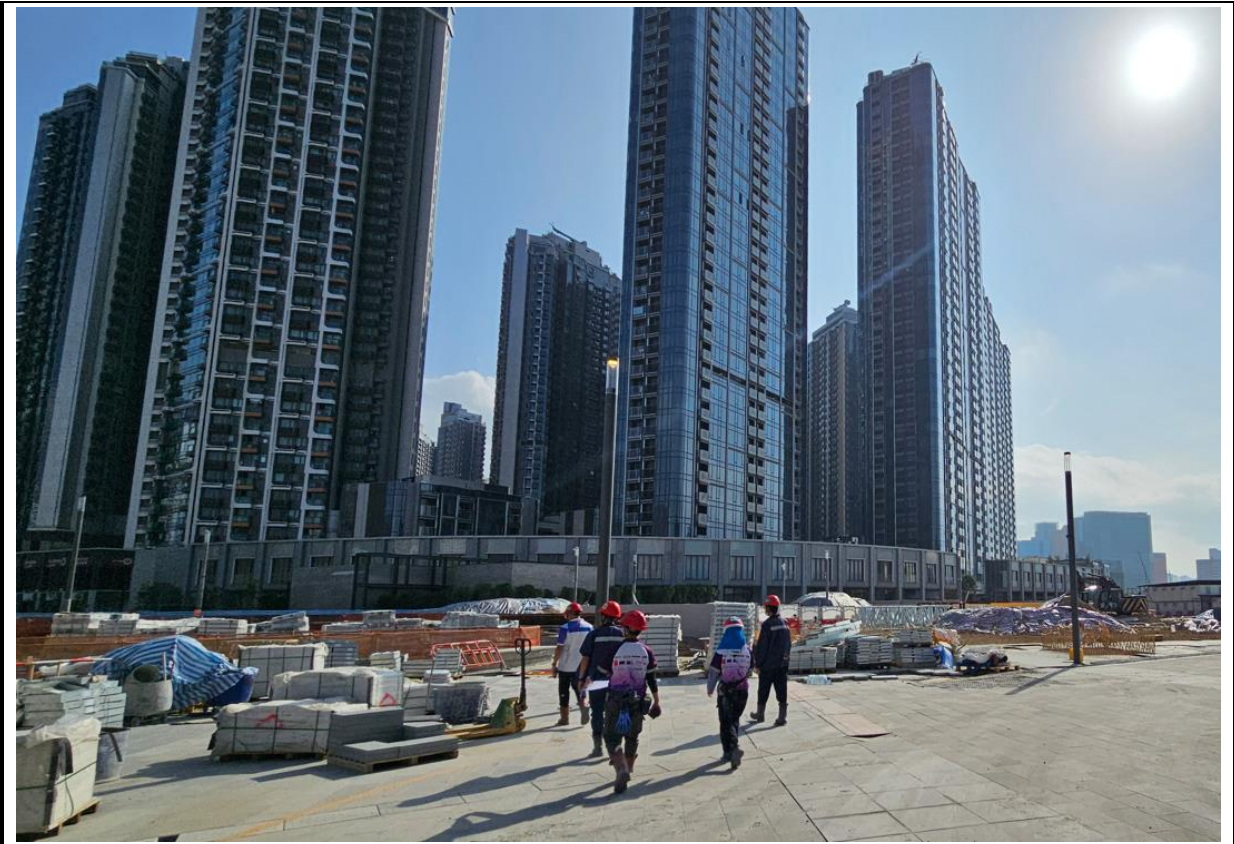
**Photo 1:** Regular site inspection carried out for checking covering of stockpile on site. (14 February 2024)

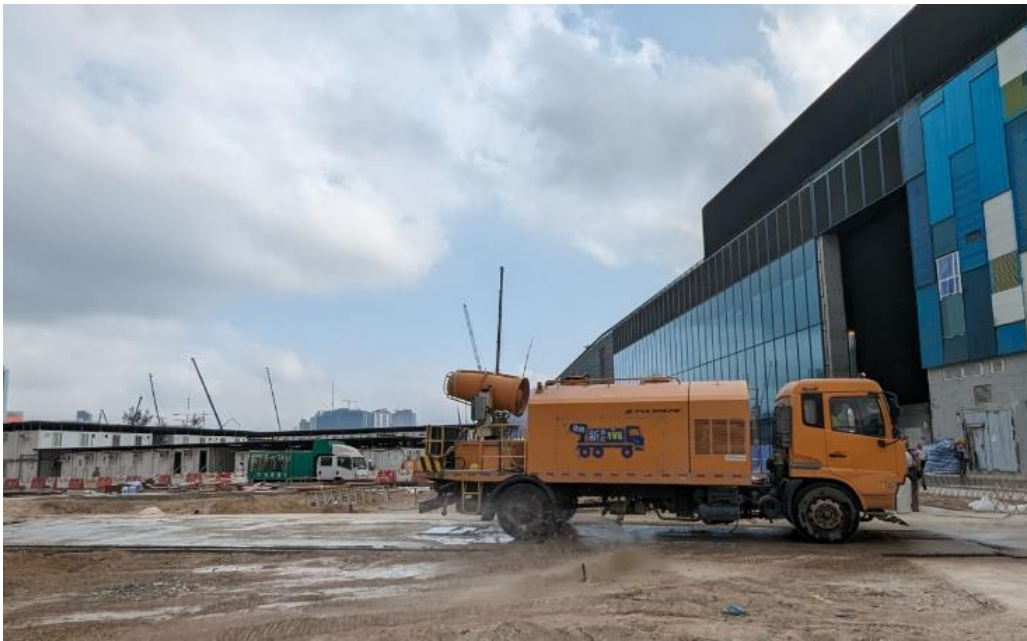
**Photo 3:** Water spraying truck has been provided on haul road to maintain wet surface.

RECOMMENDATIONS / MITIGATION MEASURES / ACTIONS			
Environmental mitigation measures have been maintained as follow:			
1. Covering has been provided for stockpile on site. (Photo 2)			
2. Water spraying truck has been provided on haul road to maintain wet surface. (Photo 3).			
3. Water misting cannon has been provided for dust suppression on site. (Photo 4)			
4. A memo has been issued and subcontractors are reminded to properly cover the stockpile and duty materials on site. (Photo 5a and 5b)			
5. Implementation of construction dust mitigation measures recommended in EIA's Environmental Mitigation Implementation Schedule.			
Prepared by:	Sunny Chan	Title:	Environmental Team Leader
Signature:

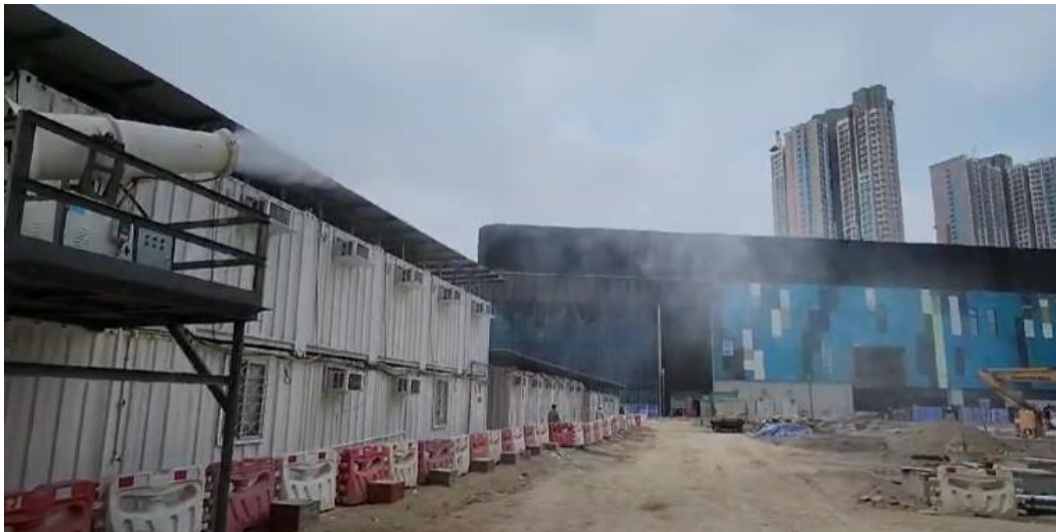
**Photo 4:** Water misting cannon has been provided for dust suppression on site.

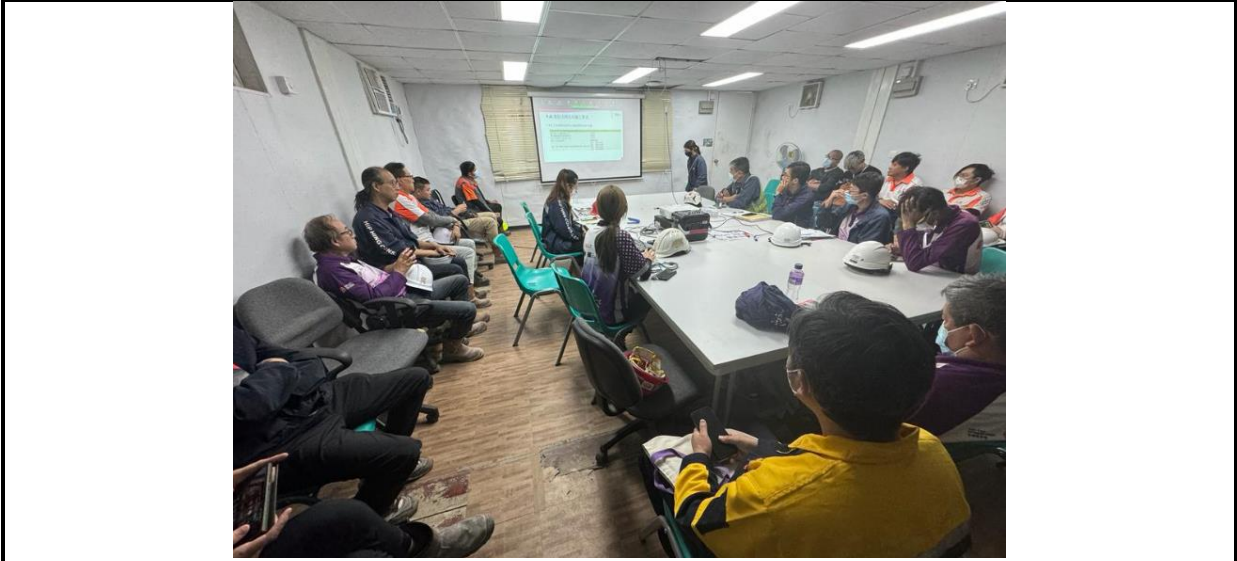
**Photo 5a and 5b:** A memo has been issued and subcontractors are reminded to properly cover the stockpile and duty materials on site.
