**Contract No. SPW 02/2023
Environmental Team for
Construction of Yuen Long
Effluent Polishing Plant
Stage 1**

**Monthly EM&A Report (July 2024)
Drainage Services Department**

Environmental Permit No. EP-565/2019

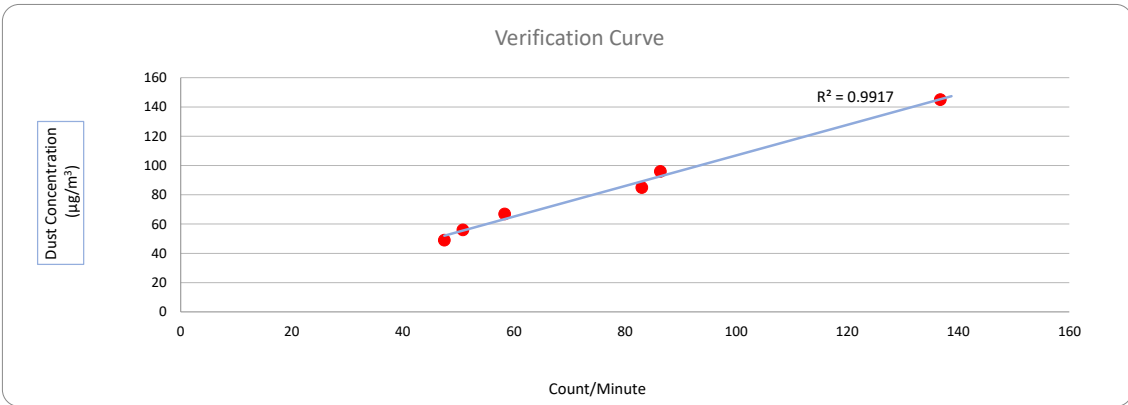
Linear Regression of y on x

Slope, K factor:	<u>1.0437</u>	Intercept:	<u>2.4993</u>	*Correlation Coefficient,R:	<u>0.9958</u>
Verification Test Result:	<u>Strong Correlation. Results were accepted.</u>			* If the Correlation Coefficient, R is <0.5. Checking and Re-verification are required.

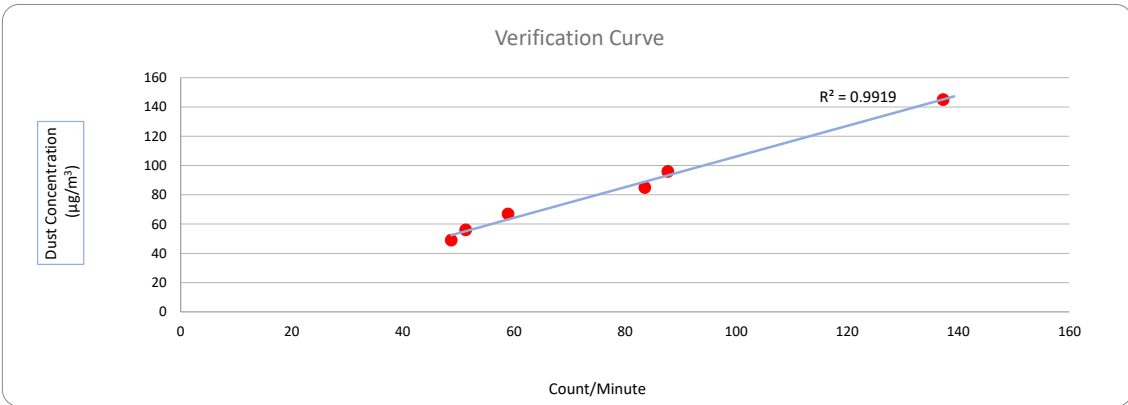
Linear Regression of y on x

Slope, K factor:	<u>1.0468</u>	Intercept:	<u>1.4320</u>	*Correlation Coefficient,R:	<u>0.9959</u>
Verification Test Result:	<u>Strong Correlation, Results were accepted.</u>			* If the Correlation Coefficient, R is <0.5. Checking and Re-verification are required.

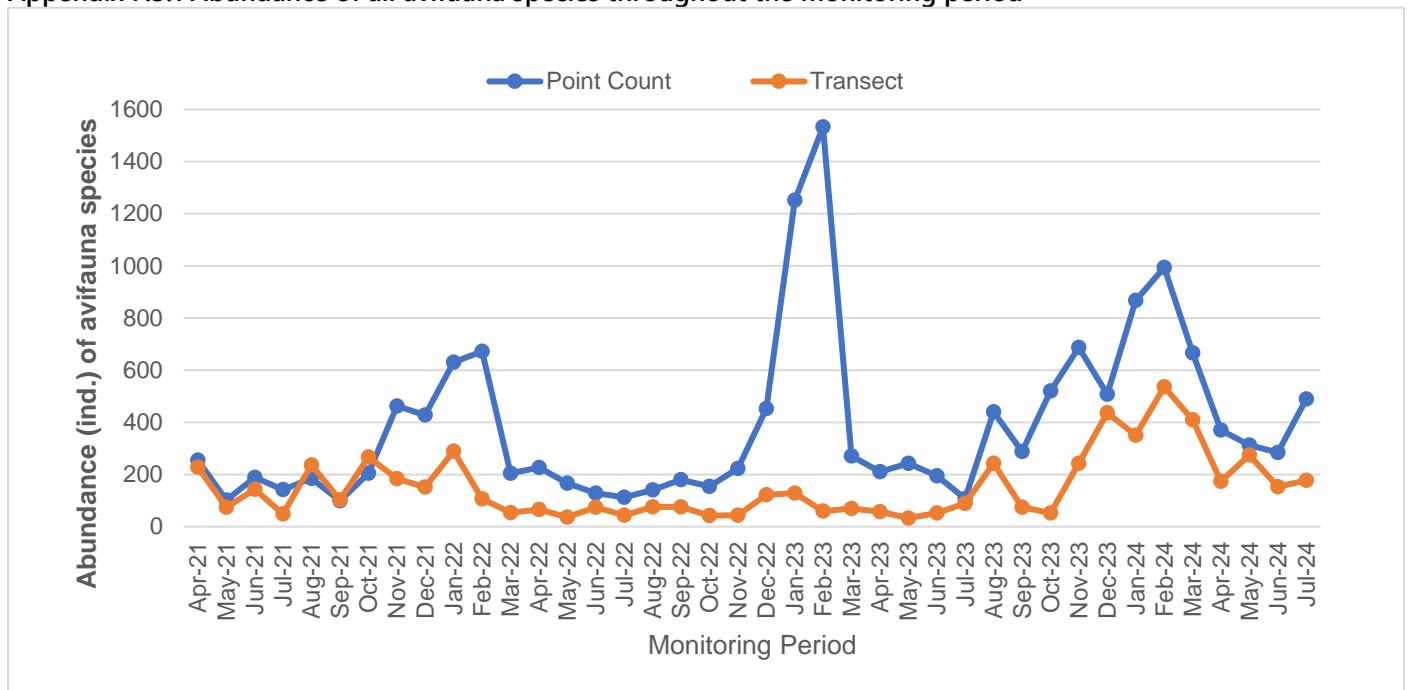
Appendix F.3.1 Abundance of all avifauna species throughout the monitoring period

An overall total of 666 avifauna individuals were recorded in the monitoring area during the July 2024 monitoring period, of which 489 individuals were recorded from the point count method and 177 individuals from the transect walk method. Relative to the July 2017 baseline data (point count method = 165; and transect walk = 36), significant increases were noted for both the point count and transect walk methods.

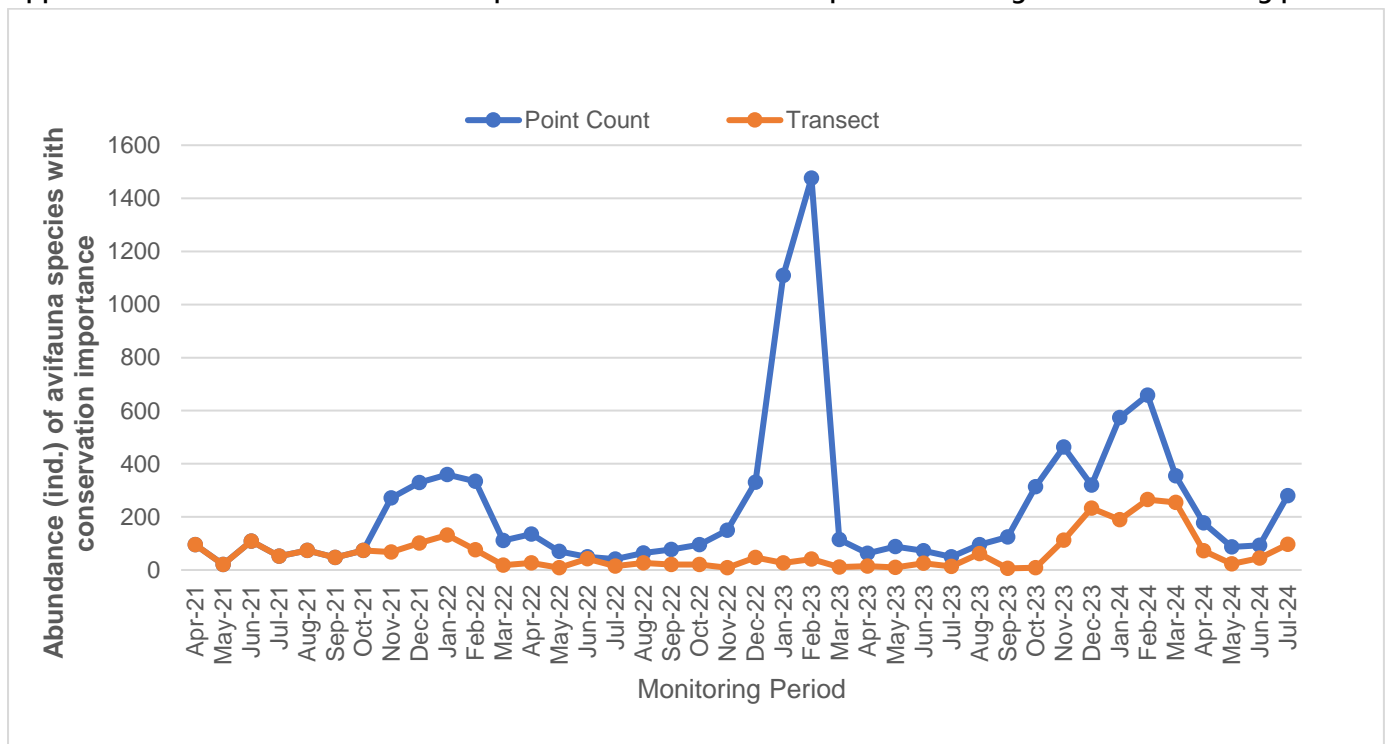
Appendix F.3.2 Abundance of avifauna species with conservation importance throughout the monitoring period

Of the 666 avifauna individuals recorded in the monitoring area during the July 2024 monitoring period, 376 individuals (point count method = 280 individuals; transect walk method = 96 individuals) were of conservation importance. With reference to July 2017 data, (point count method = 80; and transect walk = 8), significant increases were noted for both point count and transect walk method. Details of these findings are summarized in **Table 21**.

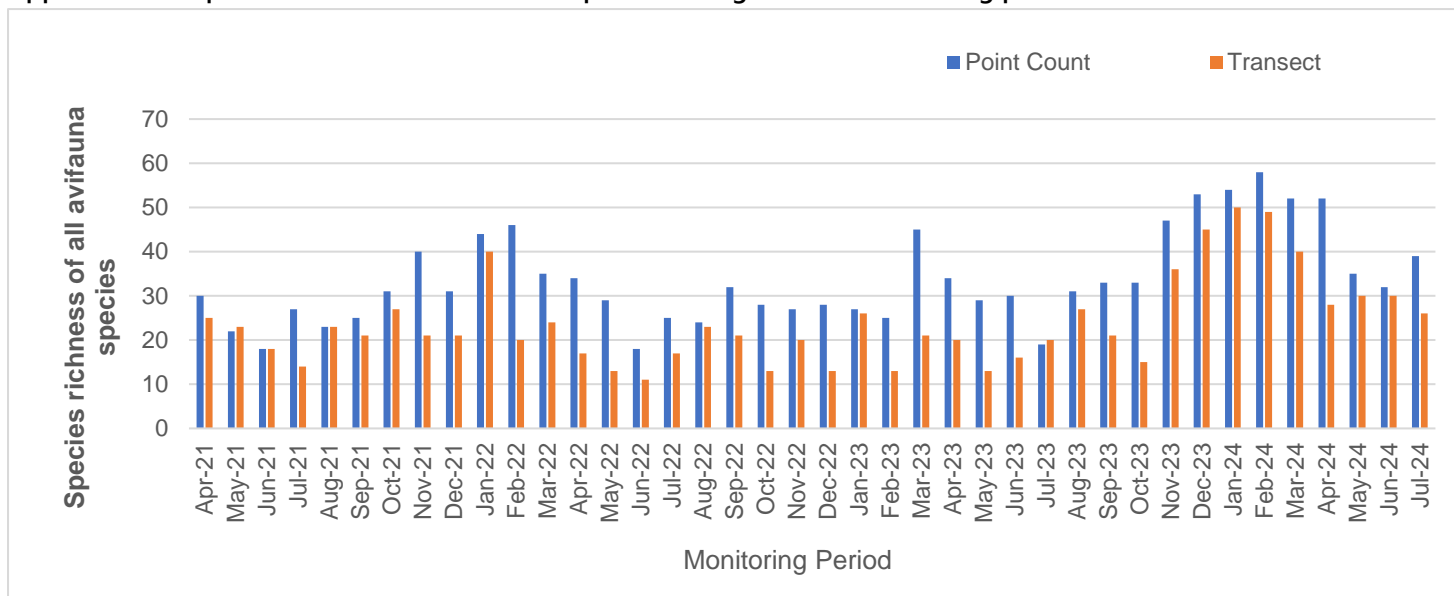
Appendix F.4.1 Species richness of all avifauna species throughout the monitoring period

A total of 41 avifauna species (species richness) were recorded during the July 2024 monitoring period, of which, 39 species were recorded by the point count method while 26 species were noted by the transect walk method. Relative to the baseline data (point count method = 26 species; transect walk method = 18 species), increases in total species richness for both transect walk count and point count methods were recorded. In terms of Shannon diversity index (H') values, current result in point count method showed a slight increase (t-value = 0.77; t-crit = 1.97; p-value = 0.44; α = 0.05) relative to the baseline reference value. The current results in the transect walk method also showed a slight increase (t-value = 0.37; t-crit = 2.00; p-value = 7.09E-1; α = 0.05) from baseline reference value. Details of these findings are summarized in **Table 22**, **Appendix F.6.1**, and **Appendix F.6.2**.

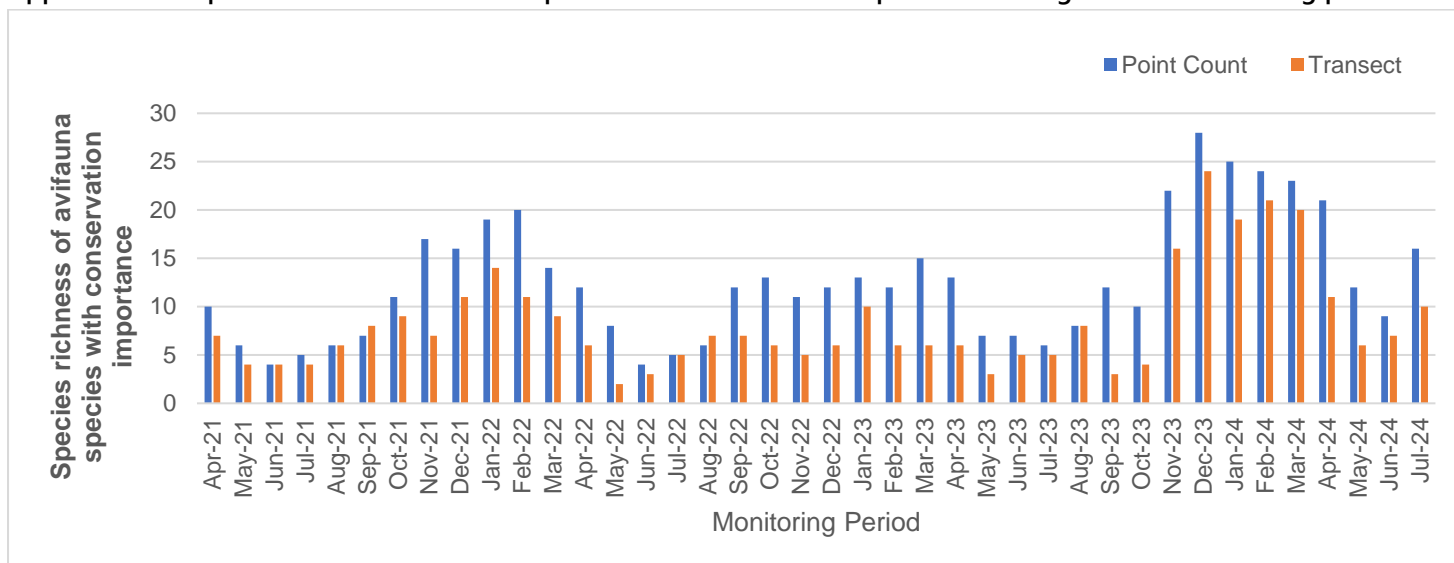
Appendix F.4.2 Species richness of avifauna species with conservation importance throughout the monitoring period

Of the 41 avifauna species identified during the July 2024 monitoring period, 16 species were of conservation importance (point count method = 16 species; transect walk method = 10 species). Meanwhile, relative to the baseline values in July 2017 (point count method = 5 species; transect walk method = 3 species), a significant increase in the number of species with conservation importance was recorded with both the point count and transect walk method. In terms of Shannon diversity index (H'), an increase was noted in point count method (t-value = 3.22; t-crit = 1.97; p-value = 0.0015; $\alpha = 0.05$) while a significant increase in transect walk method (t-value = 2.47; t-crit = 2.20; p-value = 3.09E-2; $\alpha = 0.05$) was observed relative to the baseline reference values. Details of these findings are summarized in **Table 23**, and **Appendix F.6.3**.

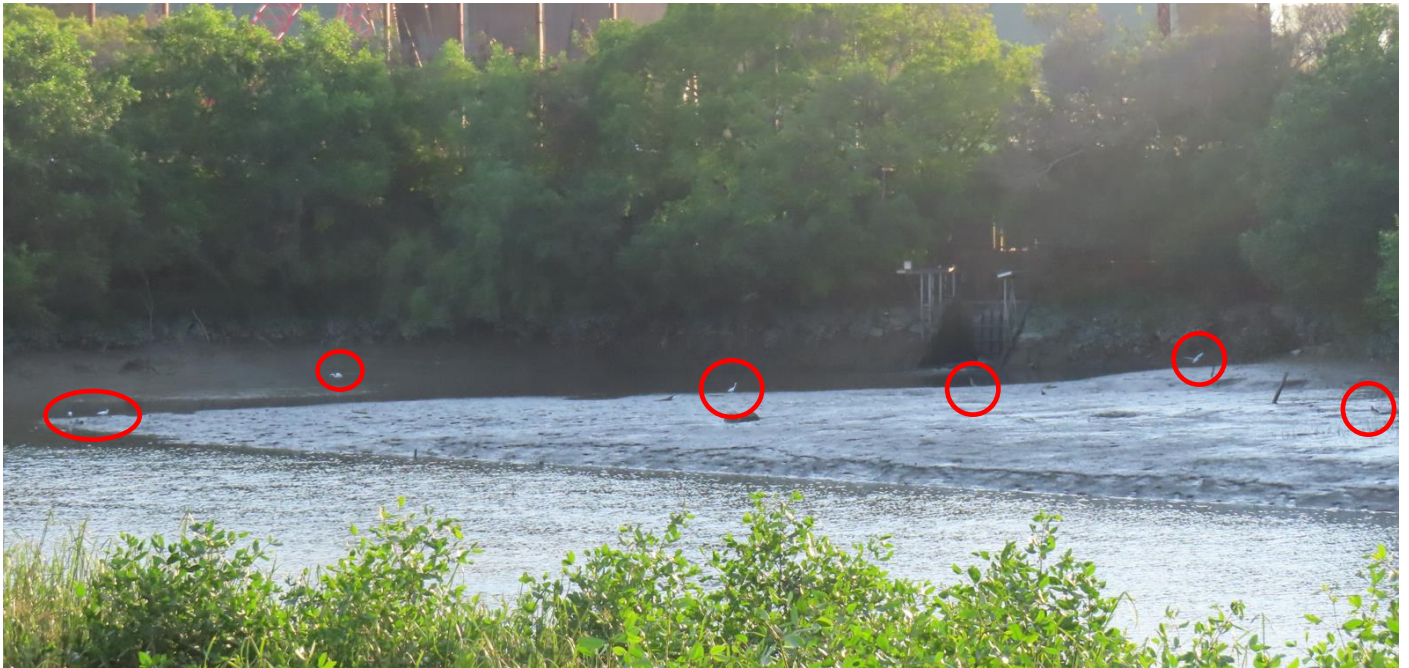
Appendix O.2.1a: Pre-roost aggregate of ardeids in the mudflat east side of the Project boundary observed on 9 July 2024 at around 18:24.

The monitoring activity was conducted on 9 July 2024 and started around 18:11 (one hour before sunset) on a low tide condition. During the pre-roost period (PRP), the period when avian individuals gather first before flying into a night roost, individuals of Chinese Pond Heron *Ardeola bacchus* (4), Little Egret *Egretta garzetta* (11) and Great Egret *Ardea alba* (1) were observed in pre-roost aggregate (PRA) around 18:24 at the mudflat east side ANR1 of the Project boundary while individuals of Chinese Pond Heron *Ardeola bacchus* (2), Little Egret *Egretta garzetta* (6) and Great Egret *Ardea alba* (2) were concurrently noted at the mudflat northeast side ANR2 of the Project boundary (Table 17).

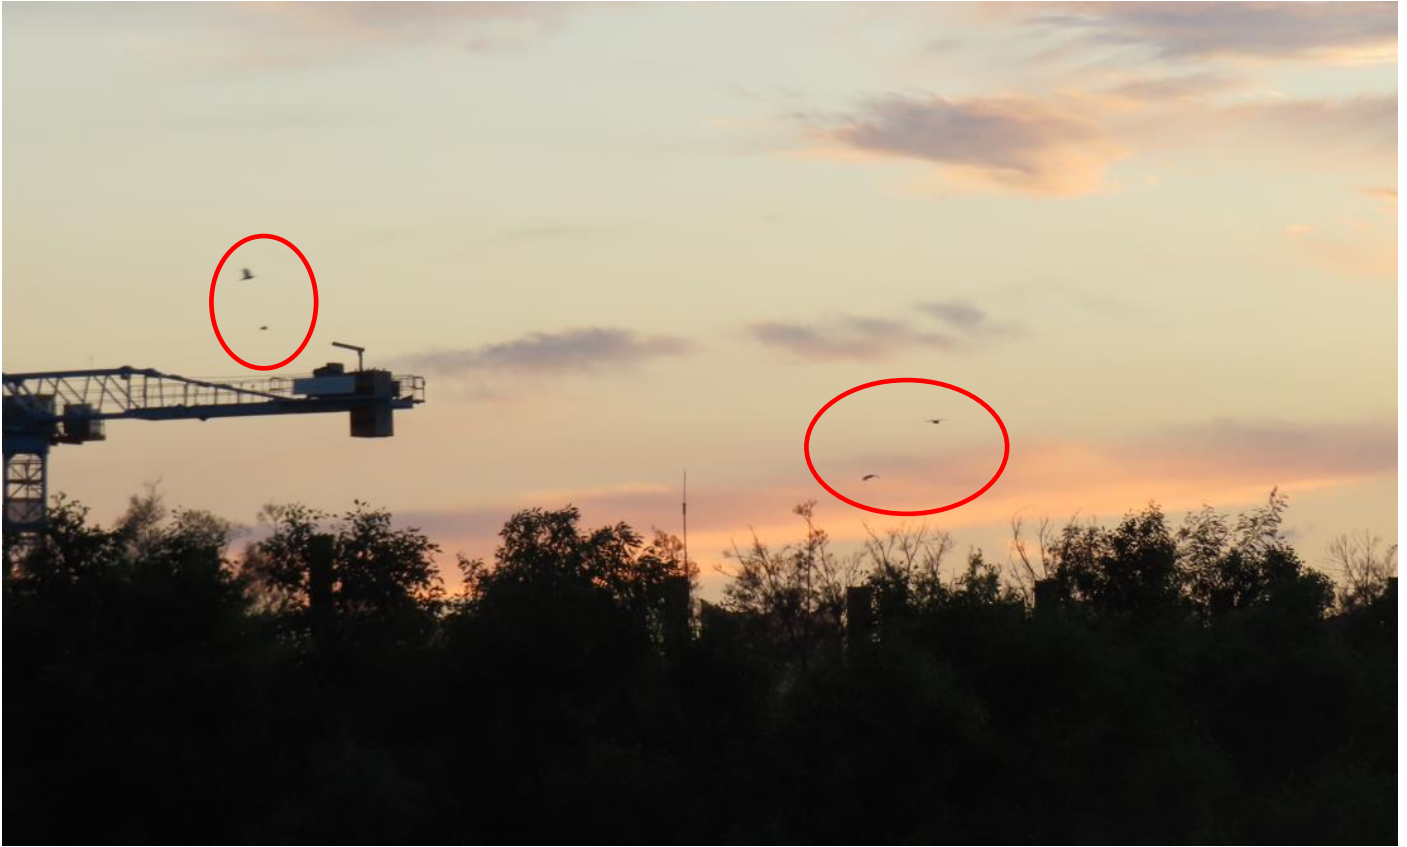
Appendix O.2.2a: Active night roost in the mudflat east side of the Project boundary observed on 9 July 2024 at around 19:14.

For the final night roost at around 19:14, individuals of Chinese Pond Heron *Ardeola bacchus* (21) and Little Egret *Egretta garzetta* (13) were observed at the roosting area ANR1 utilizing the understory to canopy layer of the roosting substrate *Sonneratia apetala* and *S. caseolaris*; while other individuals of Chinese Pond Heron *Ardeola bacchus* (13), Little Egret *Egretta garzetta* (8) and Great Egret *Ardea alba* (3) were noted at ANR2 that utilized the understory to canopy layer of the aforementioned roosting substrate.

No disturbance (construction related and/or otherwise) to the active night roost areas was observed during the period. Bird droppings were observed within the vicinity of the roosting area located east of the Project boundary.
