**Contract No. SPW 02/2023
Environmental Team for
Construction of Yuen Long
Effluent Polishing Plant
Stage 1**

**Monthly EM&A Report (August 2024)
Drainage Services Department**

EP Condition 3.4 – Monthly EM&A Report for August 2024

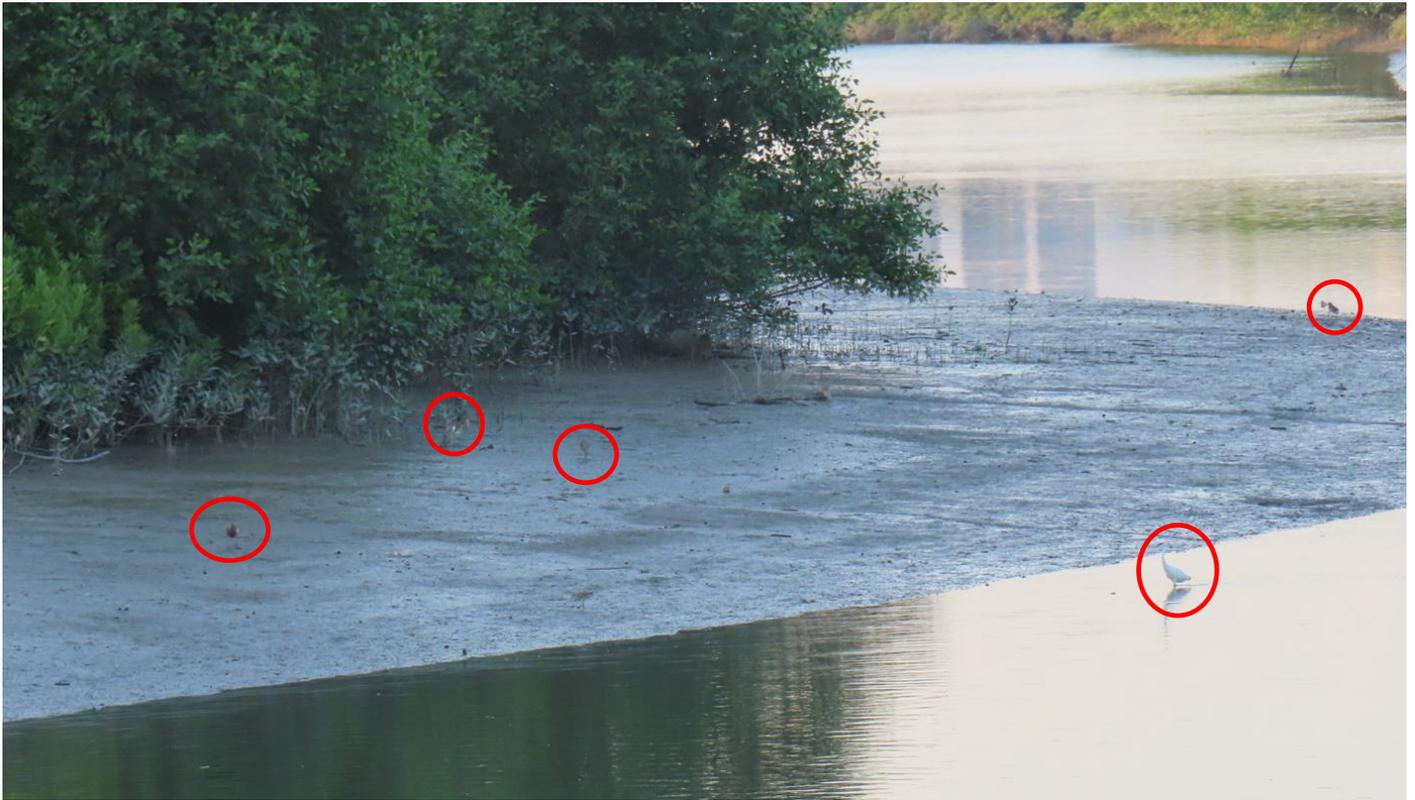
The monitoring activity was conducted on 9 August 2024 and started around 17:58 (one hour before sunset) on a low tide condition. During the pre-roost period (PRP), the period when avian individuals gather first before flying into a night roost, individuals of Chinese Pond Heron *Ardeola bacchus* (4), Little Egret *Egretta garzetta* (4) and Great Egret *Ardea alba* (2) were observed in pre-roost aggregate (PRA) around 18:34 at the mudflat east side ANR1 of the Project boundary while individuals of Chinese Pond Heron *Ardeola bacchus* (4) and Little Egret *Egretta garzetta* (2) were concurrently noted at the mudflat northeast side ANR2 of the Project boundary (Table 17).

Appendix O.2.1a: Pre-roost aggregate of ardeids in the mudflat northeast side ANR2 of the Project boundary observed on 9 August 2024 at around 18:34.

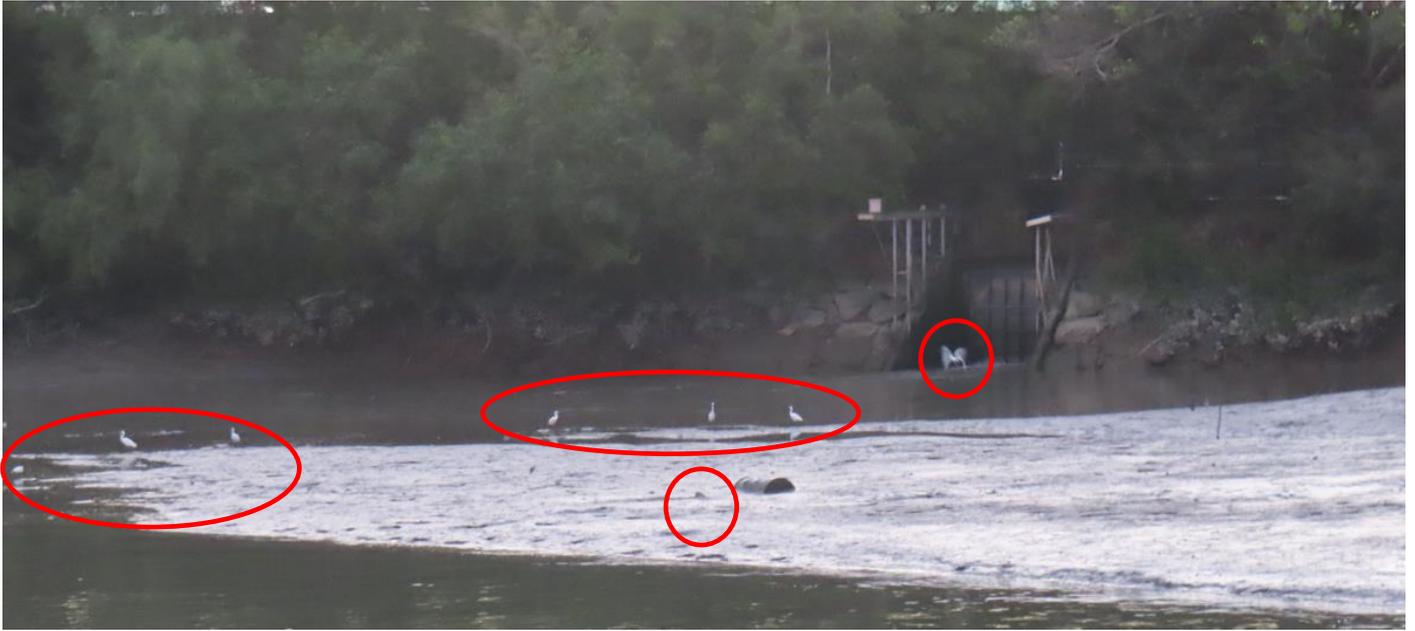
For the final night roost at around 19:09, individuals of Chinese Pond Heron *Ardeola bacchus* (3), Little Egret *Egretta garzetta* (10) and Great Egret *Ardea alba* (3) were observed at the roosting area ANR1 utilizing the understory to canopy layer of the roosting substrate *Sonneratia apetala* and *S. caseolaris*; while other individuals of Chinese Pond Heron *Ardeola bacchus* (6) and Little Egret *Egretta garzetta* (4) were noted at ANR2 that utilized the understory to canopy layer of the aforementioned roosting substrate.

No disturbance (construction related and/or otherwise) to the active night roost areas was observed during the period. Bird droppings were observed within the vicinity of the roosting area located east of the Project boundary.

Appendix O.2.2a: Active night roost in the mudflat east side of the Project boundary observed on 9 August 2024 at around 19:09.
