Contract No. DC/2022/03 Yuen Long Barrage and Nullah Improvement Schemes

Monthly Monitoring Report (EM&A) (Version 1.2)

Re: Contract No. DC/2022/03
Yuen Long Barrage and Nullah Improvement Schemes
Monthly Environmental Monitoring and Audit Report (No.1) –
December 2023

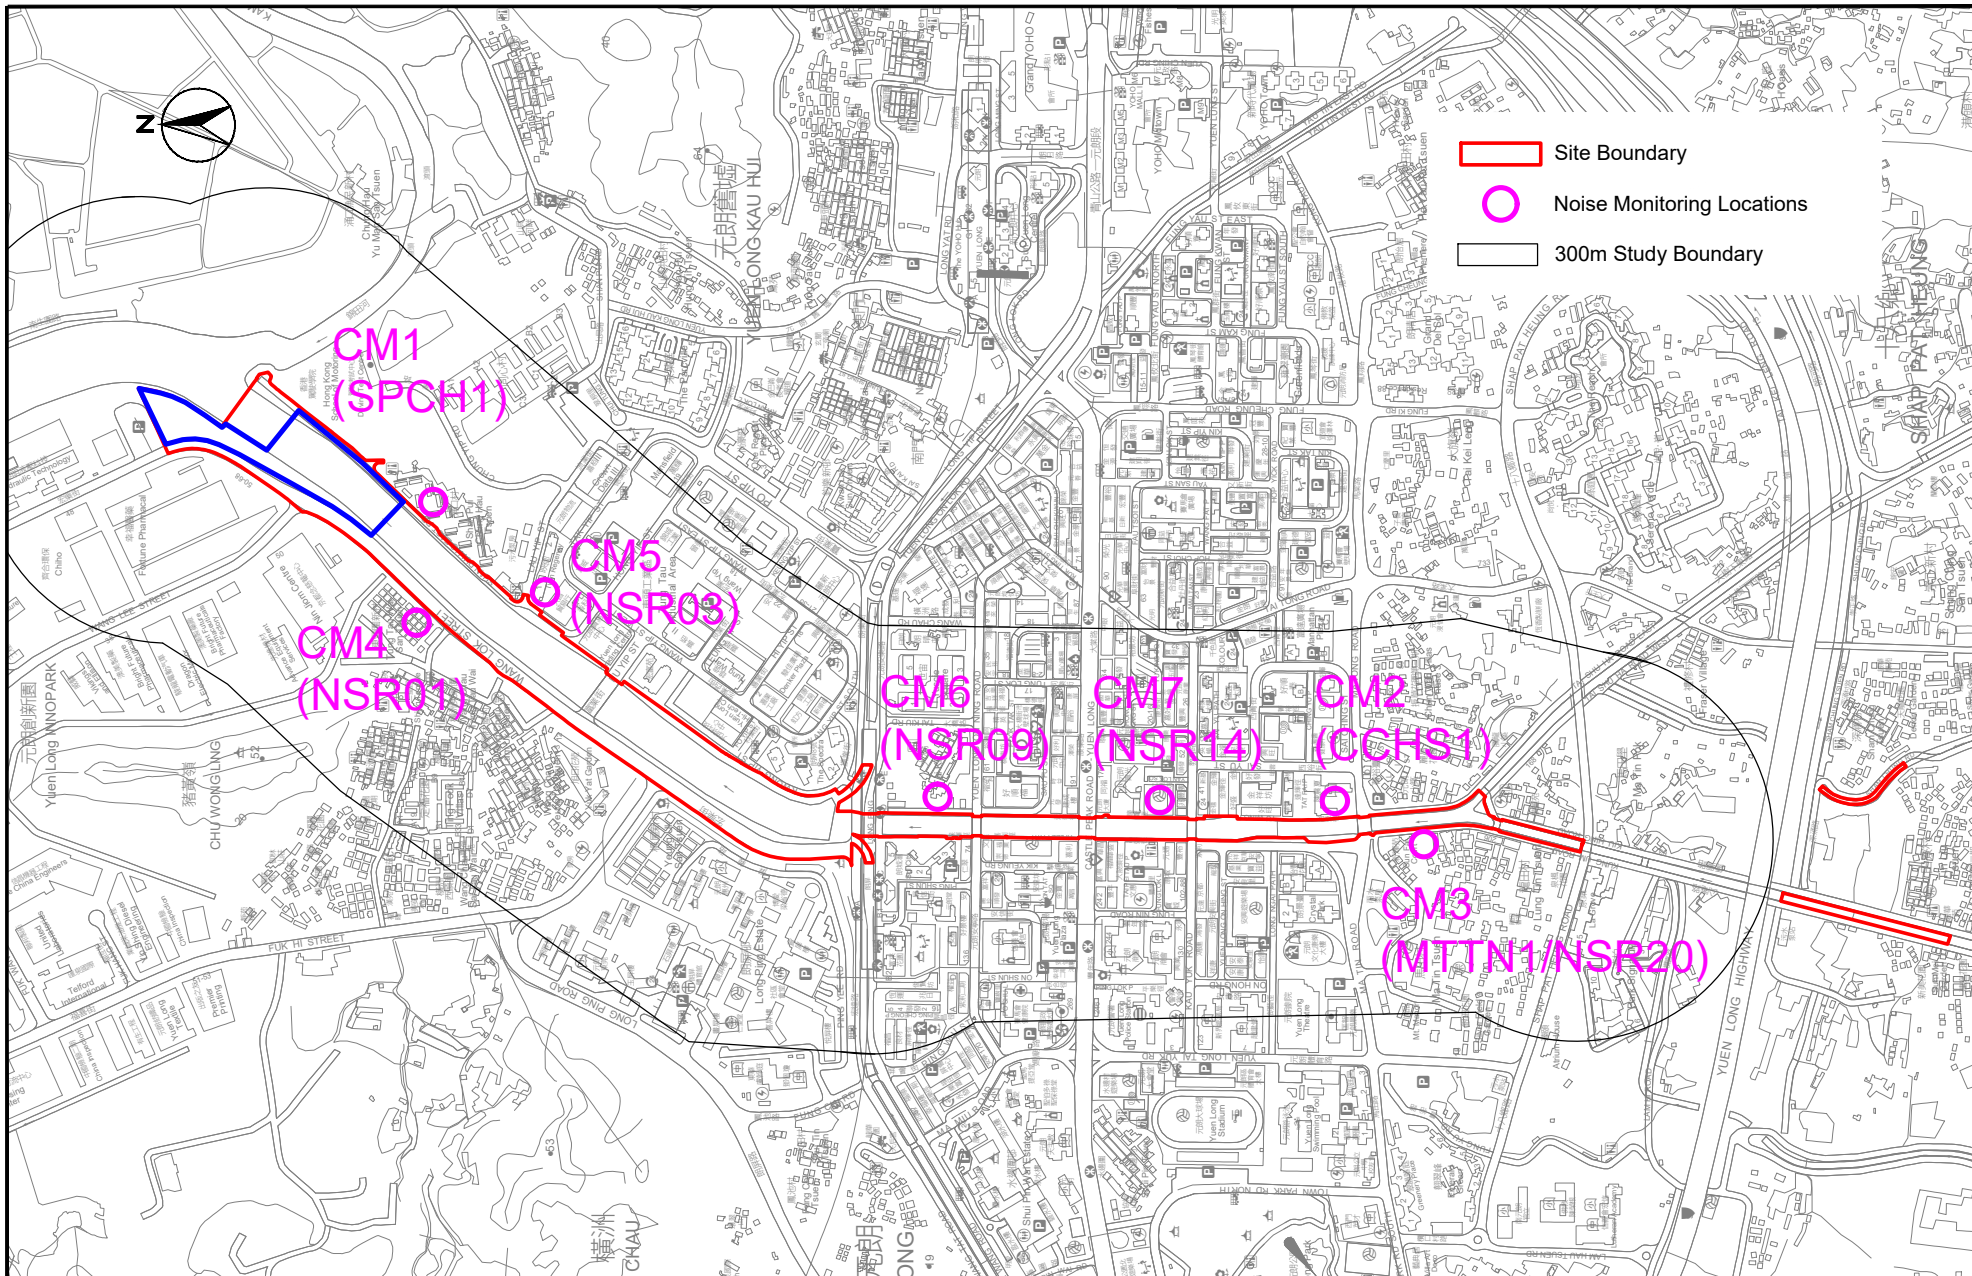
SCALE	1:8000 @ A3	DATE	Sep 2023
CHECK	BC	DRAWN	WY
JOB No.	MA23101	DRAWING No.	4
		REV	-

Contract No. DC/2022/03
 Yuen Long Barrage and Nullah Improvement Schemes
Noise Monitoring Stations

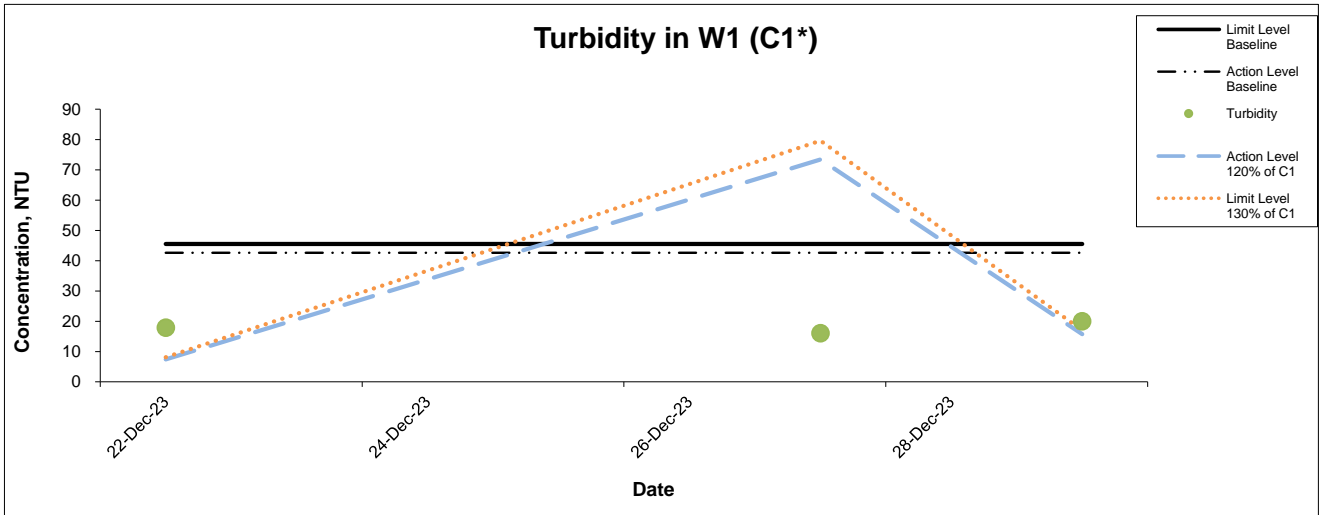
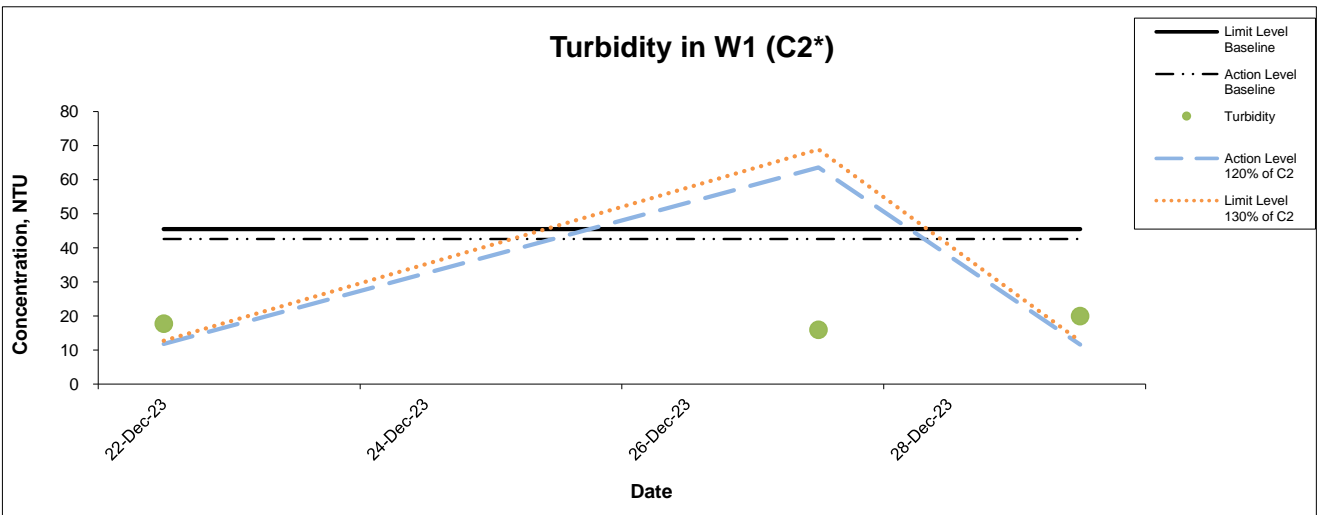
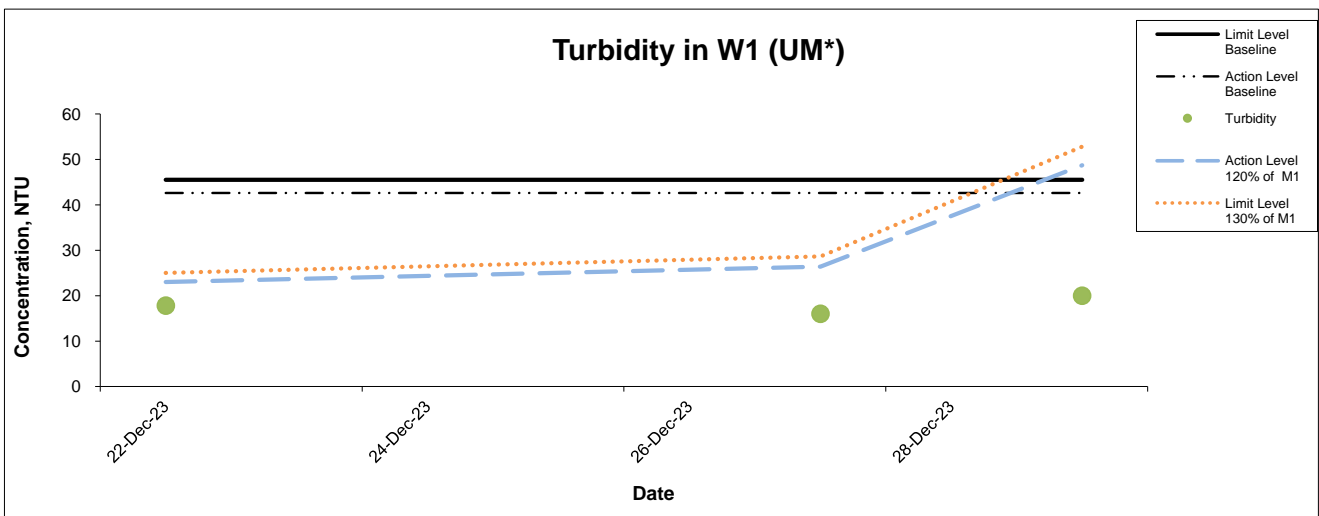
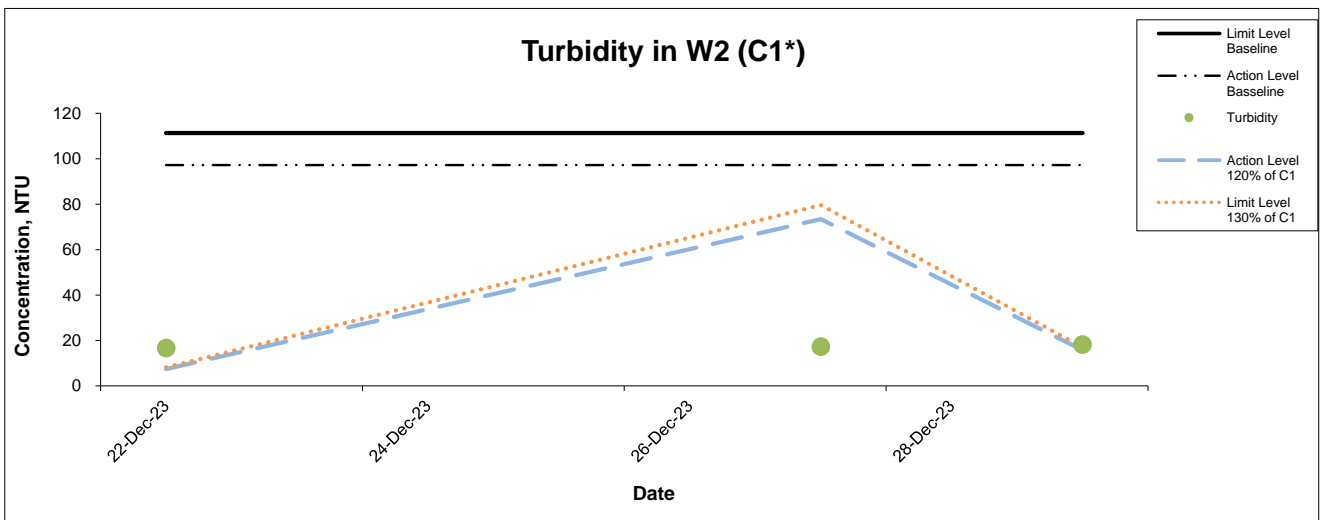
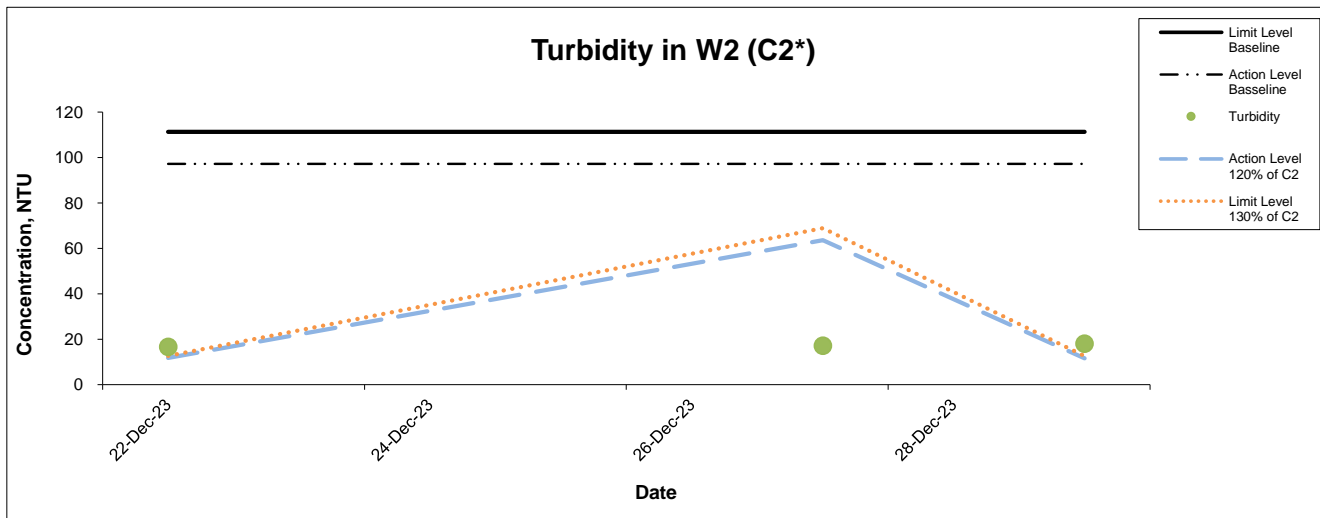
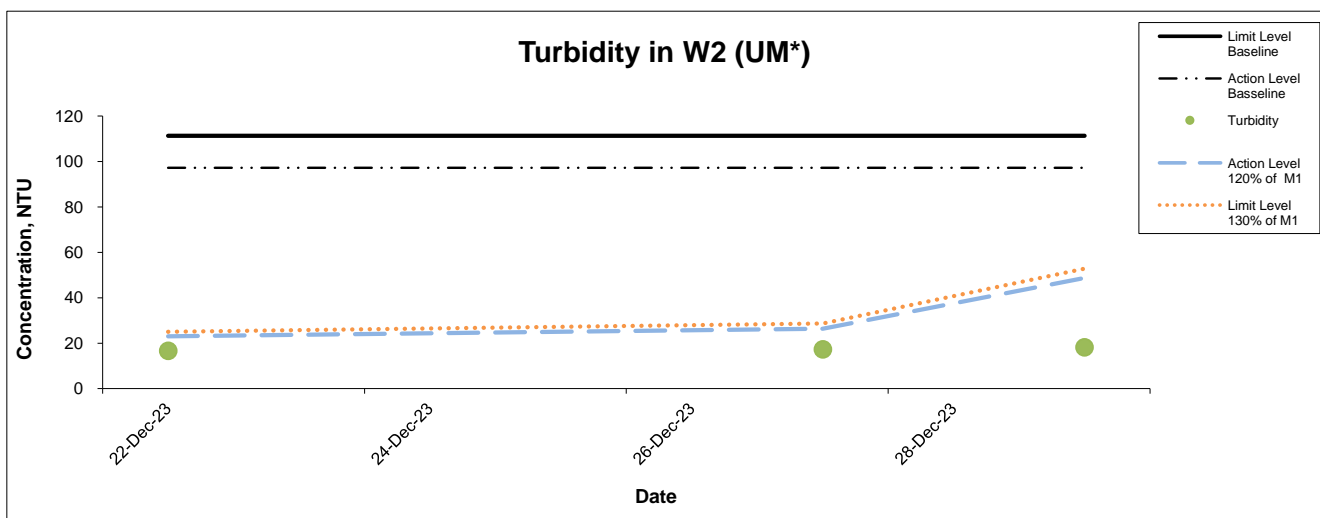
Turbidity (Depth-Averaged) at Mid-Ebb Tide

- 5.9.3 During the impact water monitoring, it was observed that the water in the Shan Pui River (W1 and W2) was very muddy and turbid, and contained various type of materials, e.g.: debris of plant, soil and general rubbish. The water body of the river was mostly greyish to yellowish and the river bed was invisible throughout the impact monitoring period. The river water was similar to the water observed in the baseline monitoring, there was no significant changes on the river condition during the construction compared to the baseline water quality monitoring result and impact water quality result. As expected from the site observations, exceedances of turbidity and suspended solid were recorded almost every monitoring.

- 5.9.5 The Contractor is reminded to strictly follow the drainage plan and clear drainage regularly. In particular, all drainage shall be checked and cleared after heavy rainstorm as sediments may accumulate along pipes and culverts. Further details can be found in **Appendix J**.

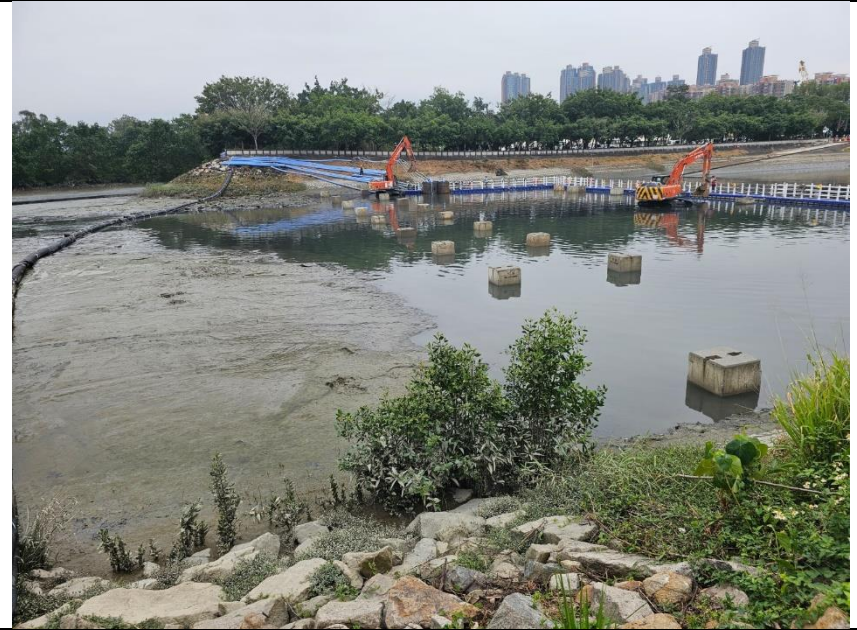
Photo 10: Preparation works for installing the inflatable dam

- 5.9.4 During this reporting month, no obvious discharge from the construction site was observed during the water quality monitoring and site audits. There was only preparation works conducted inside the river (e.g. installation of inflatable dam for translocation works), silt curtain was applied for mitigation measures to minimize the adverse impacts in the river. In addition, considering the high suspended solids (SS) and turbidity levels in the original water quality of Shan Pui River and Kam Tin River, there is no direct evidence linking the exceedances to the construction works of the Project.
