**Contract No. PM 10/2022 -
Independent Environmental Checker for Drainage Improvement Works at
Yuen Long – Stage 2**

**Drainage
Improvement Works
Near Four Villages in
Yuen Long – Sung
Shan New Village, Tai
Wo, Lin Fa Tei and Ha
Che**

Monthly Environmental
Monitoring and Audit (EM&A)
Report

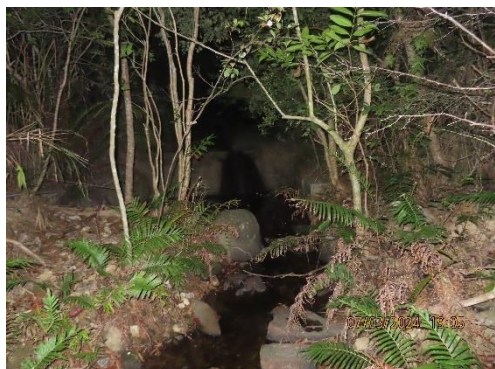
Plate 4.1 Site condition of receptor sites at Ha Che during the reporting month

4.1.14 Site conditions of both receptor sites are similar to that during the pre-construction survey, i.e., no pollution, anthropogenic disturbance or change in vegetation was observed. Representative photos of the site conditions are presented in **Plate 4.1**.

Receptor site for *C. anacoluthon* (Upper Receptor Site) at Ha Che

4.1.15 None of the translocated individuals from the pre-construction survey was found in both the upper and lower receptor sites. The inability to recapture the translocated individuals could be due to the structural complexity of the habitats of both sites. The many rocks and riffles at the upper receptor site and large and deep pools of water in the lower receptor site provides excellent refuge and protection for the crabs.

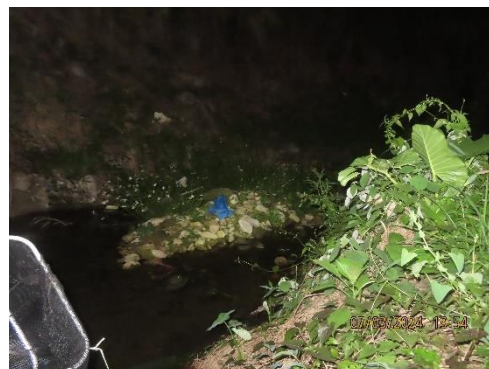
Receptor site for *S. zanklon* (Lower Receptor Site) at Ha Che
