**Drainage
Improvement Works
Near Four Villages in
Yuen Long – Sung
Shan New Village, Tai
Wo, Lin Fa Tei and Ha
Che**

Monthly Environmental
Monitoring and Audit (EM&A)
Report

1.1.7 This is the 3rd Monthly EM&A Report summarizing the key findings of the construction phase EM&A programme from 1 April to 30 April 2024 (the reporting period) and is submitted to fulfil the requirements in Condition 4.4 of EP-596/2021 and Section 12.2 of the approved EM&A Manual of the Project.

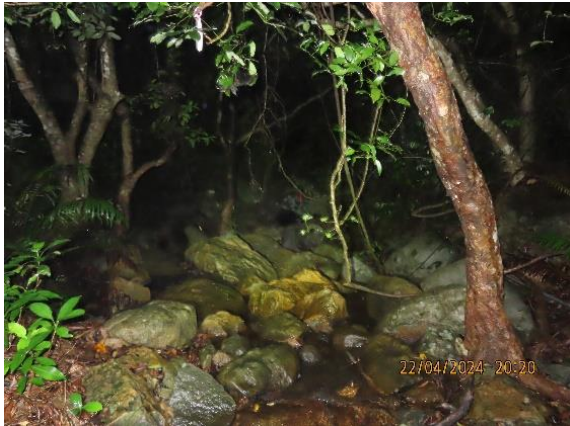
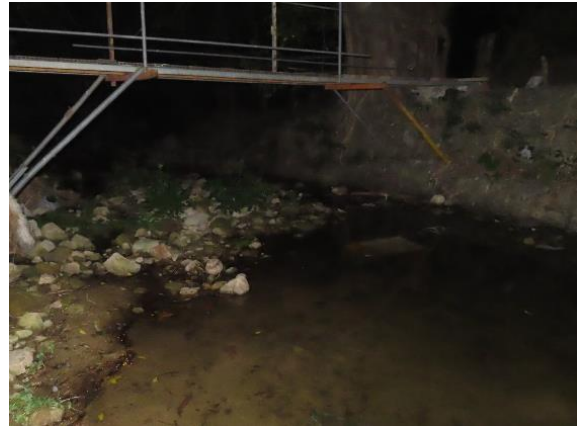
Plate 4.1 Site condition of receptor sites at Ha Che and Lin Fa Tei during the reporting month

4.1.14 Site conditions of both receptor sites are similar to that during the pre-construction survey, i.e., no pollution, anthropogenic disturbance or change in vegetation was observed. Representative photos of the site conditions are presented in **Plate 4.1**.

Receptor site for *Cryptopotamon anacoluthon* (Upper Receptor Site) at Ha Che

Receptor site for *Somanniathelphusa zanklon* (Lower Receptor Site) at Ha Che

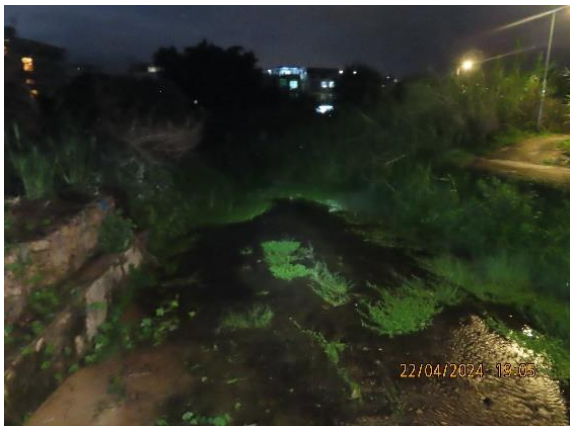
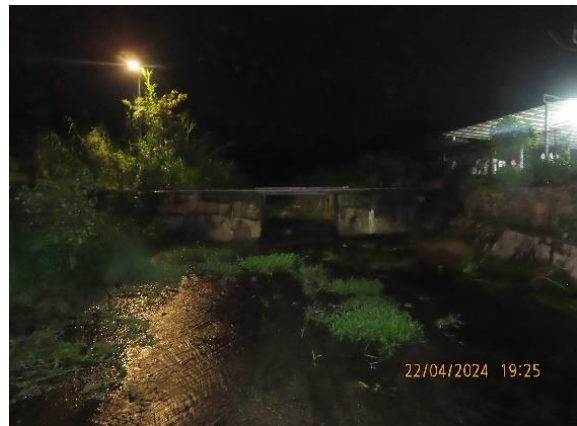
Receptor site for *Cryptopotamon anacoluthon* and *Somanniathelphusa zanklon* at Lin Fa Tei

4.1.15 None of the translocated individuals from the pre-construction survey was found in the upper and lower receptor sites of Ha Che or the receptor site of Lin Fa Tei. The inability to recapture the translocated individuals could be due to the structural complexity of the habitats of both sites. The many rocks and riffles at the upper Ha Che receptor site and large and deep pools of water in the lower Ha Che and Lin Fa Tei receptor sites provides excellent refuge and protection for the crabs.
