**Contract No. DC/2022/02  
Environmental Team for Drainage Improvement Works at Yuen Long – Stage 2  
Environmental Permit No. EP-596/2021  
EP Condition 4.4 – Monthly EM&A Report for June 2024**

**Contract No. PM 10/2022 -  
Independent Environmental Checker for Drainage Improvement Works at  
Yuen Long – Stage 2**

**Verification of Monthly EM&A Report (June 2024)**

1.1.7 This is the 5<sup>th</sup> Monthly EM&A Report summarizing the key findings of the construction phase EM&A programme from 1 June to 30 June 2024 (the reporting period) and is submitted to fulfil the requirements in Condition 4.4 of EP-596/2021 and Section 12.2 of the approved EM&A Manual of the Project.

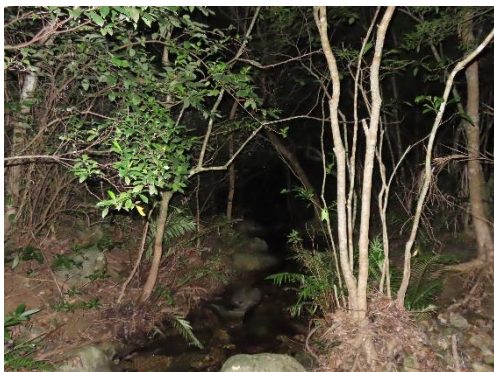
**Plate 4.1 Site condition of receptor sites at Ha Che and Lin Fa Tei during the reporting month**

- 4.1.16 Site conditions of both receptor sites are similar to that during the pre-construction survey, i.e., no pollution, anthropogenic disturbance or change in vegetation was observed. Representative photos of the site conditions are presented in **Plate 4.1**.

Receptor site for *Cryptopotamon anacoluthon* (Upper Receptor Site) at Ha Che

- 4.1.17 None of the translocated individuals from the pre-construction survey was found in the upper and lower receptor sites of Ha Che or the receptor site of Lin Fa Tei. The inability to recapture the translocated individuals could be due to the structural complexity of the habitats of both sites. The many rocks and riffles at the upper Ha Che receptor site and large and deep pools of water in the lower Ha Che and Lin Fa Tei receptor sites provides excellent refuge and protection for the crabs.

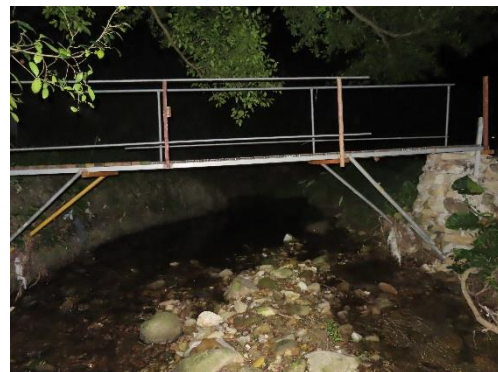
Receptor site for *Somanniathelphusa zanklon* (Lower Receptor Site) at Ha Che

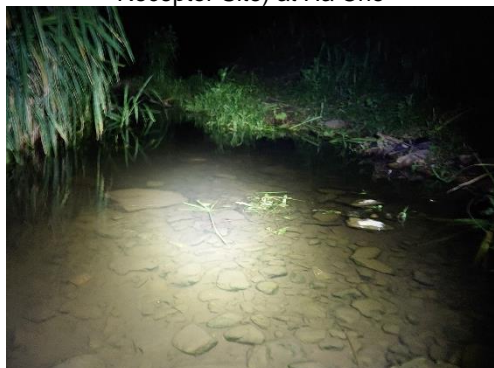
Receptor site for *Cryptopotamon anacoluthon* and *Somanniathelphusa zanklon* at Lin Fa Tei
