**Drainage  
Improvement Works  
Near Four Villages in  
Yuen Long – Sung  
Shan New Village, Tai  
Wo, Lin Fa Tei and Ha  
Che**

Monthly Environmental  
Monitoring and Audit (EM&A)  
Report

**Wing Tat Civil Engineering Co.  
Limited**

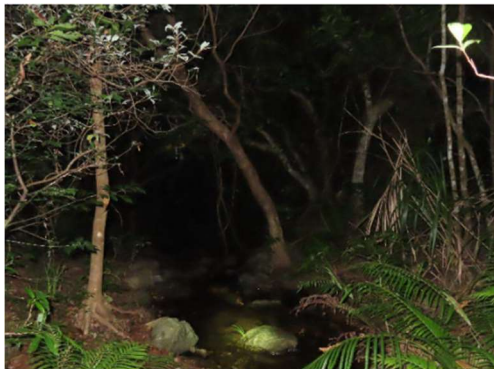
Receptor site for *Cryptopotamon anacoluthon* (Upper Receptor Site) at Ha Che

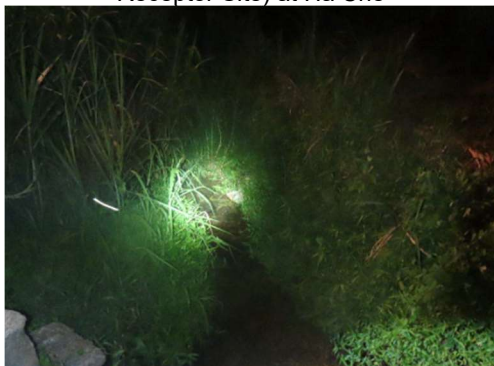
Receptor site for *Cryptopotamon anacoluthon* and *Somanniathelphusa zanklon* at Lin Fa Tei

4.1.17 None of the translocated individuals from the pre-construction surveys was found in the upper and lower receptor sites of Ha Che or the receptor site of Lin Fa Tei. The inability to recapture the translocated individuals could be due to the structural complexity of the habitats of both sites. The presence of many rocks and riffles at the upper Ha Che receptor site and large and deep pools in the lower Ha Che and Lin Fa Tei receptor sites provides excellent refuge and protection for the crabs.
