Quotation Ref. 23-02230 Provision of Independent Environmental Checker Consultancy Services for West New Territories Landfill Extension Decommissioning of Remaining Portion of Middle Ash Lagoon in Tsang Tsui Monthly Dust Monitoring Report No.1

1. This is the 1st Monthly Dust Monitoring Report for Contract No. EP/SP/186/21 "West New Territories Landfill Extension (WENTX)" at Nim Wan, Tuen Mun. This report summarized the monitoring results and audit findings of the EM&A programme in accordance with dust monitoring plan under clause 2.2 of the EP (EP/618/2022) and clause 2.2 of the FEP (FEP-01/618/2022) during the 1st reporting month covering 23 February to 31 March 2024.

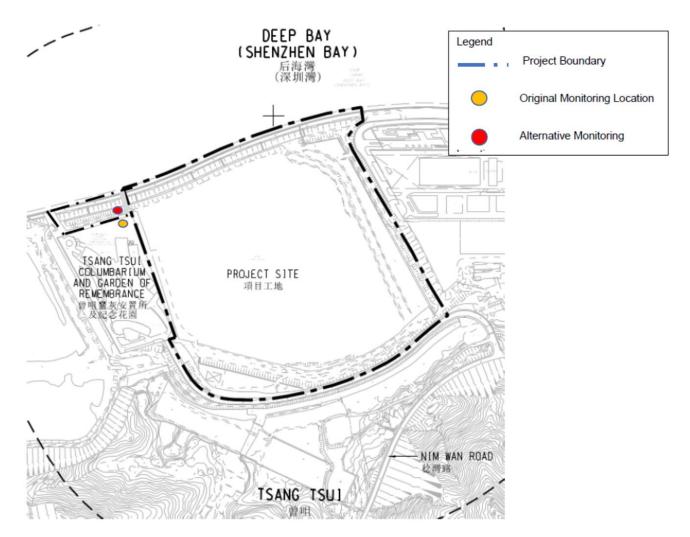
Appendix A - The Original Monitoring Location and Proposed Alternative Monitoring Location

- Close to the sensitive receptors; and
 - Account for the prevailing meteorological conditions
- 2.2.3 An alternative location has been sought and proposed to the site boundary of the Middle Tsang Tsui Ash Lagoon and shown in *Table 2.2*. It is proposed to relocate the monitoring location (north facing) to the site boundary of Middle Tsang Tsui Ash Lagoon and at location avoid the burner emission from the Columbarium (east facing). This proposed monitoring location is approximately 10 meters away from the Tsang Tsui Columbarium- Garden of Remembrance. Both locations are situated to the north-west of the site boundary and experiencing the same prevailing meteorological conditions. The original monitoring location and proposed alternative monitoring location was presented in *Appendix A*.

THE ORIGINAL MONITORING LOCATION AND PROPOSED ALTERNATIVE MONITORING LOCATION

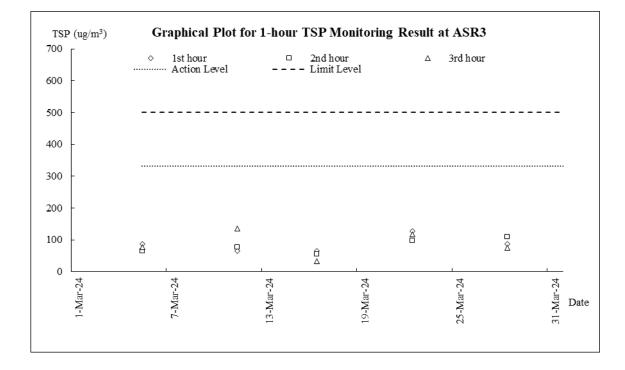
Impact Monitoring Results for 1-hour TSP at Location ASR3

• No Action/Limit Level exceedance for 1-hour TSP was recorded.

Date	Start Time	1 st hour	2 nd hour	3 rd hour	Action Level	Limit Level
5-Mar-24	9:00	87	65	76	331	500
11-Mar-24	10:00	65	77	135	331	500
16-Mar-24	9:22	64	54	33	331	500
22-Mar-24	9:16	128	96	118	331	500
28-Mar-24	9:36	86	109	75	331	500
