Quotation Ref. 23-02230
Provision of Independent Environmental Checker Consultancy Services for
West New Territories Landfill Extension
Decommissioning of Remaining Portion of Middle Ash Lagoon in Tsang Tsui
Monthly Dust Monitoring Report No.7

Decommissioning of Remaining Portion of Middle Ash Lagoon in Tsang Tsui
Monthly Dust Monitoring Report No.7 (1 September to 30 September 2024)

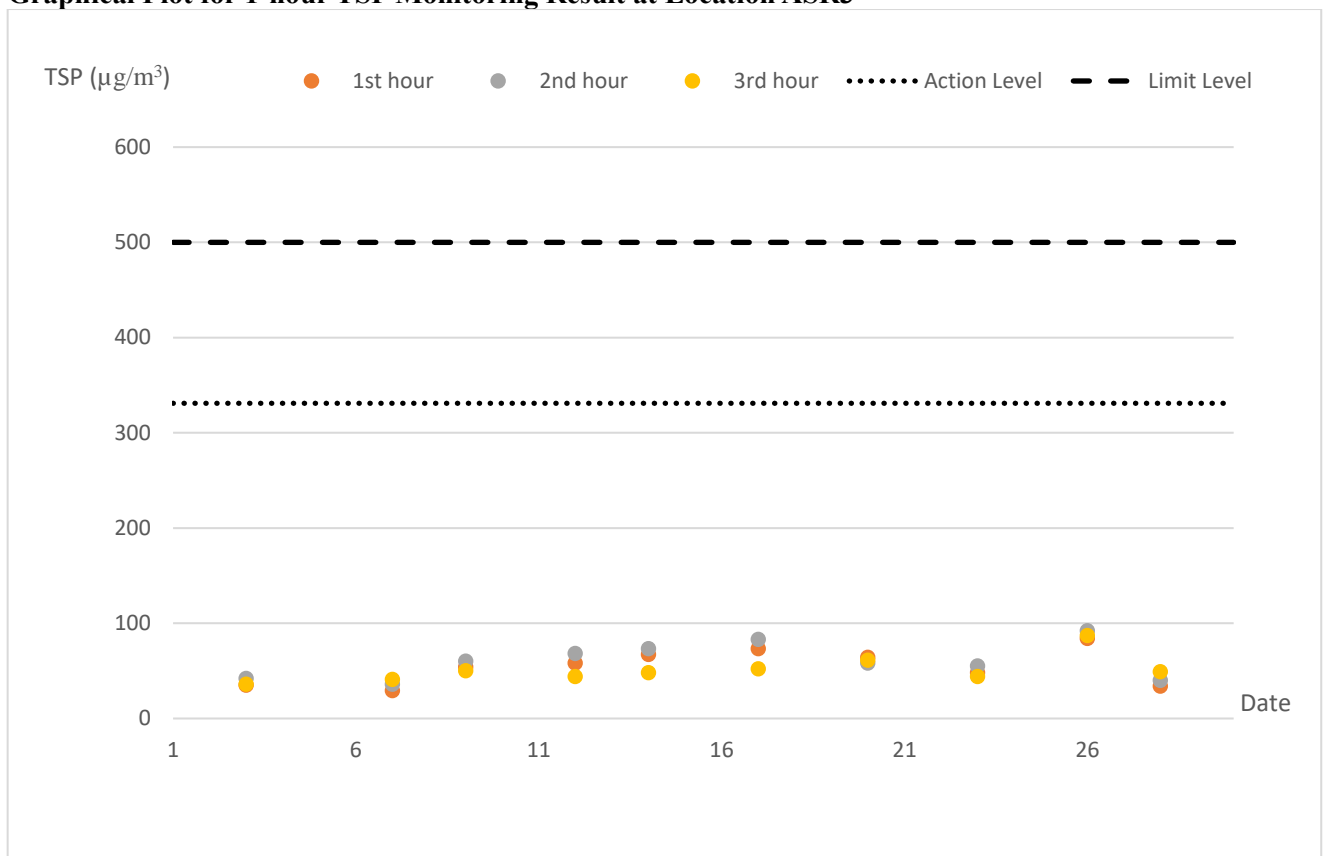
Graphical Plot for 1-hour TSP Monitoring Result at Location ASR3

2.9.4 No Action / Limit Level exceedance was recorded for all 1-hour TSP monitoring in the reporting month.

2.9.3 The monitoring data and graphical presentation of 1-hour TSP monitoring results are shown in **Appendix G** respectively.
