Contract No. EP/SP/66/12
Integrated Waste Management Facilities, Phase 1
Monthly EM&A Report No.70

Monthly EM&A Report No.70

(Period from 1 April to 30 April 2024)

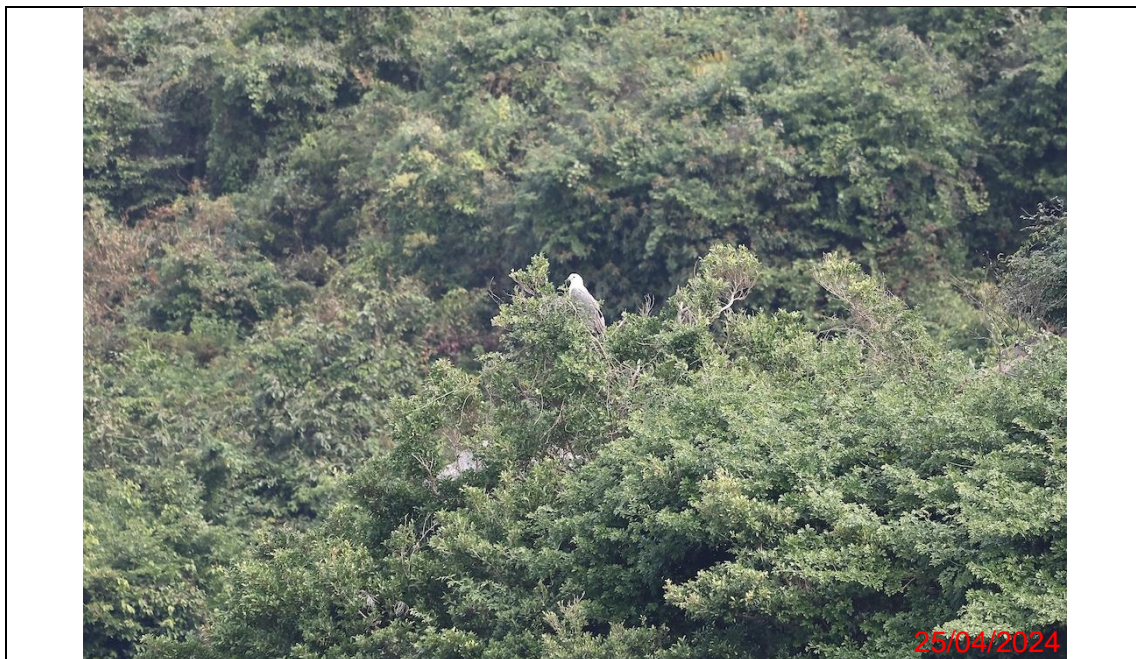
One Adult WBSE was recorded Staying near the nest on 25 April 2024
