Contract No. EP/SP/66/12
Integrated Waste Management Facilities, Phase 1
Monthly EM&A Report No.73

Monthly EM&A Report No.73 (Period from 1 July to 31 July 2024)

(Clause 3.3, Further Environmental Permit FEP-01/429/2012/A)

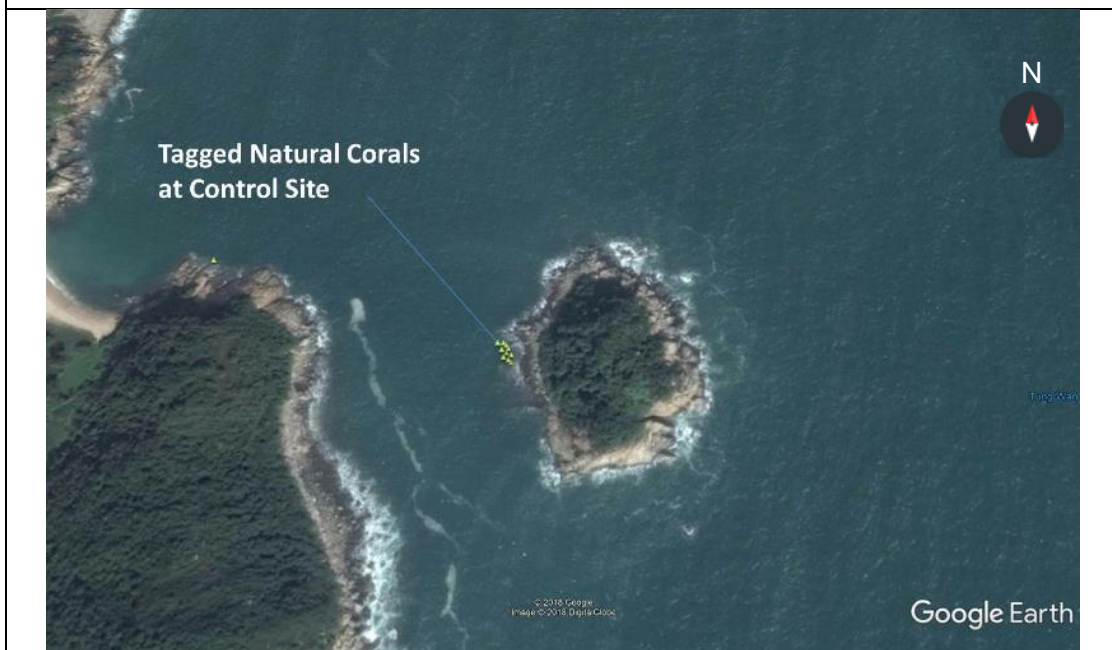
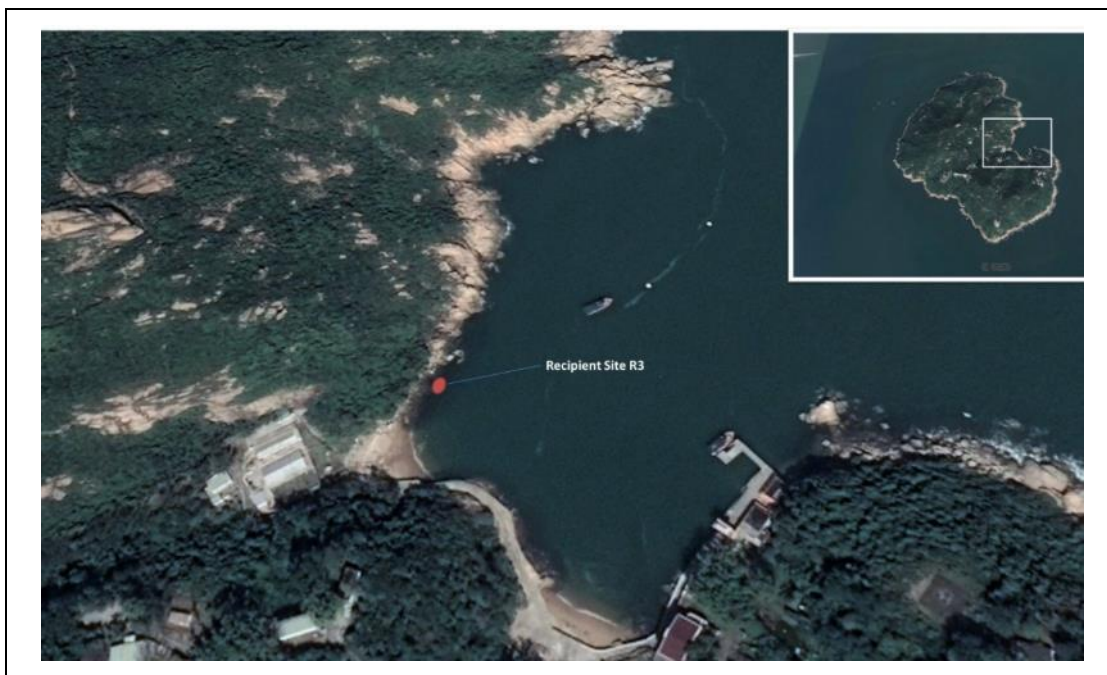
5.3.1 Location of the ten tagged coral colonies at each of the proposed indirect impact site (re-tagging after typhoon Mangkhut), control site (baseline) and recipient site R3 (translocation) are shown in **Figure 5.1**, **Figure 5.2** and **Figure 5.3** respectively:

Figure 5.1 Tagged Natural Corals at Indirect Impact Site Near SKC for re-tagging after typhoon Mangkhut

Figure 5.2 Tagged Natural Corals at Control Site Near Yuen Kong Chau for re-tagging after typhoon Mangkhut

Figure 5.3 Tagged Translocation Corals at Recipient Site R3 near SKC
