Contract No. EP/SP/66/12
Integrated Waste Management Facilities, Phase 1
Monthly EM&A Report No.75

Monthly EM&A Report No.75 (Period from 1 September to 30 September 2024)

(Clause 3.3, Further Environmental Permit FEP-01/429/2012/A)

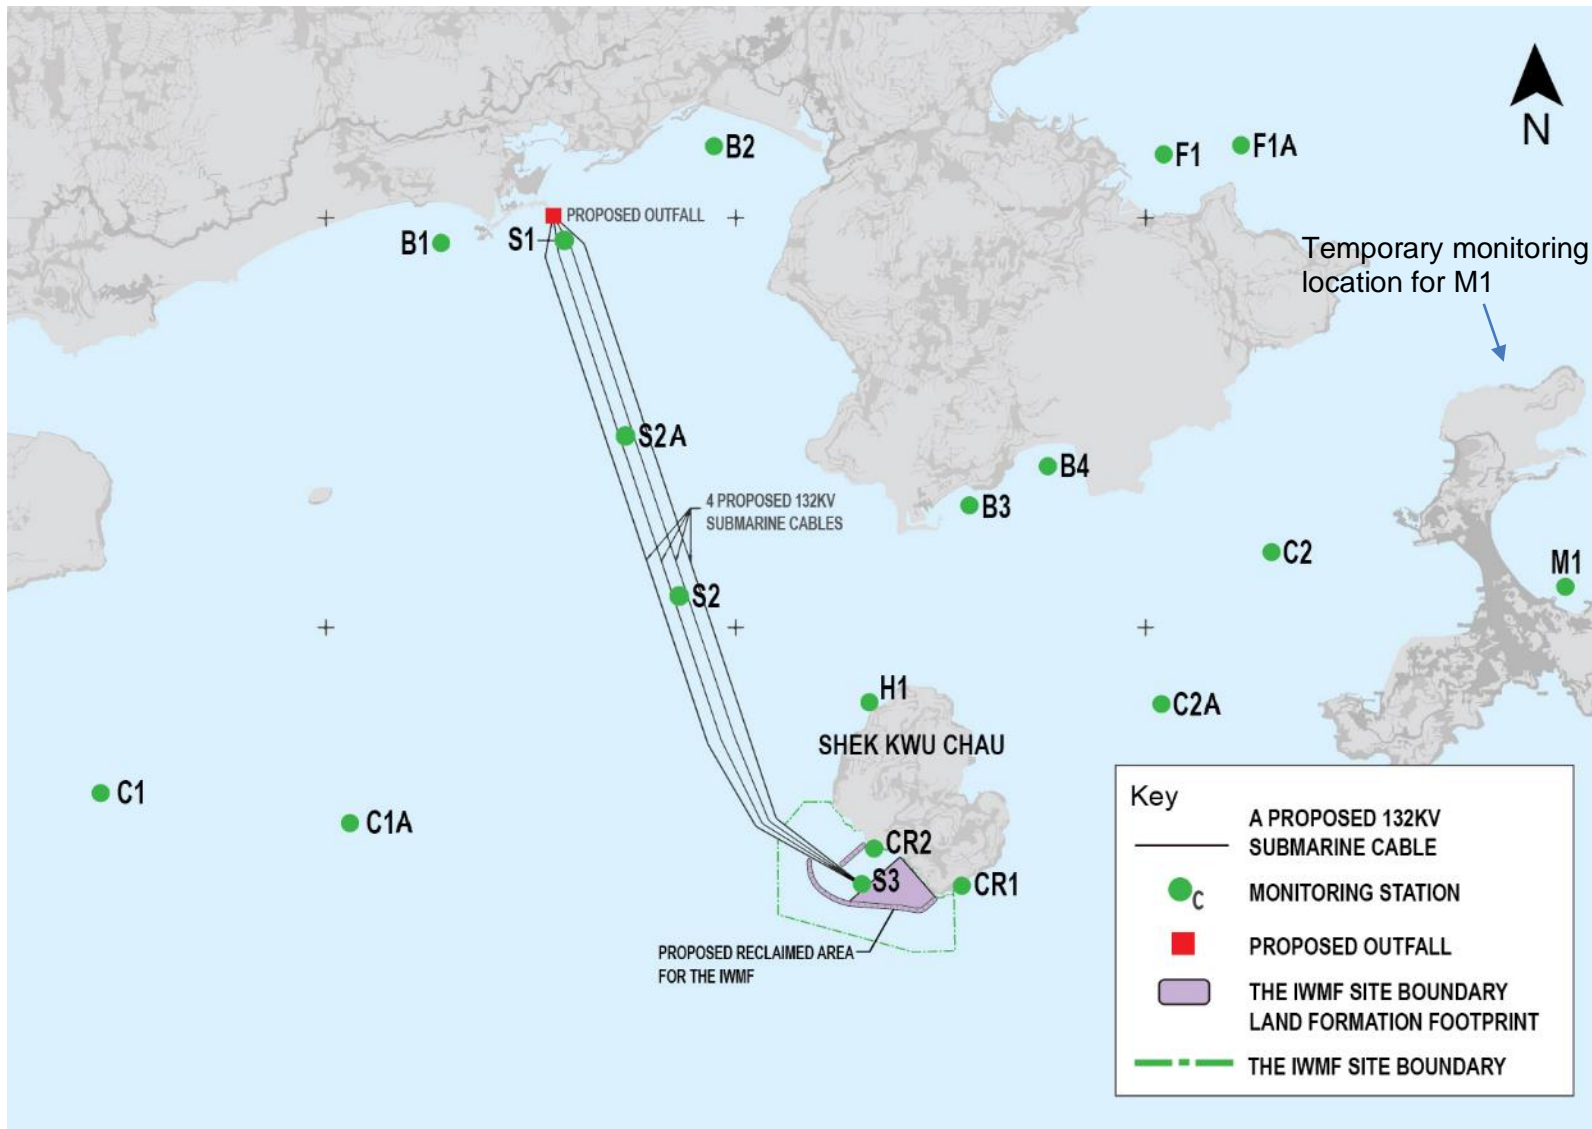
Figure 2.1 Water monitoring locations at Artificial Island near SKC

- 2.3.1 Impact water quality monitoring was conducted at eleven monitoring locations (B1-B4, H1, C1, C2, F1, CR1, CR2 & M1) during general water quality monitoring in the reporting period as shown in **Figure 2.1**. As per the relocation proposal verified by IEC and approved by EPD, the monitoring location C1, C2, S2, F1 are relocated at C1A, C2A, S2A, F1A as equivalent points respectively to clear up the concerns from stakeholders.

2.3.2 B1 to B4 are located at 4 beaches respectively at the southern shore of Lantau Island. Monitoring station H1 is located at the horseshoe crab habitat at northern SKC, while CR1 and CR2 are located at the coral communities at southwestern shore of SKC. Monitoring station F1 is located at the Cheung Sha Wan Fish Culture Zone while monitoring station M1 is located at Tung Wan at Cheung Chau. Monitoring station F1A is relocated for F1 at the Cheung Sha Wan Fish Culture Zone. S1, S2 and S3 are located at the northern landing site, midway and southern landing site of the proposed submarine cable, respectively. S2A is the relocated monitoring station of S2 which represents the midway landing site of the proposed submarine cable. S1, S2/S2A and S3 are required for monitoring due to the laying of submarine cable. Control stations C1 and C2 at far field locations are for comparison. Control stations C1A and C2A are relocated for C1 and C2 respectively as equivalent far field locations for comparison.

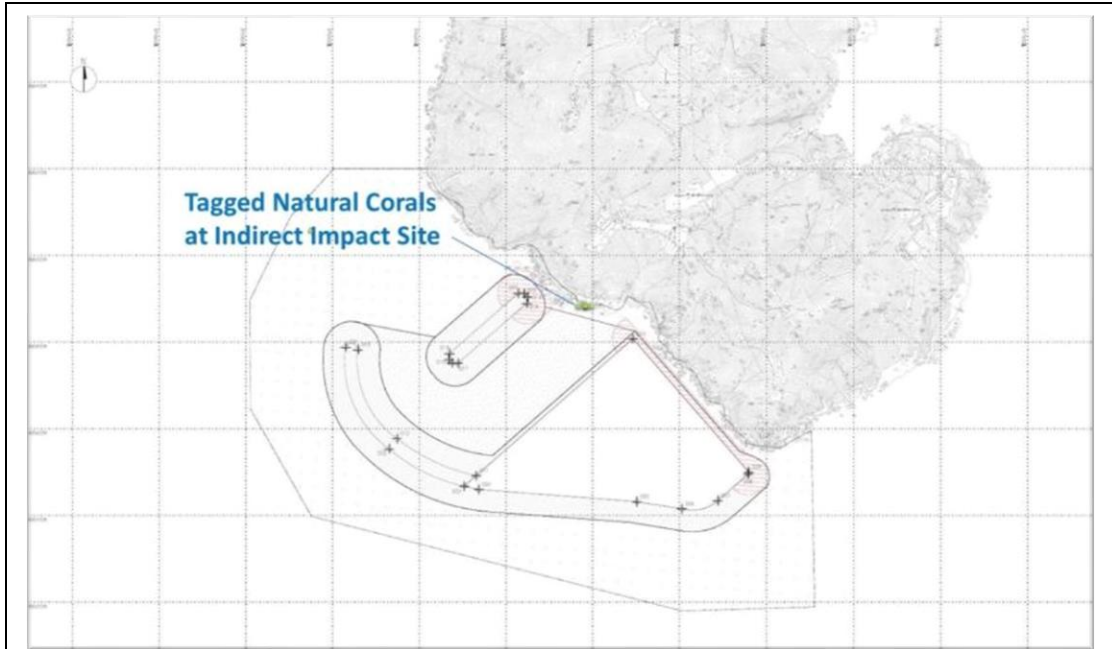
Figure 5.1 Tagged Natural Corals at Indirect Impact Site Near SKC for re-tagging after typhoon Mangkhut

5.3.1 Location of the ten tagged coral colonies at each of the proposed indirect impact site (re-tagging after typhoon Mangkhut), control site (baseline) and recipient site R3 (translocation) are shown in **Figure 5.1**, **Figure 5.2** and **Figure 5.3** respectively:

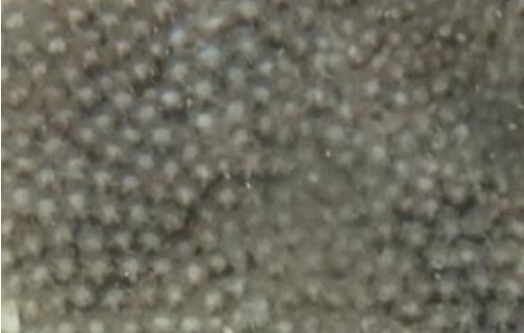
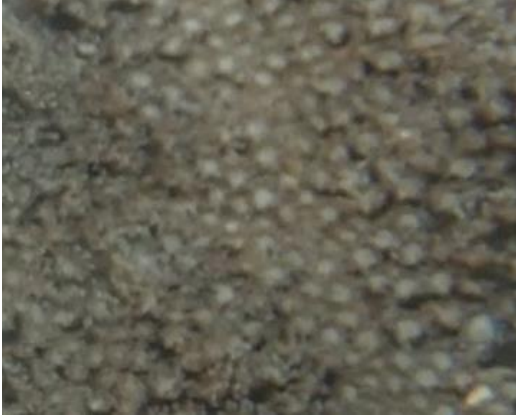
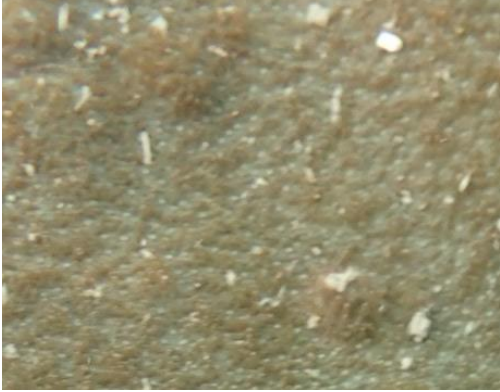
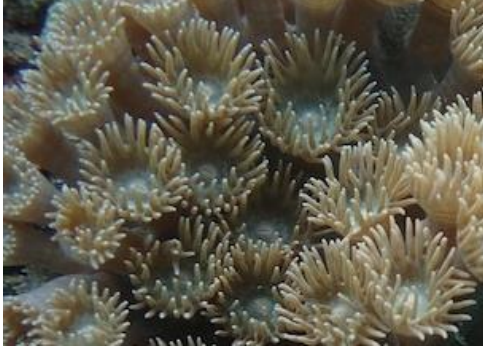
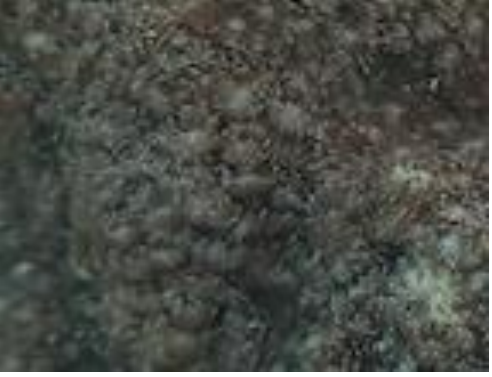
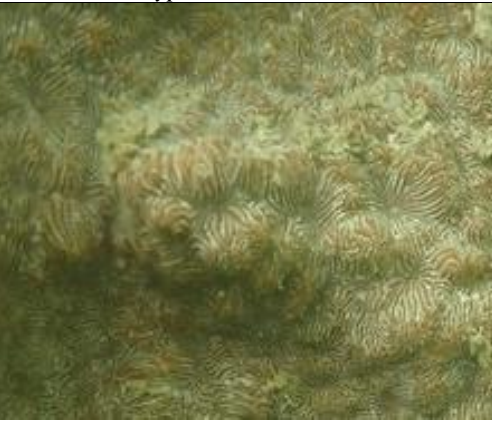
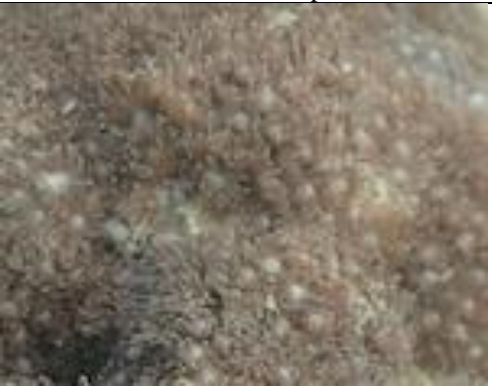
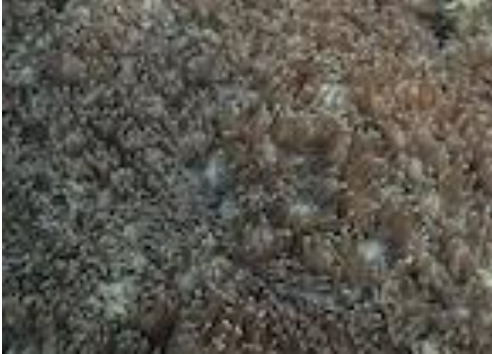
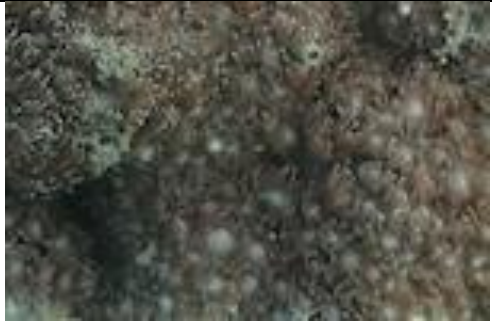
Photo Plate 5.1 Ten (10) Monitored Corals at Control Site

5.6.2 Ten (10) hard coral colonies were monitored at each Control site and Indirect Impact Site as suggested in the Construction Phase Monitoring Plan. The general health conditions (size, mortality, bleaching and sediment) were recorded and summarized in **Table 5.8** and **Table 5.9**. Photos of each coral colonies were taken during the monitoring activities shown in **Photo Plate 5.1** and **Photo Plate 5.2**.

- 5.6.4 All tagged and re-tagged coral colonies showed good health condition during the 23rd Quarterly Construction Phase Monitoring. There was no increased level of mortality, bleaching and sediment when compared with the baseline results.

- 5.6.5 No sediment, bleaching or increased mortality in the general condition of coral colonies were observed during the tenth construction phase monitoring period. No deterioration of the coral community was observed in the ecological monitoring results when compared with the baseline ecological monitoring results. There is no AL/LL exceedance during the monitoring period. Photos of each tagged corals colonies were taken and shown in **Photo Plates 5.1** and **Photo Plate 5.2**.

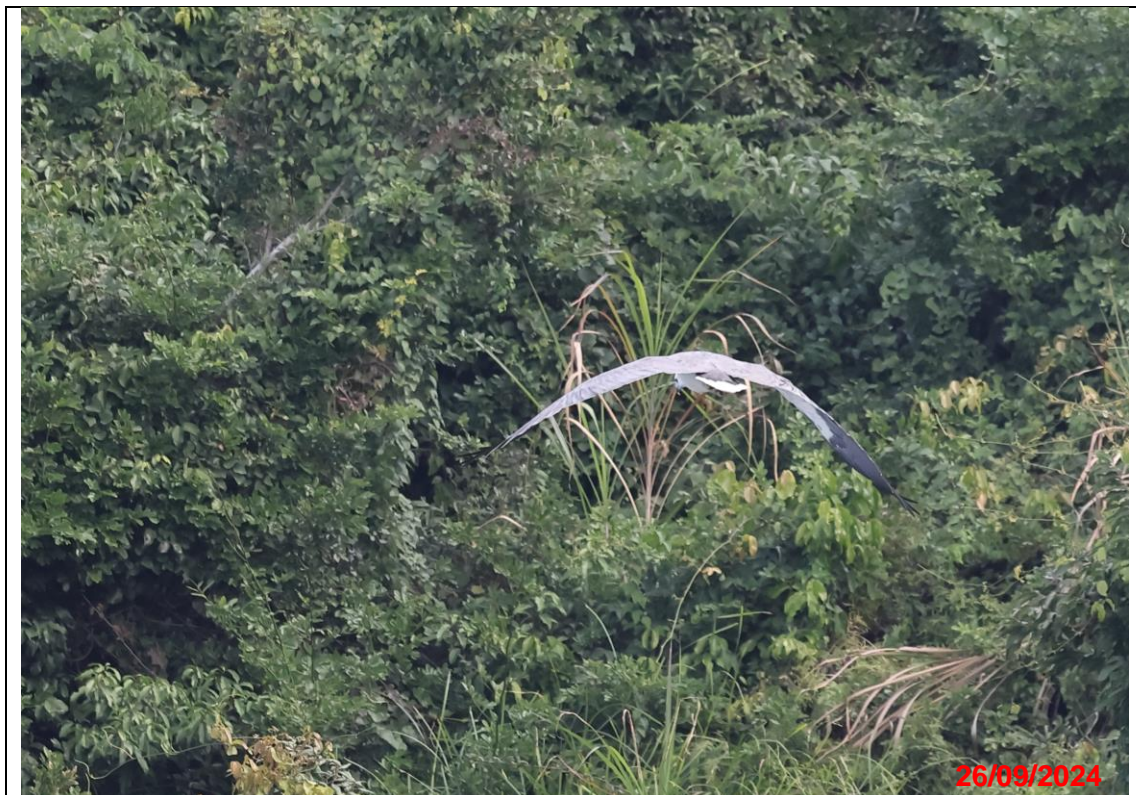
One adult WBSE was recorded staying near the nest on 26 September 2024
