Contract No. EP/SP/66/12 Integrated Waste Management Facilities, Phase 1 23rd Quarterly EM&A Report

Quarterly EM&A Report No.23 (Period from 1 January to 31 March 2024)

(Clause 3.3, Further Environmental Permit FEP-01/429/2012/A)

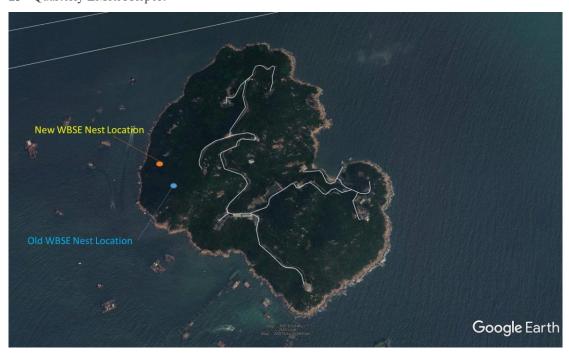
Figure 7.1 Location of WBSE Nest on SKC

- 7.2.4 The juvenile recorded in 2022 and 2023 has not been observed since monitoring event in September 2022 and September 2023 respectively, it is suggested that the juvenile left the nest at SKC and nesting in other area outside our monitoring boundary.
- 7.2.5 No disturbances from anthropogenic activities on the island were recorded during the monitoring survey. No invasion of other fauna species was recorded as well.

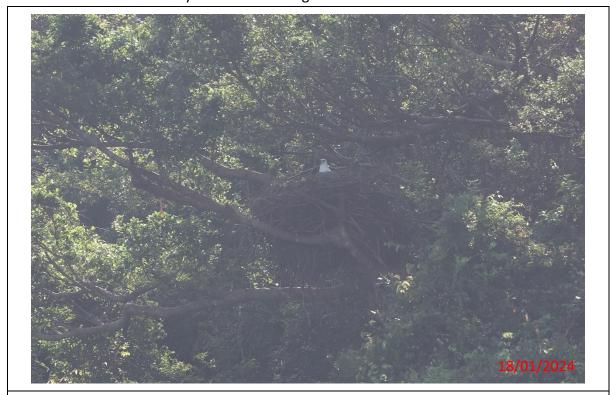
One Adult Female WBSE Staying in nest for incubation on 18 January 2024

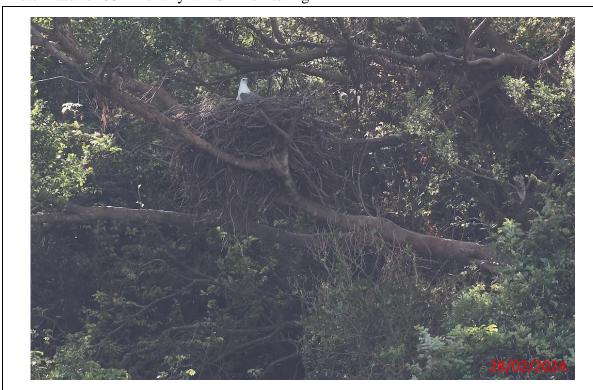
One Adult Female WBSE staying in nest for incubation on 28 February 2024

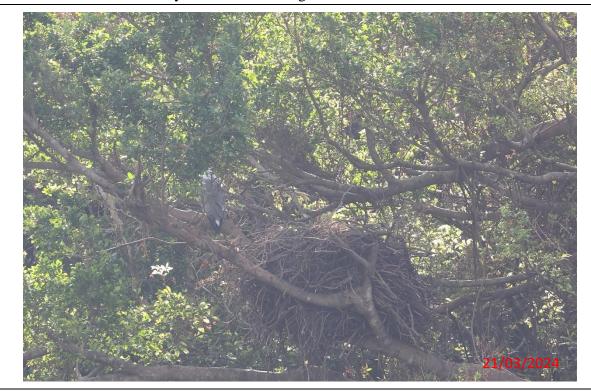
One Adult WBSE was recorded Staying near the nest on 21 March 2024

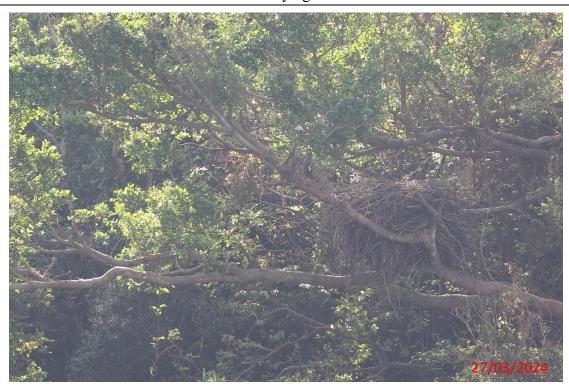
- 7.2.3 No incubation activity nor chick was observed during the monitoring event on 27 March 2024. Thus, the monitoring frequency will return to twice per month in April 2024.

No Adult WBSE was recorded inside the nest on 27 March 2024
