**Re: Agreement No. CE 48/2011 (EP)
Environmental Project Office for the
HZMB Hong Kong Link Road, HZMB Hong Kong Boundary Crossing Facilities,
and Tuen Mun-Chek Lap Kok Link – Investigation**

**Contract No. HY/2011/09 HZMB Hong Kong Link Road –
Section between HKSAR Boundary and Scenic Hill
Revised Monthly EM&A Report for April 2015 (EP-352/2009/D)**

Contract HY/2011/09
Hong Kong-Zhuhai-Macao Bridge
Hong Kong Link Road-Section between
HKSAR Boundary and Scenic Hill
Monthly EM&A Report
April 2015
(Version 2.0)

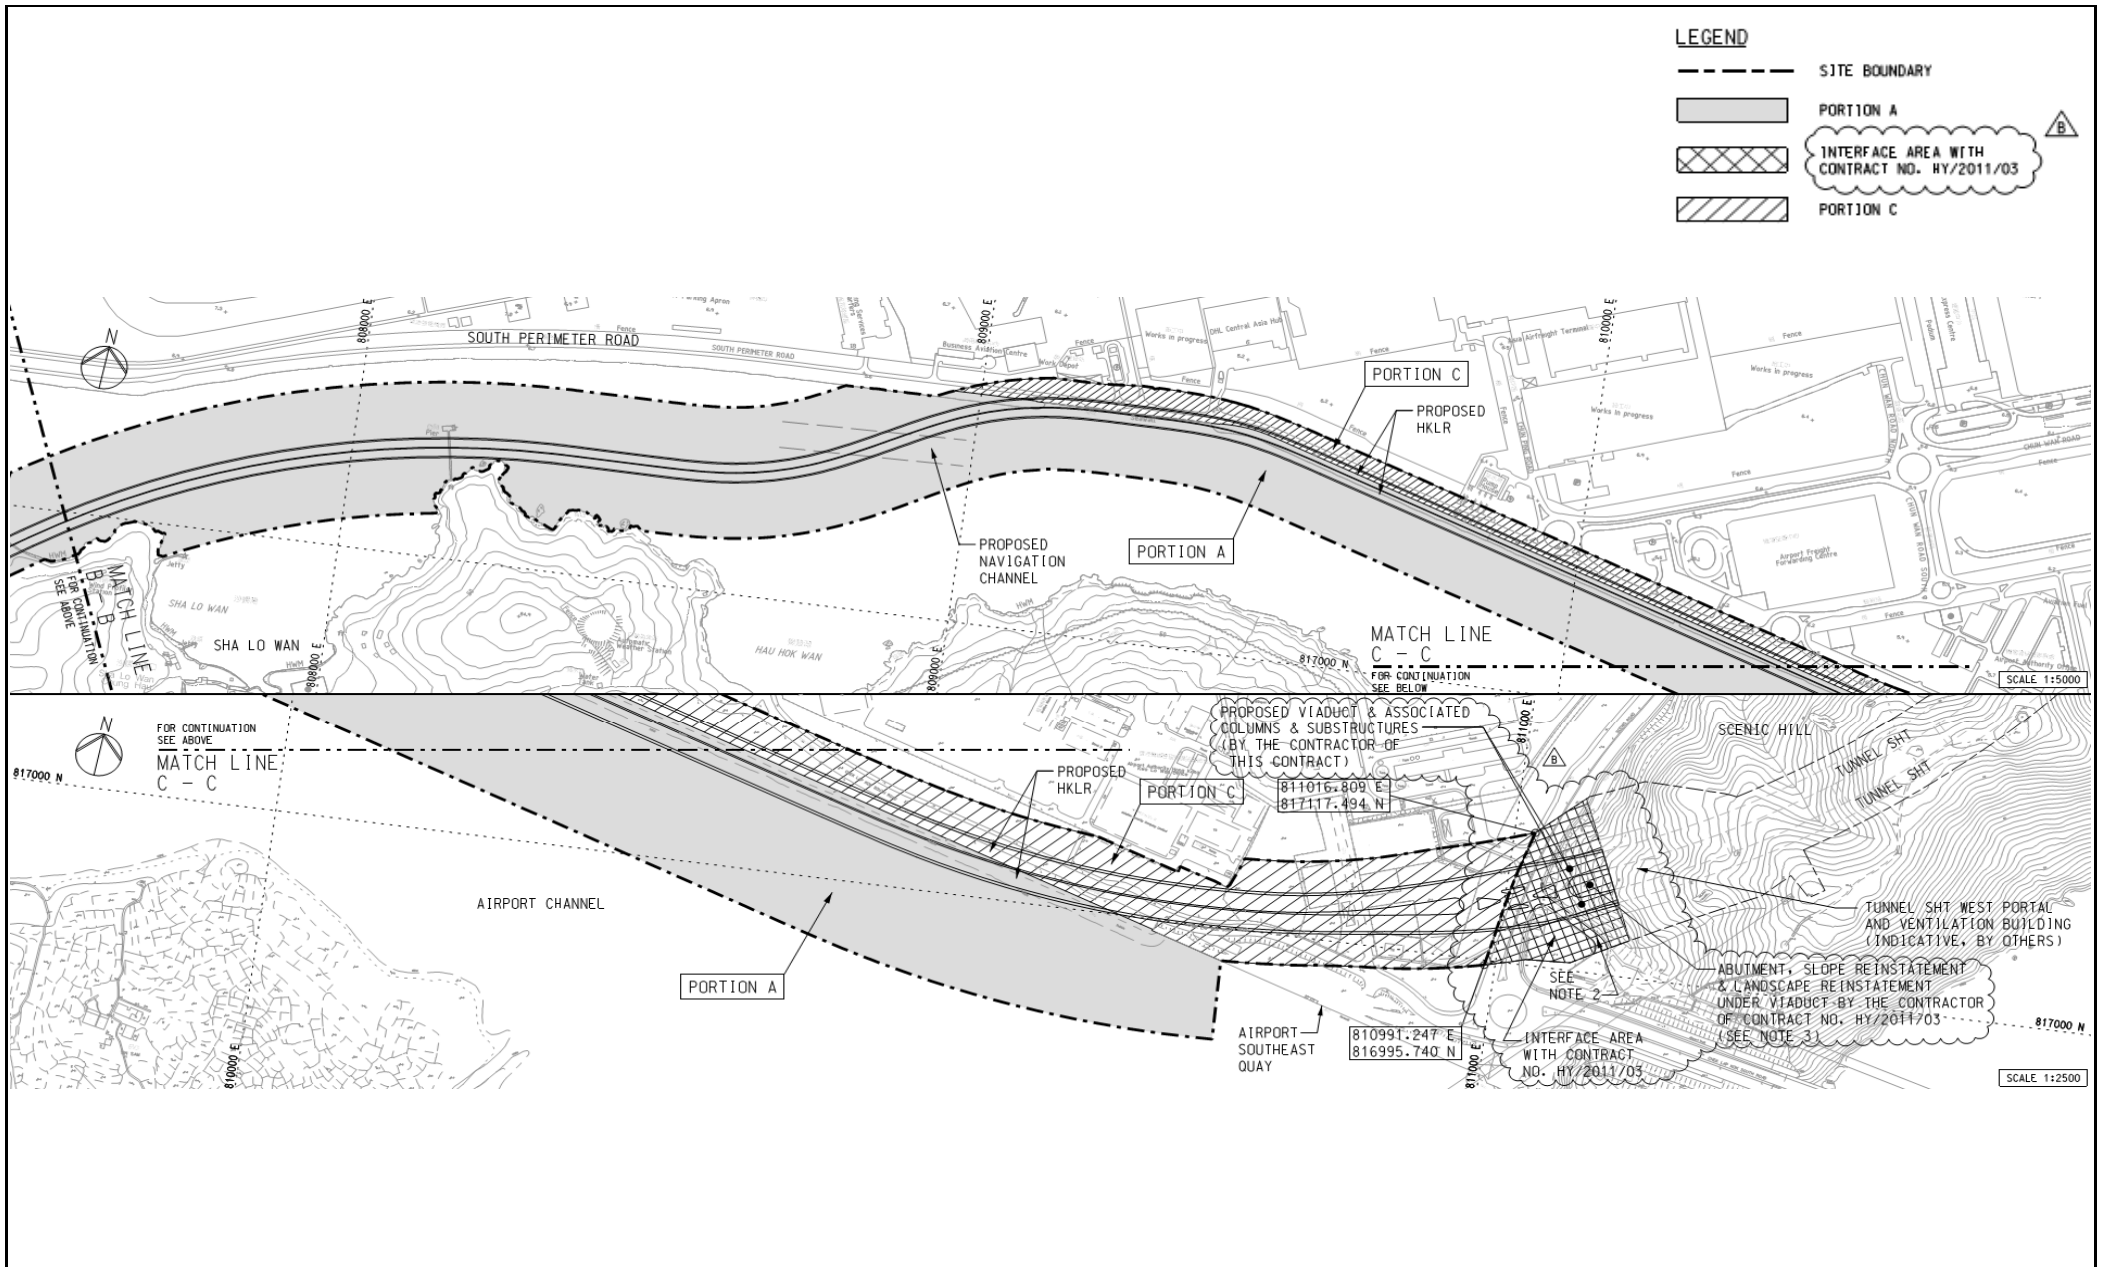
Title	Contract No. HY/2011/09 Hong Kong-Zhuhai-Macao Bridge Hong Kong Link Road – Section between HKSAR Boundary and Scenic Hill Site Layout Plan (Portion A and C)		Scale	N.T.S	Propose No.	MA12014	CINOTECH
	Date	May-13	Figure	1c

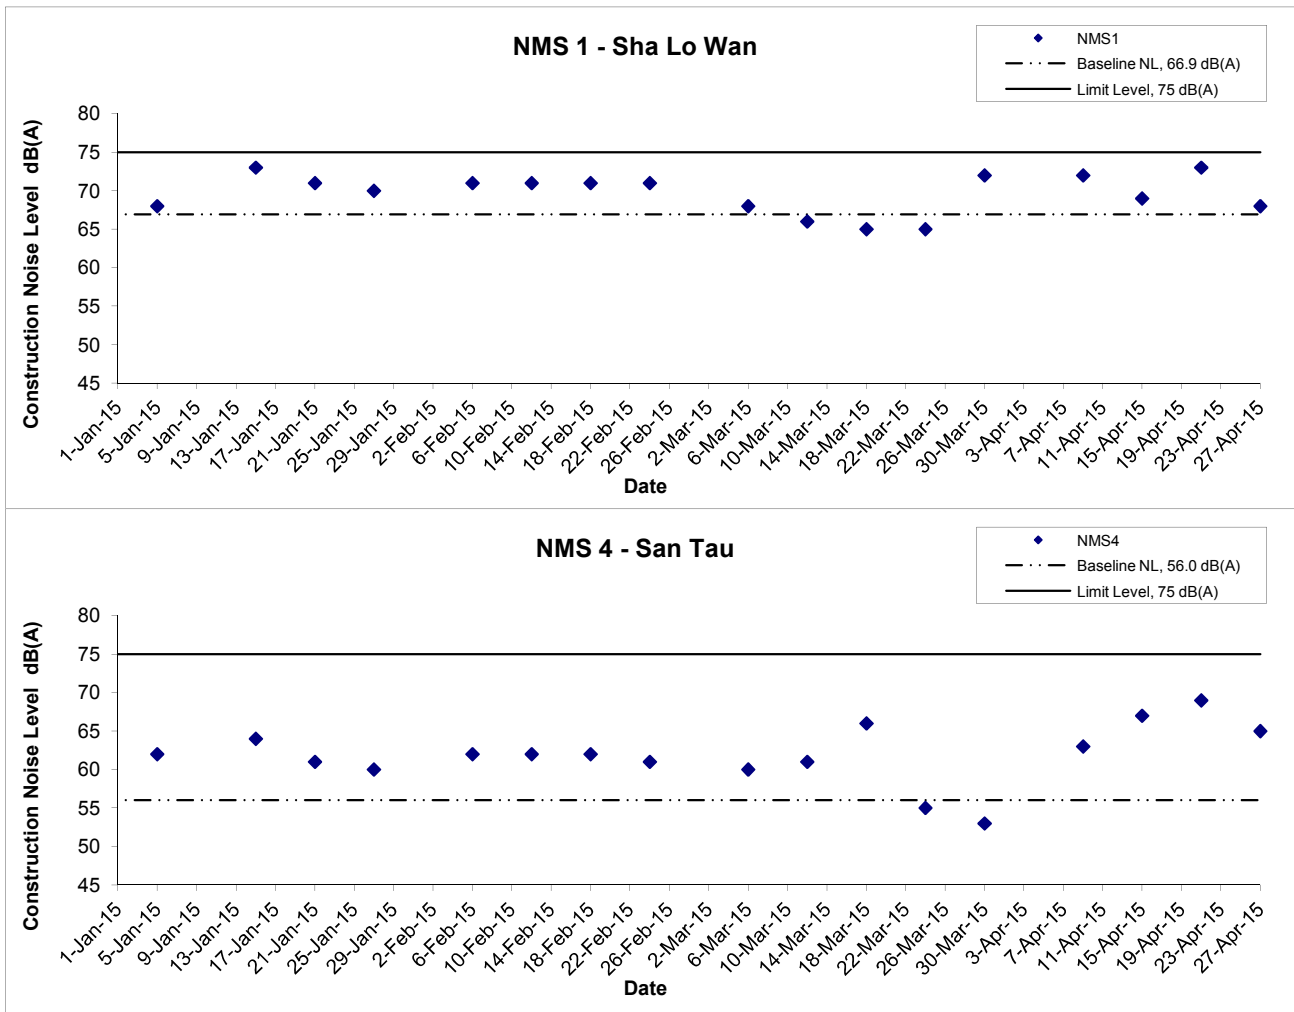
Noise Levels

Title Contract HY/2011/09 Hong Kong-Zhuhai-Macao Bridge Hong Kong Link Road-Section between HKSAR Boundary and Scenic Hill Graphical Presentation of Construction Noise Monitoring Results	Scale N.T.S	Project No. MA12014	
	Date Apr 15	Appendix G

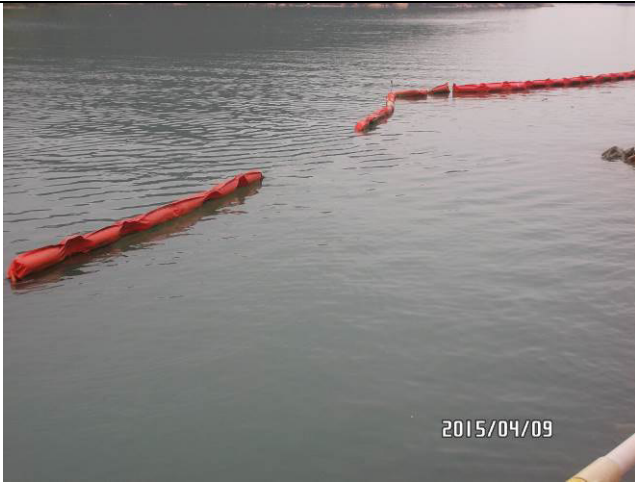
Parameters	Date	Observations and Recommendations	Follow-up
<i>Water Quality</i>	09/04/2015	Properly deploy the silt curtain at P99 and P103.	Rectification/improvement was observed during the follow-up audit session on 14 April 2015.
	09/04/2015	Clear the sedimentation tank to ensure it can function properly at Portion C.	Rectification/improvement was observed during the follow-up audit session on 14 April 2015.
	21/04/2015	Properly deploy the silt curtain to avoid the gap at P106.	Rectification/improvement was observed during the follow-up audit session on 29 April 2015.
	29/04/2015	Wastewater from the works area at P82 was observed discharging to the marine water. The Contractor was reminded to provide sufficient mitigation measures to rectify this deficiency as soon as possible. (e.g. check and repair the silt curtain, pump out the excess wastewater for treatment, erect bunds to surround the works area etc.)	Rectification/improvement was observed during the follow-up audit session on 5 May 2015.

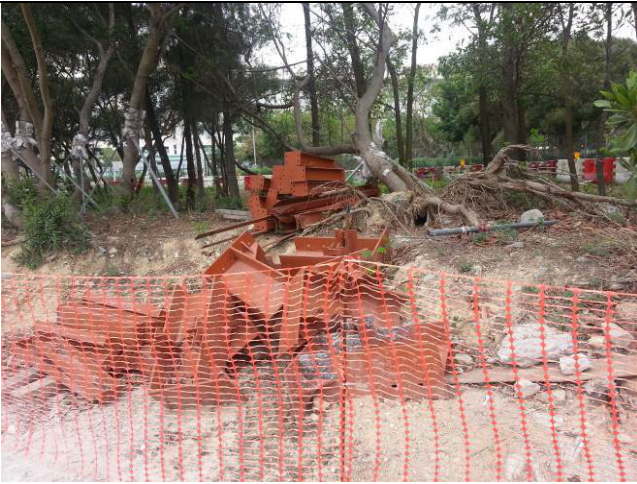
<i>Ecology</i>	09/04/2015	Clear the construction wastes / materials at near the trees at P113, P102, between P94&P95, between P88&P89 and P87	Rectification/improvement was not observed during the follow-up audit session on 14 April 2015. Further follow-up on this item is required.
	21/04/2015	Clear the construction materials / wastes at near the trees at P102 and between P96 & P97.	Rectification/improvement was not observed during the follow-up audit session on 29 April 2015. Further follow-up on this item is required.
<i>Air Quality</i>	N/A ⁽¹⁾	N/A ⁽¹⁾	N/A ⁽¹⁾
<i>Noise</i>	N/A ⁽¹⁾	N/A ⁽¹⁾	N/A ⁽¹⁾
<i>Waste / Chemical Management</i>	09/04/2015	Clear the oil spillage at near the generator at P114 and area near P109.	Rectification/improvement was observed during the follow-up audit session on 29 April 2015.
	14/04/2015	Clear the oil spillage at near the mobile crane at WA4.	Rectification/improvement was observed during the follow-up audit session on 21 April 2015.

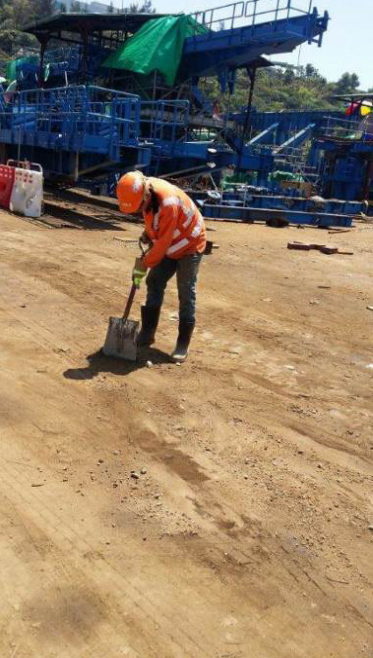
<p>Ref No: 150414-R01</p> <p>Impact: Waste / Chemical Management (F8)</p> <p>Details: Clear the oil spillage at near the mobile crane at WA4.</p> <p>Follow Up: The oil spillage was cleared by the worker as chemical waste.</p>
