**Re: Agreement No. CE 48/2011 (EP)
Environmental Project Office for the
HZMB Hong Kong Link Road, HZMB Hong Kong Boundary Crossing Facilities,
and Tuen Mun-Chek Lap Kok Link – Investigation**

**Contract No. HY/2011/09 HZMB Hong Kong Link Road –
Section between HKSAR Boundary and Scenic Hill
Revised Monthly EM&A Report for May 2015 (EP-352/2009/D)**

Contract HY/2011/09
Hong Kong-Zhuhai-Macao Bridge
Hong Kong Link Road-Section between
HKSAR Boundary and Scenic Hill
Monthly EM&A Report
May 2015
(Version 2.0)

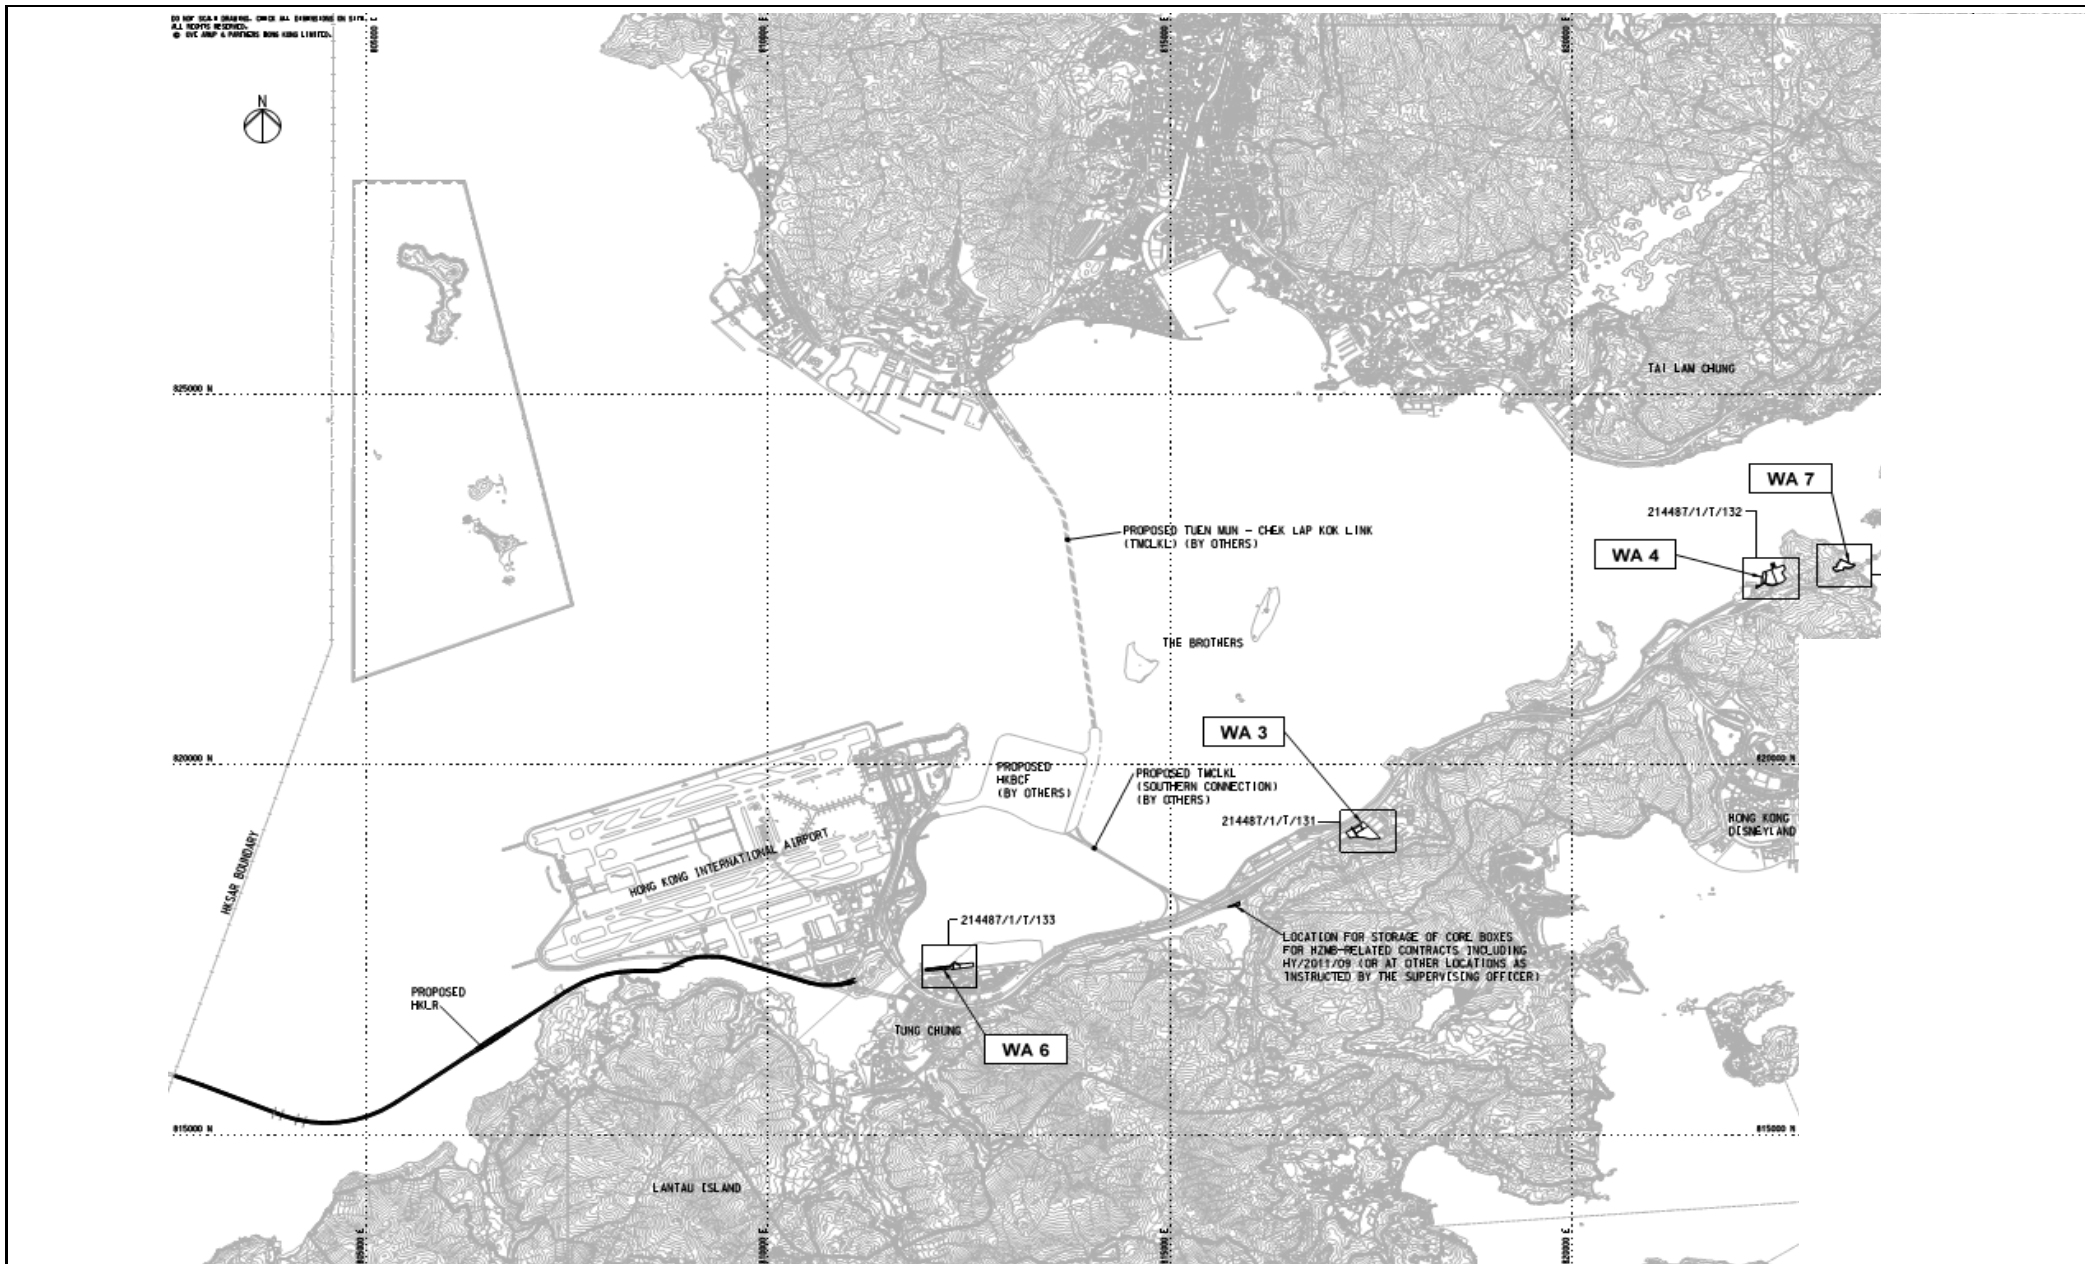
Title	Contract No. HY/2011/09 Hong Kong-Zhuhai-Macao Bridge Hong Kong Link Road – Section between HKSAR Boundary and Scenic Hill Site Layout Plan (WA3, WA4, WA6 and WA7)		Scale	N.T.S	Propose No.	MA12014
	Date	Feb-13	Figure	1a

- 2.5 **Figure 1a-d** shows the layout of the Contract and the scope of the Contract works comprises the following major items:
 - a dual 3-lane carriageway in the form of viaduct from the HKSAR boundary (connecting with the HZMB Main Bridge) to the Scenic Hill (connecting with the tunnel under separate Contract No. HY/2011/03), of approximately 9.4km in length with a hard shoulder for each bound of carriageway and a utilities trough on the outer edge of each bound of viaducts;

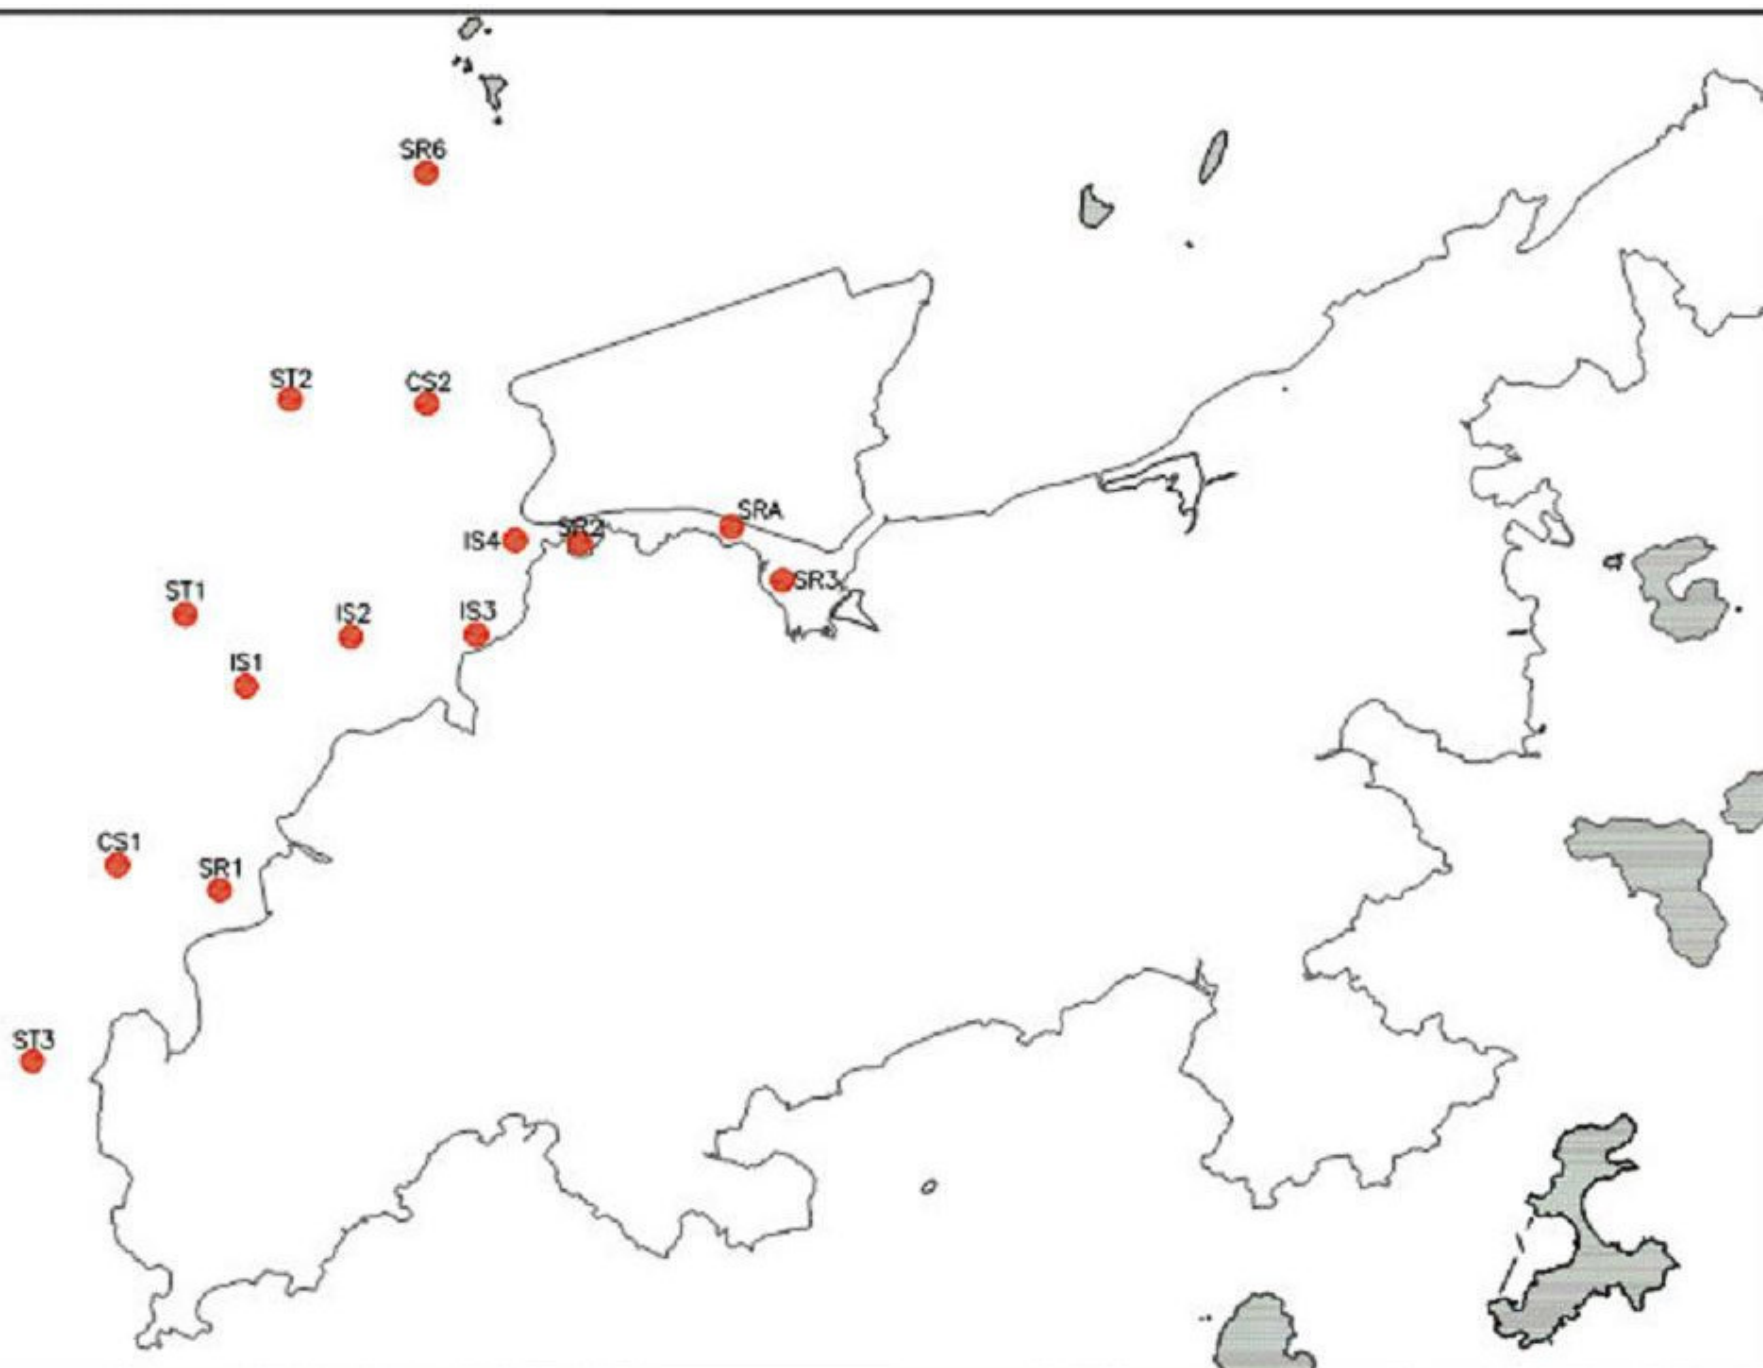
Title	Contract No. HY/2011/09 Hong Kong-Zhuhai-Macao Bridge Hong Kong Link Road – Section between HKSAR Boundary and Scenic Hill		Scale	N.T.S	Propose No.	MA12014	CINOTECH
	Locations of Air Quality and Noise Monitoring Stations		Date	Feb-13	Figure	3

- 3.3 Impact air quality monitoring was conducted at the 2 monitoring stations under the Contract, as shown in **Figure 3**. **Table 3.1** describes the locations of the air quality monitoring stations.

- 3.17 The wind speed and wind direction were recorded by the installed Wind Anemometer set at AMS4. The location is shown in **Figure 3**.
- 3.18 The wind data for the reporting month is summarized in **Appendix J**.

- 4.2 Impact noise monitoring was conducted at the 2 monitoring stations under the Contract, as shown in **Figure 3**. **Table 4.1** describes the locations of the noise monitoring stations.

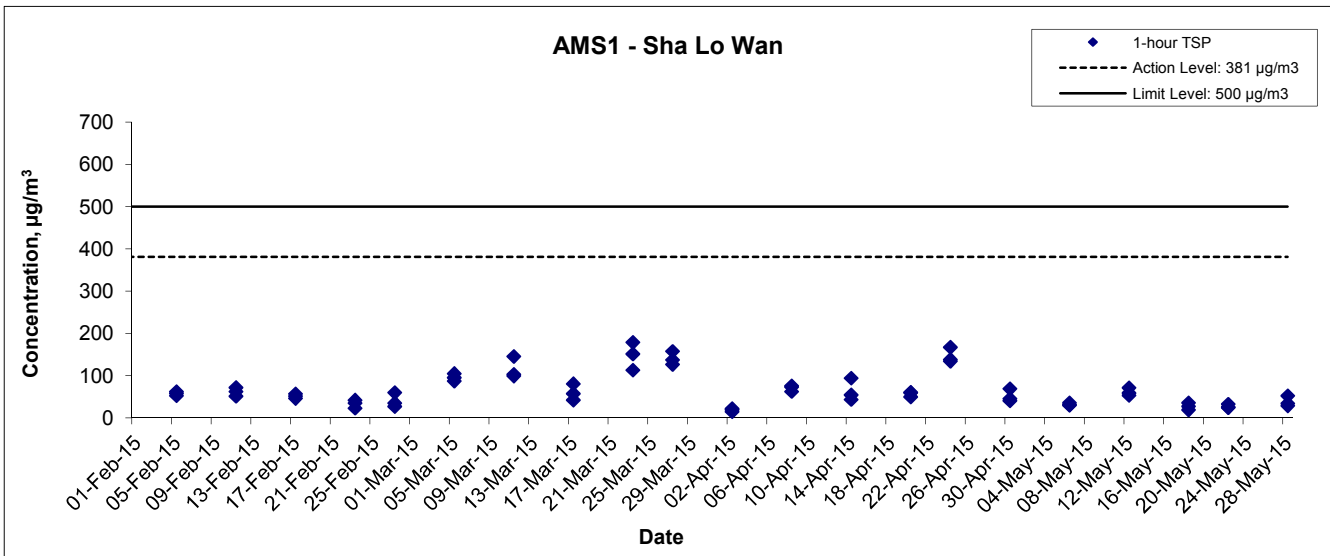
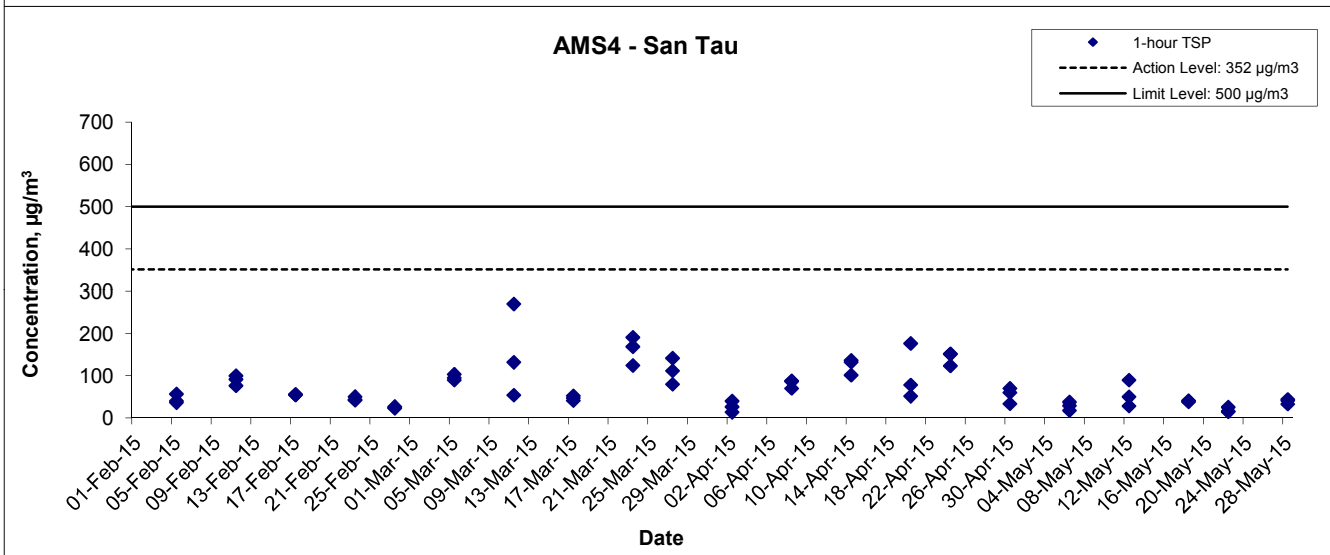
Title Contract No. HY/2011/09 Hong Kong-Zhuhai-Macao Bridge Hong Kong Link Road – Section between HKSAR Boundary and Scenic Hill Graphical Presentation of 1-hour TSP Monitoring Results	Scale N.T.S	Project No. MA12014	
	Date May 15	Appendix E

1-hour TSP Concentration Levels

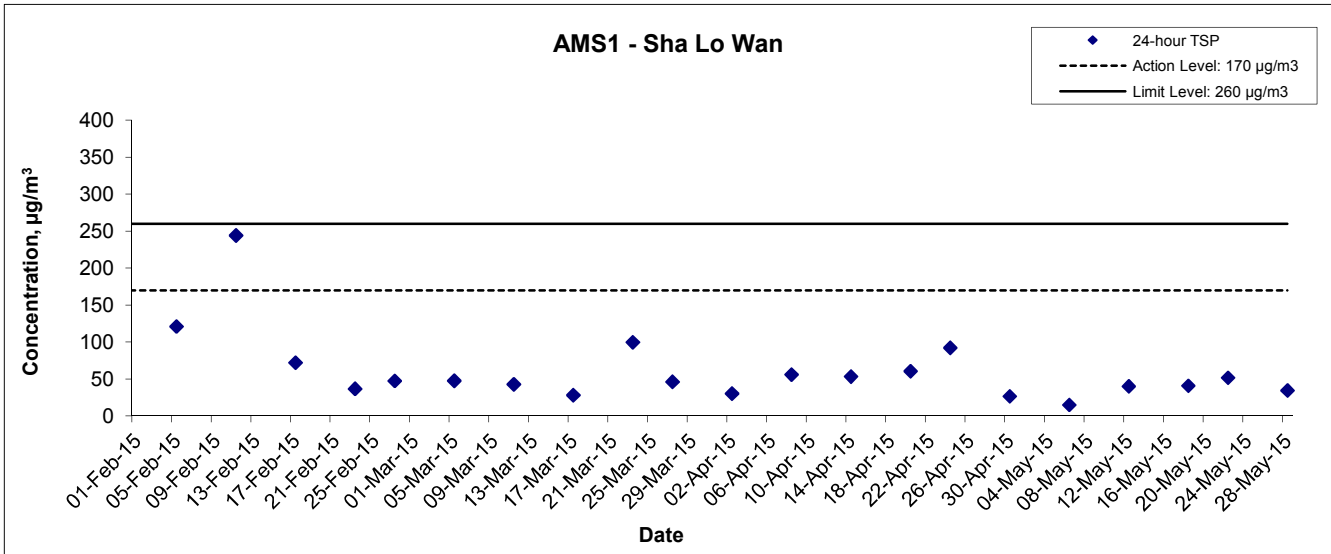
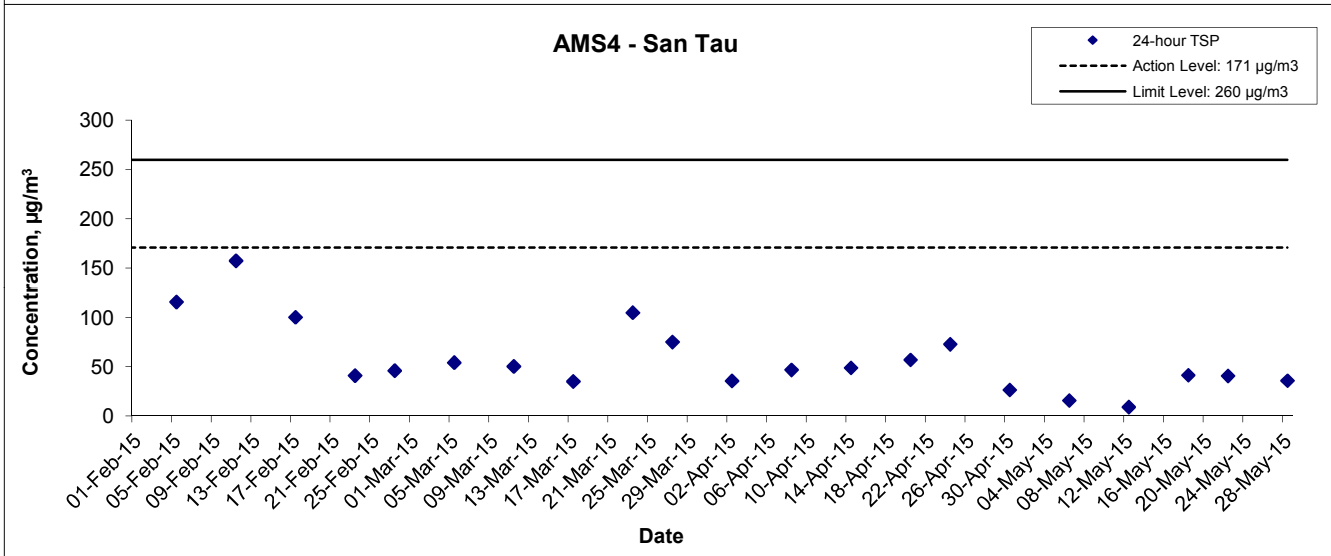
Title Contract No. HY/2011/09 Hong Kong-Zhuhai-Macao Bridge Hong Kong Link Road – Section between HKSAR Boundary and Scenic Hill Graphical Presentation of 24-hour TSP Monitoring Results	Scale N.T.S	Project No. MA12014	
	Date May 15	Appendix F

24-hour TSP Concentration Levels

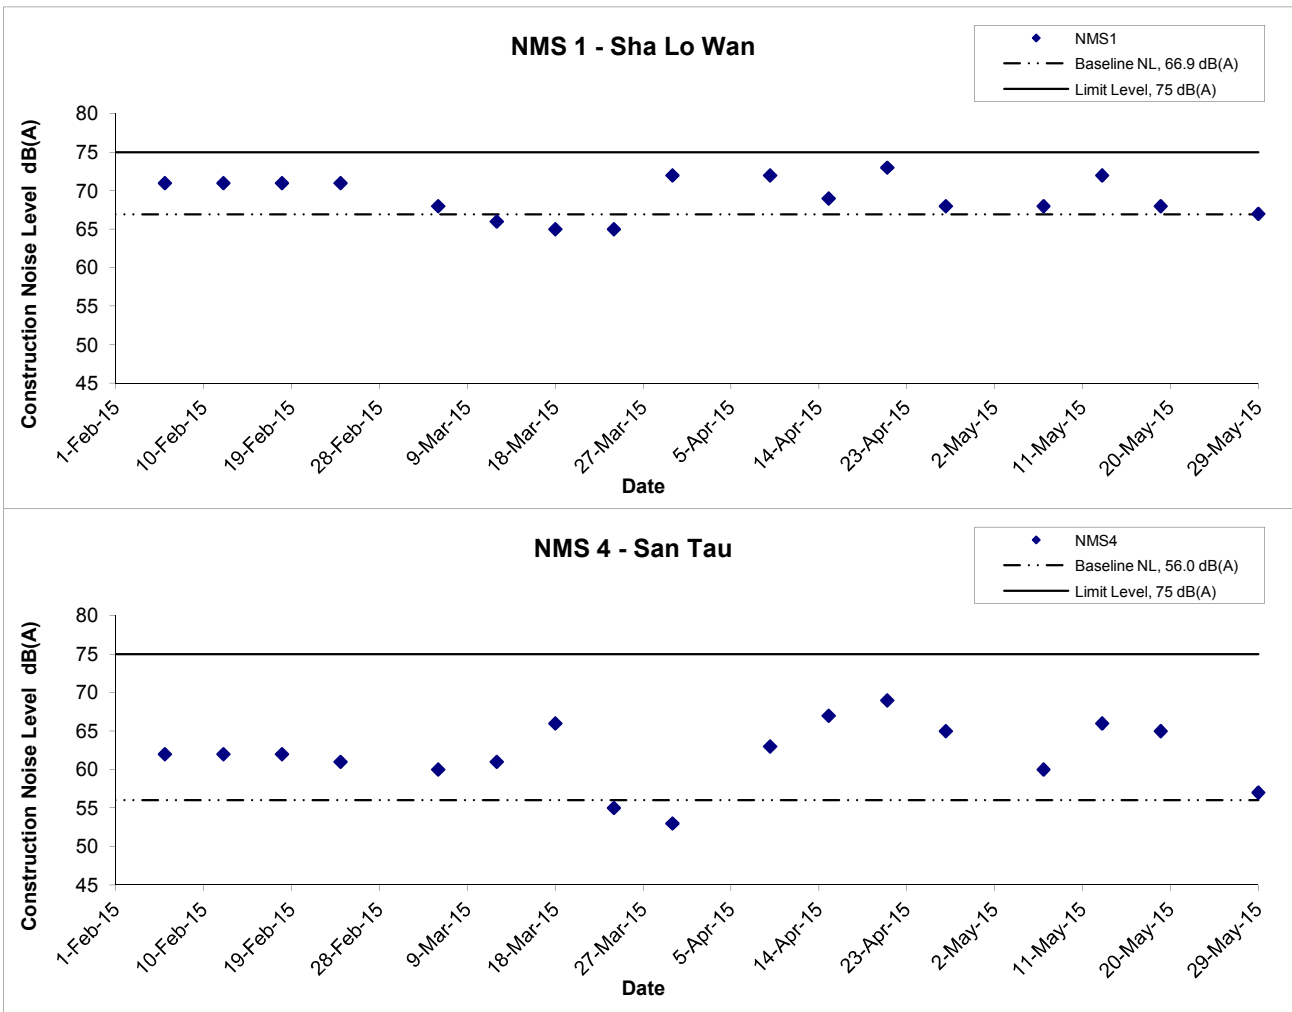
Title Contract HY/2011/09 Hong Kong-Zhuhai-Macao Bridge Hong Kong Link Road-Section between HKSAR Boundary and Scenic Hill Graphical Presentation of Construction Noise Monitoring Results	Scale	N.T.S	Project No.	MA12014	CINOTECH
	Date	May 15	Appendix	G

Noise Levels

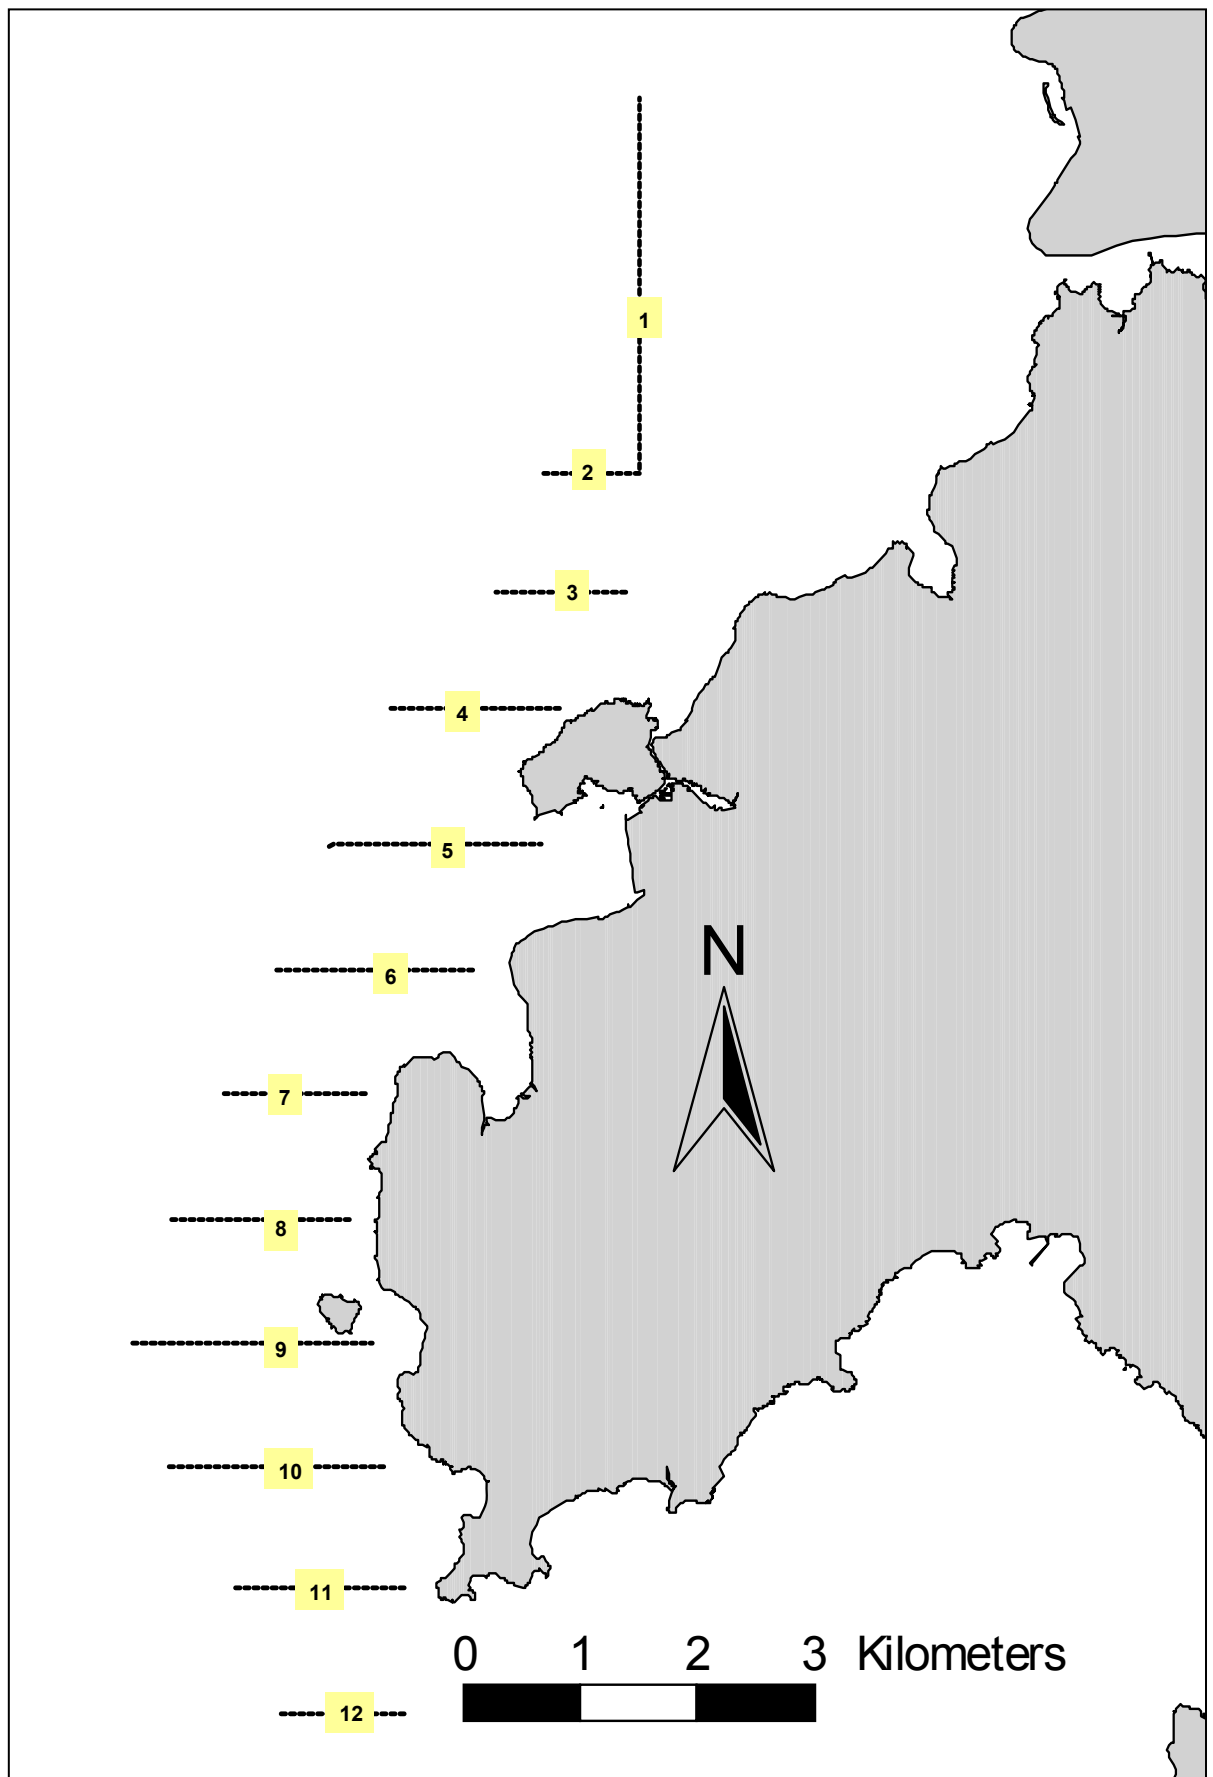
Figure 1. Transect Line Layout in West Lantau Survey Areas

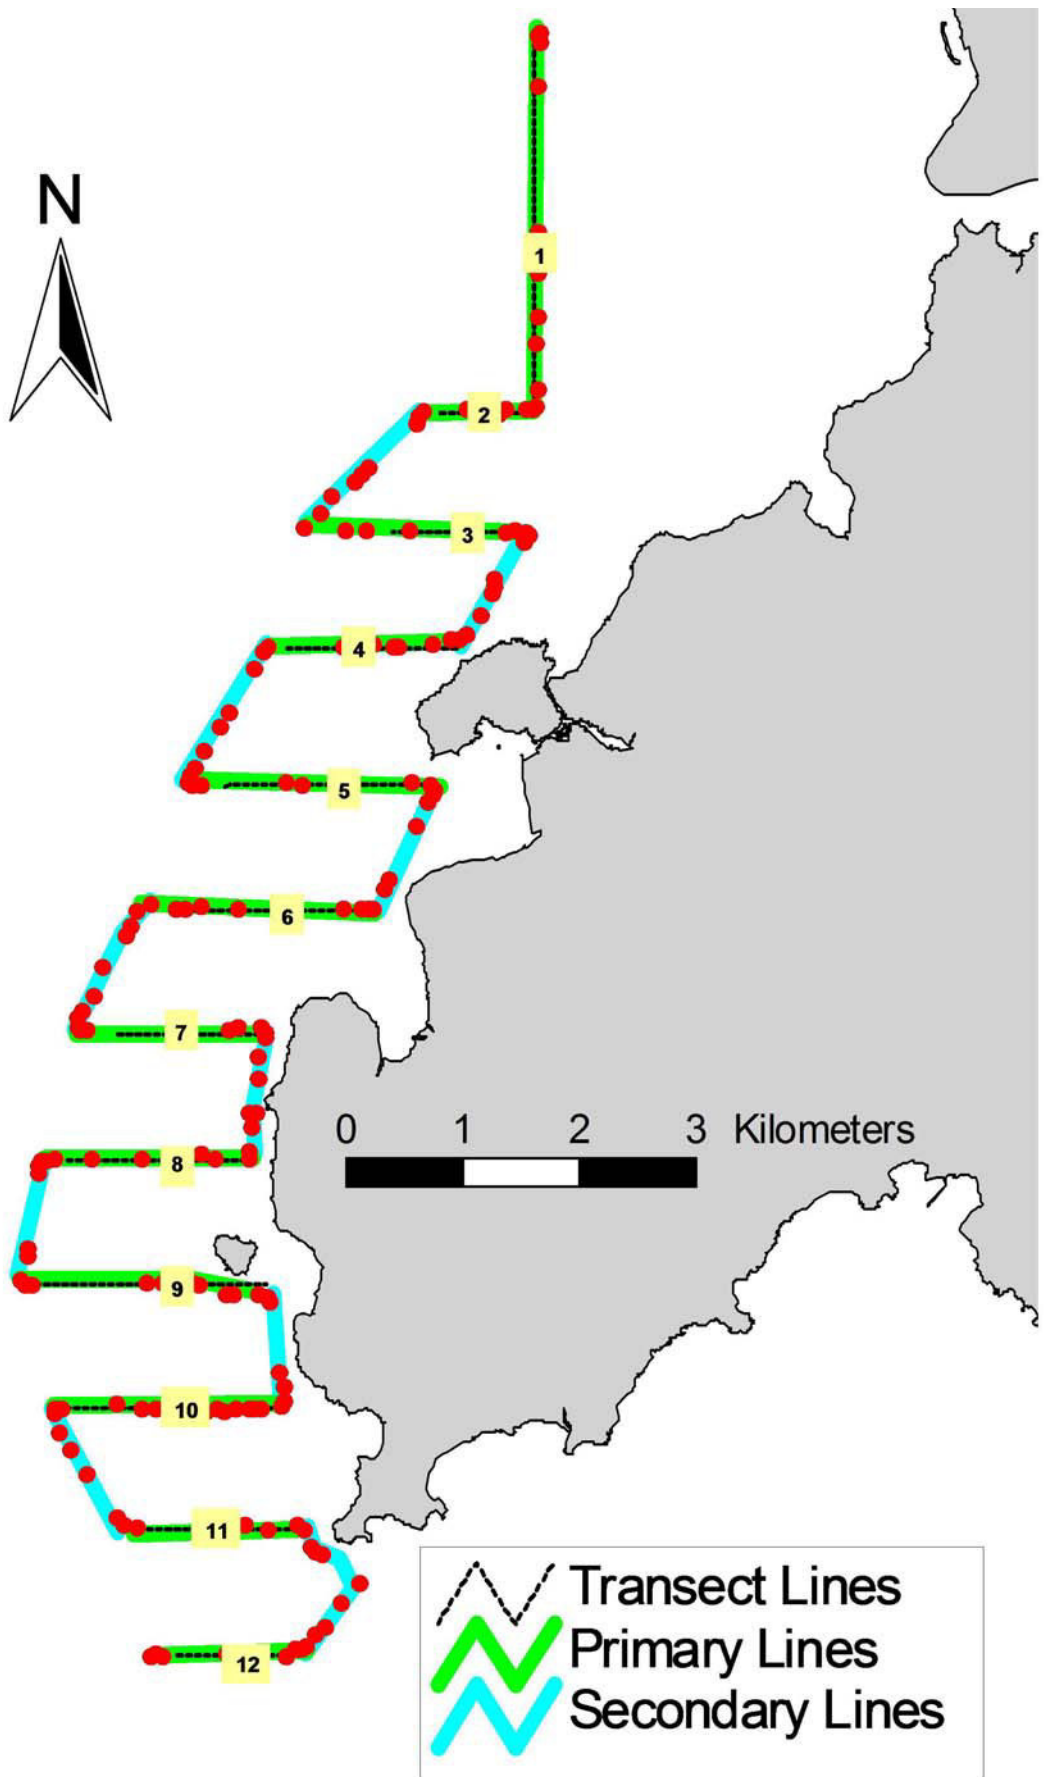
Figure 2. Survey Route on May 7th, 2015 (note: red dots represent the tracked positions of survey boat logged continuously by GPS throughout the course of the survey)

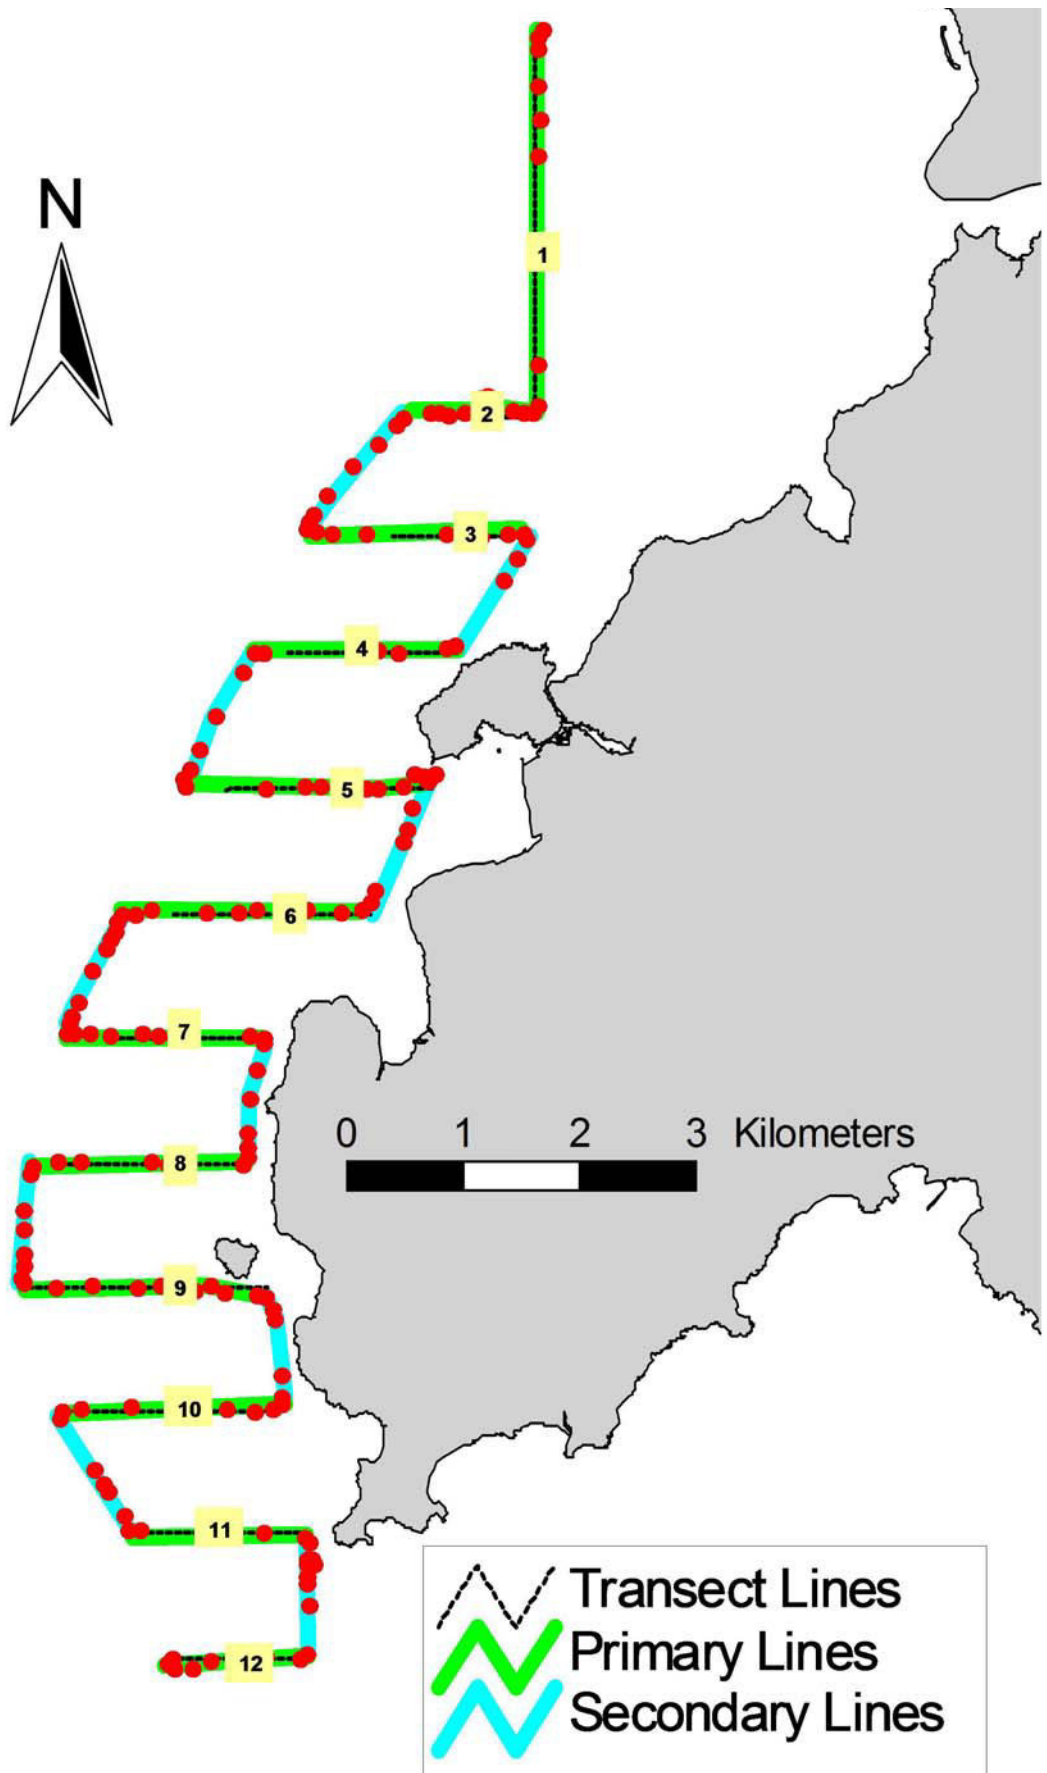
Figure 3. Survey Route on May 15th, 2015 (note: red dots represent the tracked positions of survey boat logged continuously by GPS throughout the course of the survey)

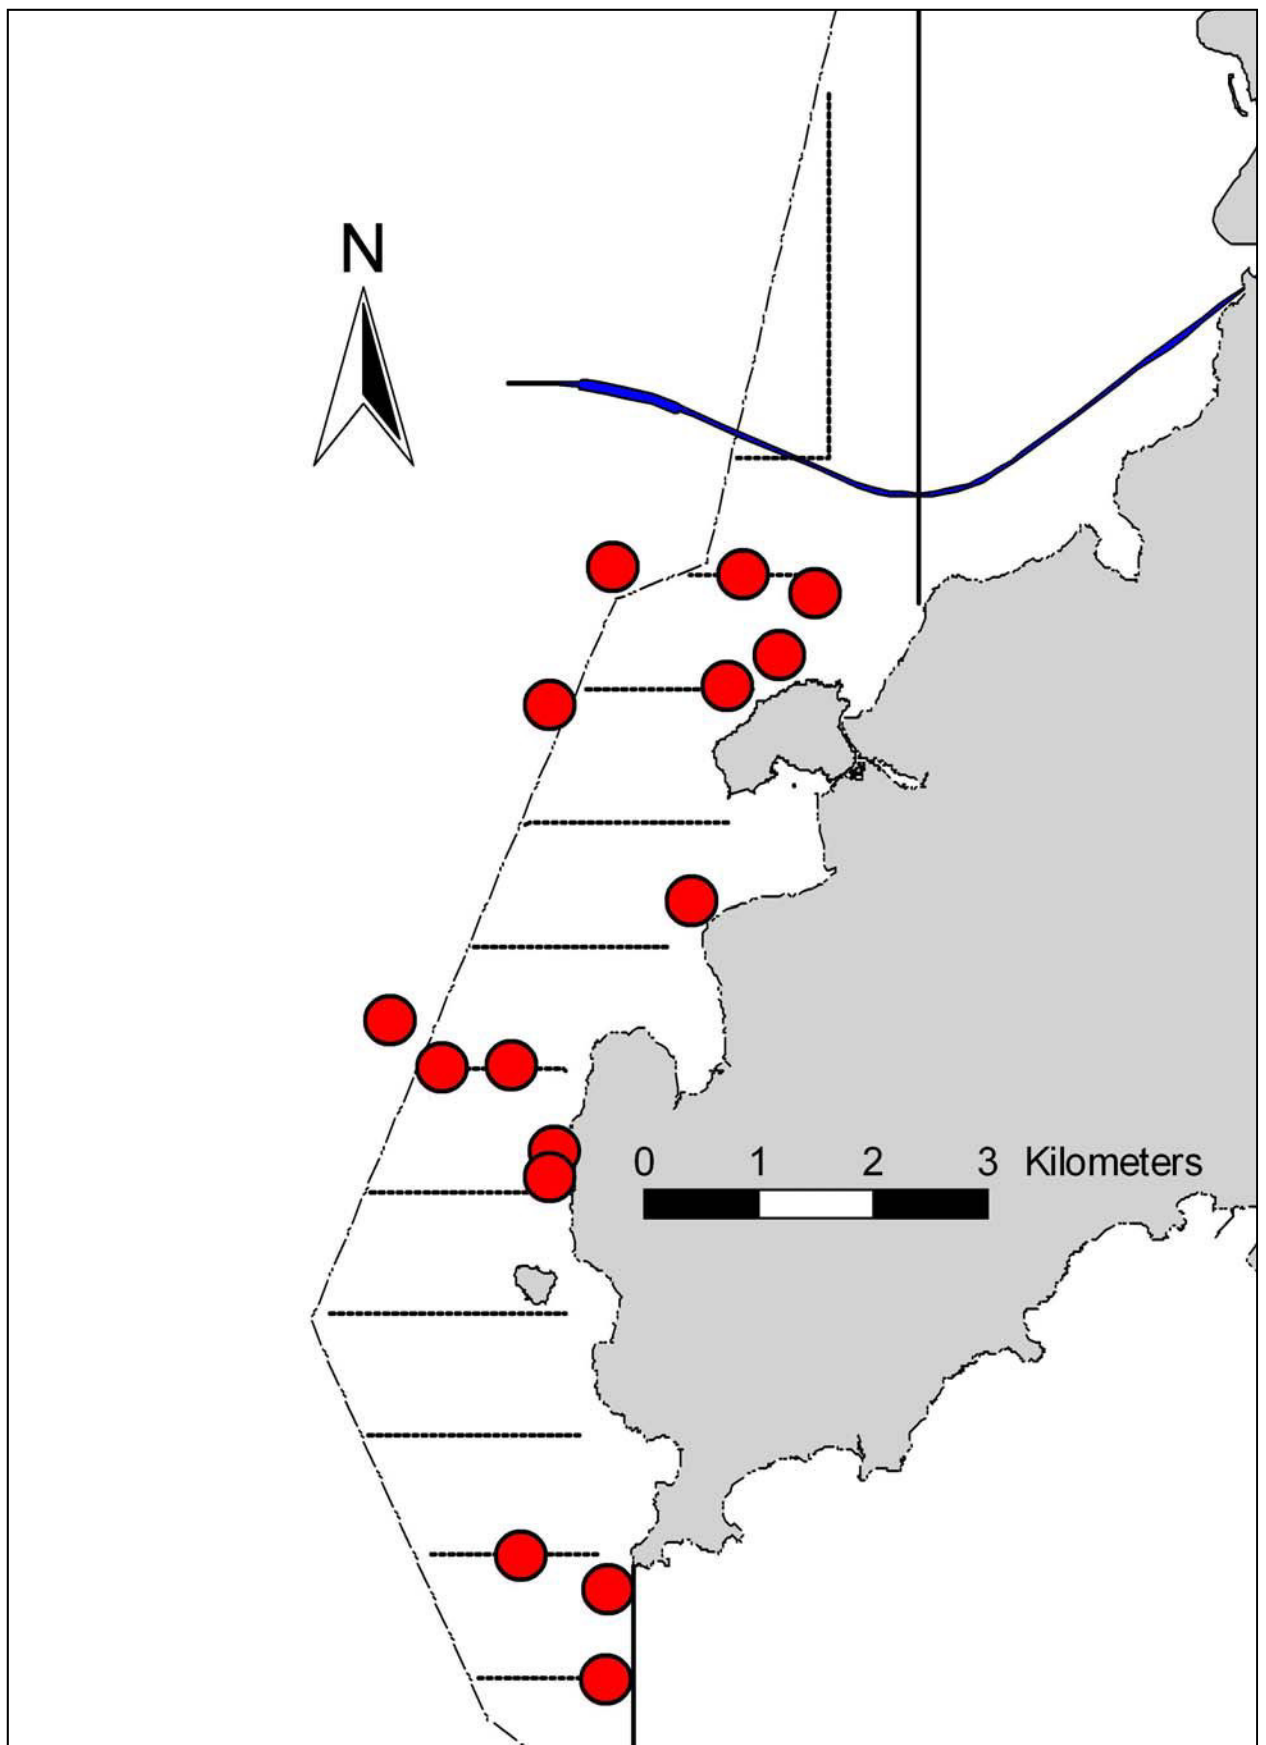
Figure 4. Distribution of Chinese White Dolphin Sighting during May 2015 HKLR09 Monitoring Surveys

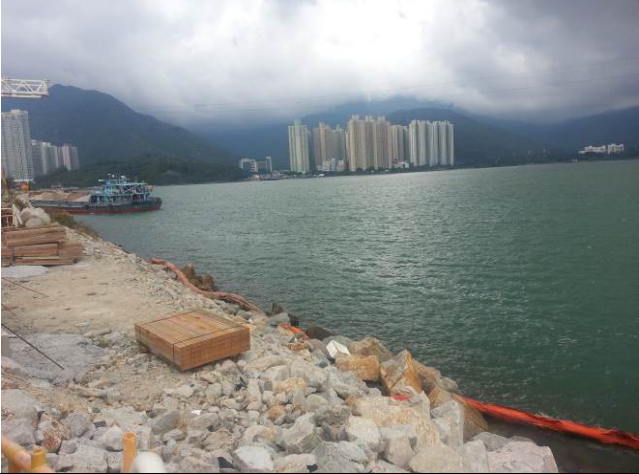
<p>Ref No: 150505-R04</p> <p>Impact: Water Quality (B25)</p> <p>Details: Properly deploy the silt curtain at P106 and P107.</p>

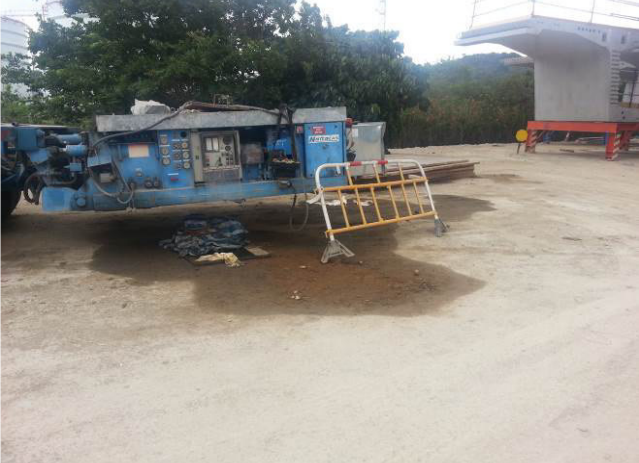
<p>Ref No: 150505-R05</p> <p>Impact: Waste / Chemical Management (F8)</p> <p>Details: Clear the oil spillage at the area near P108.</p>

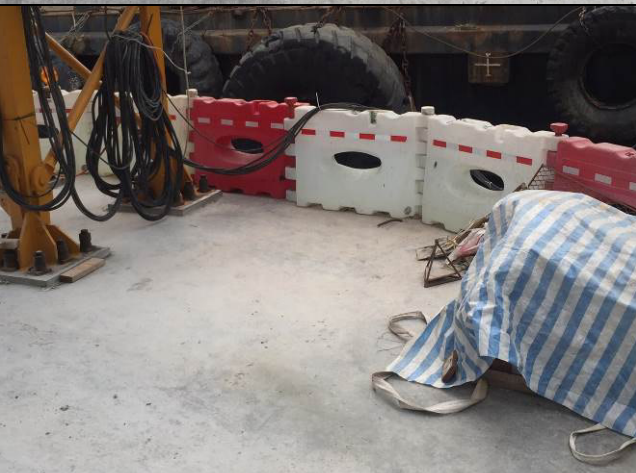
<p>Ref No: 150505-R02</p> <p>Impact: Waste / Chemical Management (F1iii.)</p> <p>Details: Clear the general refuse which was not disposed properly at P18.</p> <p>Follow Up: The general refuse was cleared.</p>

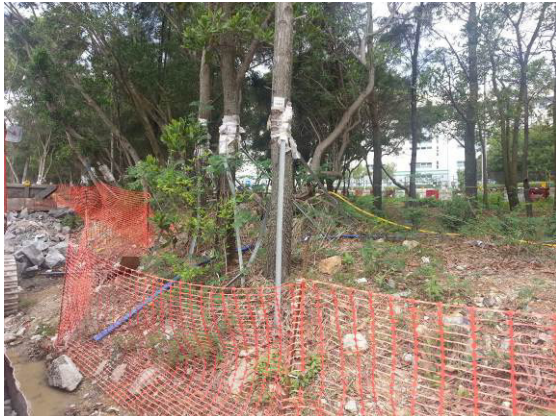
P102

Ref No: 150505-R03, 150421-R04, 150409-R02 and 150331-R05

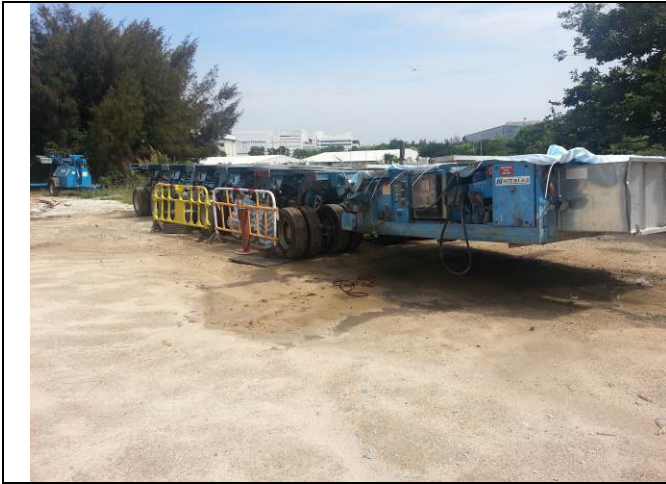
Ref No: 150505-R05

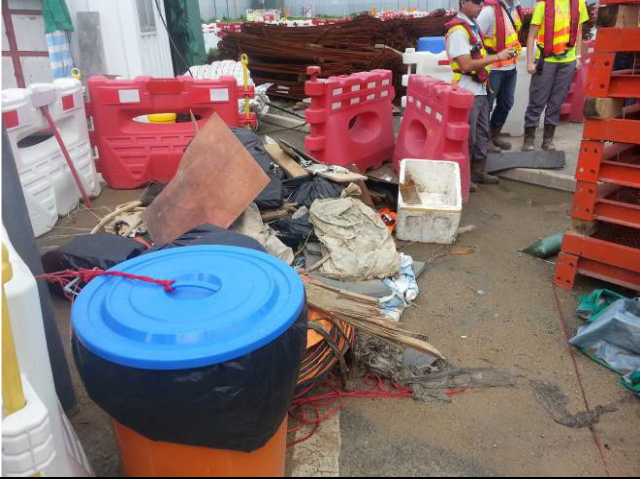
<p>Ref No: 150518-R02</p> <p>Impact: Waste / Chemical Management (F1i., F1iii. &F4ii.)</p> <p>Details: Clear the general refuse / construction wastes accumulated at the area near P83.</p>

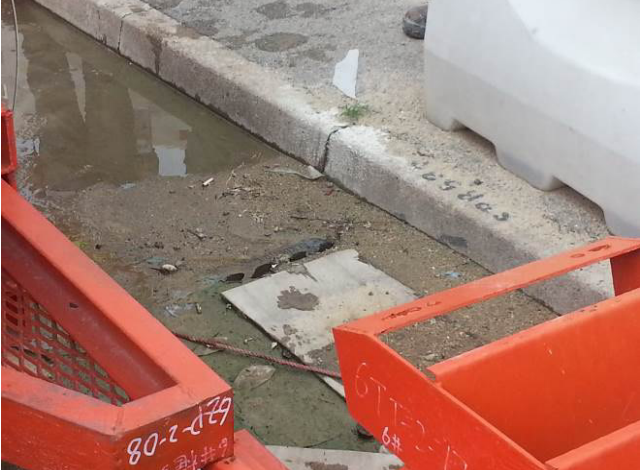
<p>Ref No: 150518-R03</p> <p>Impact: Water Quality (B4)</p> <p>Details: Provide sand bag bund to surround the gully at near P83.</p>

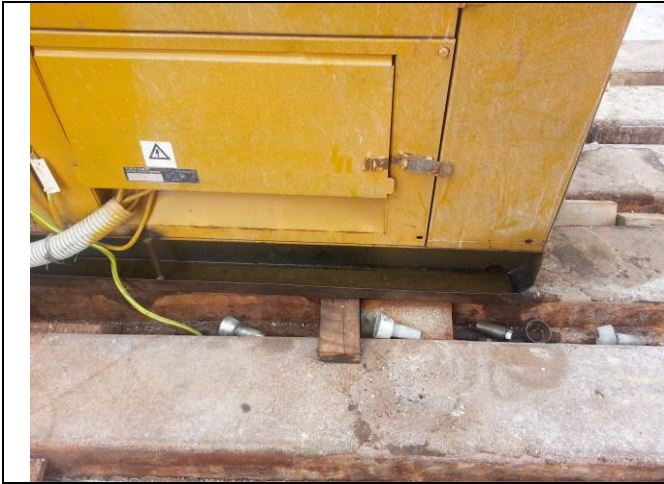
Ref No: 150518-R04

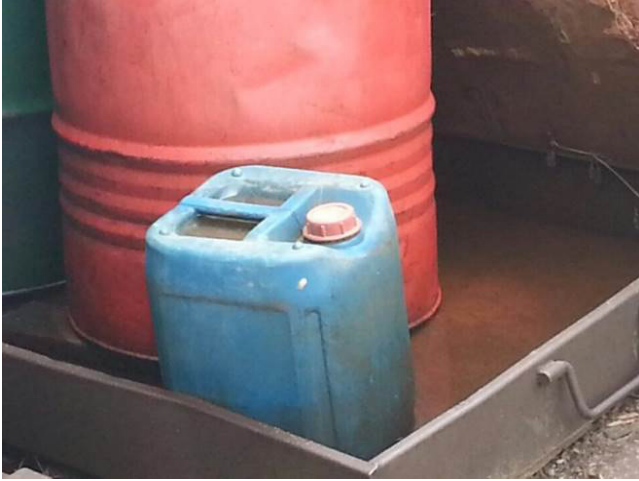
Ref No: 150512-R03

The drip tray at near P105 and P87 were cleared.

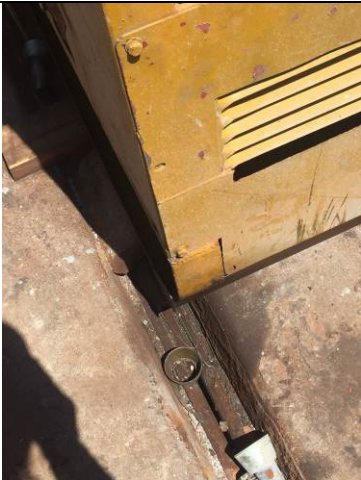
<p>Ref No: 150518-R04</p> <p>Impact: Waste / Chemical Management (F9)</p> <p>Details: Clear the mixture of chemical oil and stagnant water which is nearly overflow at the drip tray at P18.</p> <p>Follow Up: The drip tray was cleared.</p>
---	---
