**Re: Agreement No. CE 48/2011 (EP)
Environmental Project Office for the
HZMB Hong Kong Link Road, HZMB Hong Kong Boundary Crossing
Facilities, and Tuen Mun-Chek Lap Kok Link – Investigation**

**Contract No. HY/2011/09 HZMB Hong Kong Link Road –
Section between HKSAR Boundary and Scenic Hill
Revised Monthly EM&A Report for January 2016 (EP-352/2009/D)**

Contract HY/2011/09
Hong Kong-Zhuhai-Macao Bridge
Hong Kong Link Road-Section between
HKSAR Boundary and Scenic Hill
Monthly EM&A Report
January 2016
(Version 2.0)

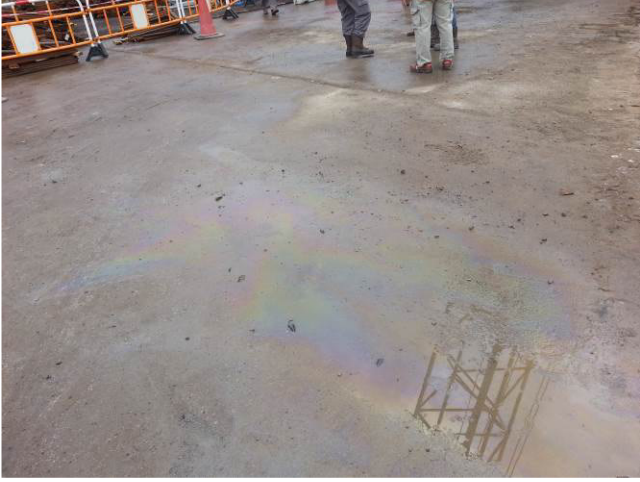
<p>Ref No: 160105-R02</p> <p>Impact: Waste / Chemical Management (F8)</p> <p>Details: Clear the oil spillage at the platform at P68.</p>

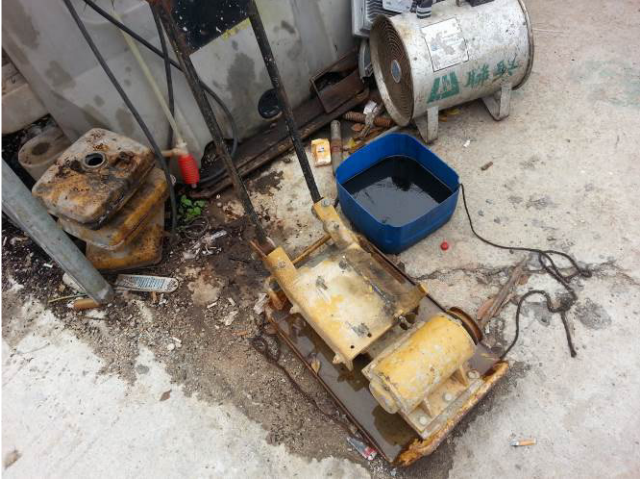
<p>Ref No: 160112-R01</p> <p>Impact: Waste / Chemical Management (F8)</p> <p>Details: Clear the engine oil properly to avoid oil leakage at P106 (Portion C).</p>
 	<p>Ref No: 160112-R02</p> <p>Impact: Waste / Chemical Management (F9)</p> <p>Details: Provide drip tray for the chemical containers at P102.</p>

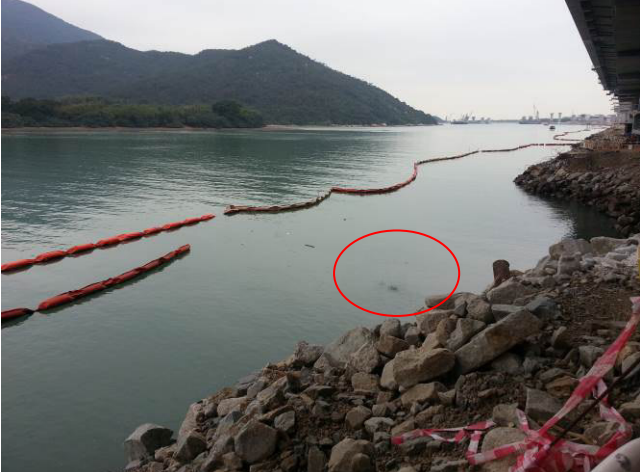
<p>Ref No: 160112-R03</p> <p>Impact: Water Quality (B16)</p> <p>Details: Provide mitigation measures to avoid the deck-surface runoff dropping to the sea at P101.</p>

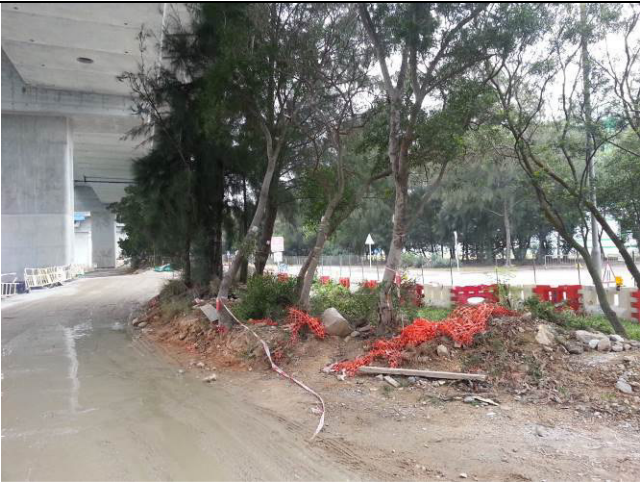
<p>Ref No: 160112-R04</p> <p>Impact: Ecology (C31)</p> <p>Details: Properly erect the fencing to protect the trees at P98.</p>
