**Re: Agreement No. CE 48/2011 (EP)  
Environmental Project Office for the  
HZMB Hong Kong Link Road, HZMB Hong Kong Boundary Crossing  
Facilities, and Tuen Mun-Chek Lap Kok Link – Investigation**

**Contract No. HY/2011/09 HZMB Hong Kong Link Road –  
Section between HKSAR Boundary and Scenic Hill  
Revised Monthly EM&A Report for February 2016 (EP-352/2009/D)**

**Contract HY/2011/09**  
**Hong Kong-Zhuhai-Macao Bridge**  
**Hong Kong Link Road-Section between**  
**HKSAR Boundary and Scenic Hill**  
**Monthly EM&A Report**  
**February 2016**  
**(Version 2.0)**

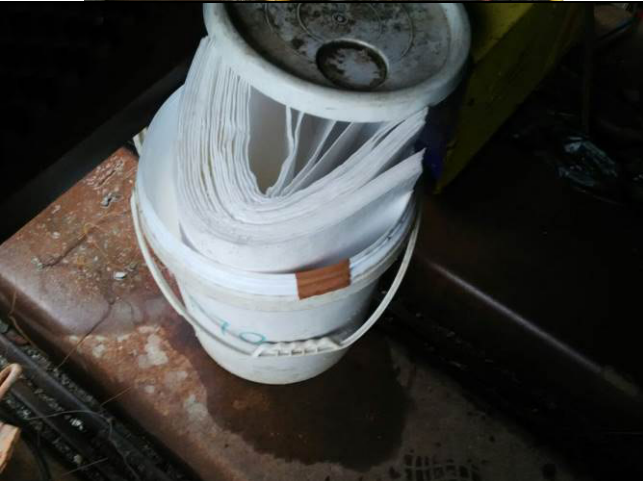
<p><b>Ref No:</b> 160126-R05</p> <p><b>Impact:</b> Waste / Chemical Management (F8)</p> <p><b>Details:</b> Provide spill kit at P78.</p> <p><b>Follow Up:</b> Spill kit was provided.</p>

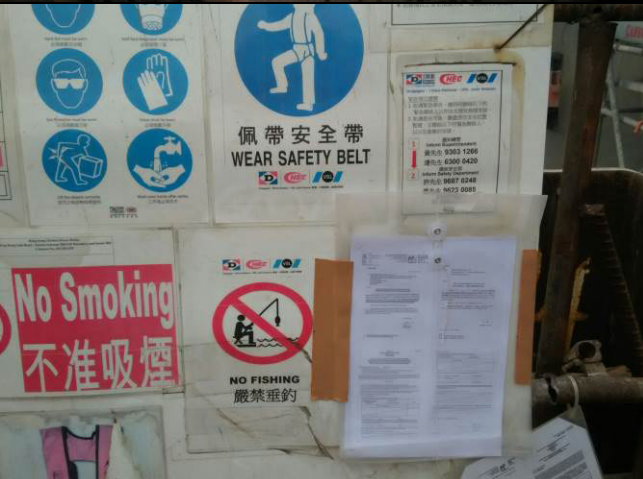
<p><b>Ref No:</b> 160126-R06</p> <p><b>Impact:</b> Permit / Licenses (G1)</p> <p><b>Details:</b> Provide the valid construction noise permit at P78.</p> <p><b>Follow Up:</b> The valid construction noise permit was displayed.</p>

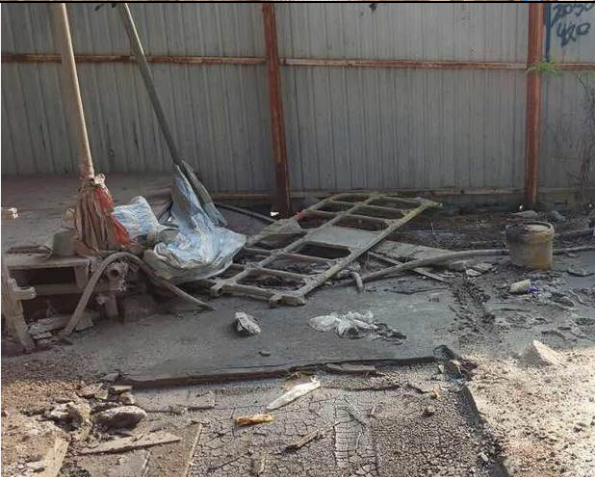
<p><b>Ref No:</b> 160202-R06</p> <p><b>Impact:</b> Water Quality (B16)</p> <p><b>Details:</b> To seal the gap at bottom of hoarding at near the area for washing cement trucks (P110).</p> <p><b>Follow Up:</b> Sand bag bund was provided to seal the gap at bottom of hoarding.</p>

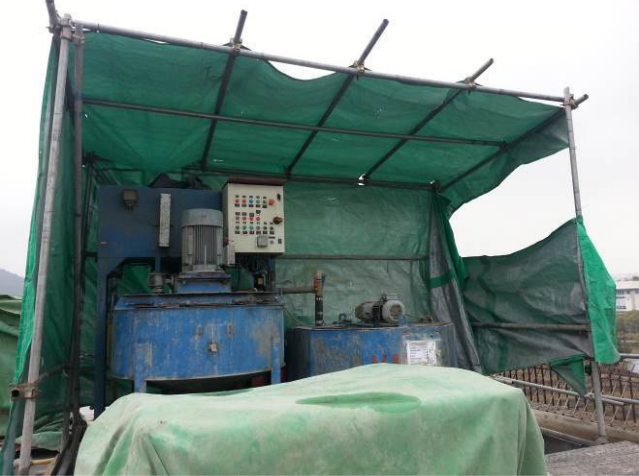
<p><b>Ref No:</b> 160218-R04</p> <p><b>Impact:</b> Air Quality (D13)</p> <p><b>Details:</b> Properly repair the enclosure for the grouting works at bridge surface.</p>

18/02/2016	Properly repair the enclosure for the grouting works at bridge surface.	Rectification/improvement was not observed during the follow-up audit session on 23 February 2016. Follow-up on this item is required.
	23/02/2016	The three-side enclosure with top shelter should be provided before commencement of grouting works at P45.	Rectification/improvement was observed during the follow-up audit session on 1 March 2016.
<i>Noise</i>	N/A <sup>(1)</sup>	N/A <sup>(1)</sup>	N/A <sup>(1)</sup>
<i>Waste / Chemical Management</i>	02/02/2016	Clear the accumulated rubbish at near the waste skip at P83.	Rectification/improvement was observed during the follow-up audit session on 11 February 2016.
	02/02/2016	Clear the chemical waste container at near the discharging point at P106 (Portion C).	Rectification/improvement was observed during the follow-up audit session on 11 February 2016.
	11/02/2016	Clear the oily water at the drip tray as chemical wastes at WA4 and WA3.	Rectification/improvement was observed during the follow-up audit session on 18 February 2016.
