**Re: Agreement No. CE 48/2011 (EP)  
Environmental Project Office for the  
HZMB Hong Kong Link Road, HZMB Hong Kong Boundary Crossing  
Facilities, and Tuen Mun-Chek Lap Kok Link – Investigation**

**Contract No. HY/2011/09 HZMB Hong Kong Link Road –  
Section between HKSAR Boundary and Scenic Hill  
Revised Monthly EM&A Report for March 2016 (EP-352/2009/D)**

**Contract HY/2011/09**  
**Hong Kong-Zhuhai-Macao Bridge**  
**Hong Kong Link Road-Section between**  
**HKSAR Boundary and Scenic Hill**

**Monthly EM&A Report**

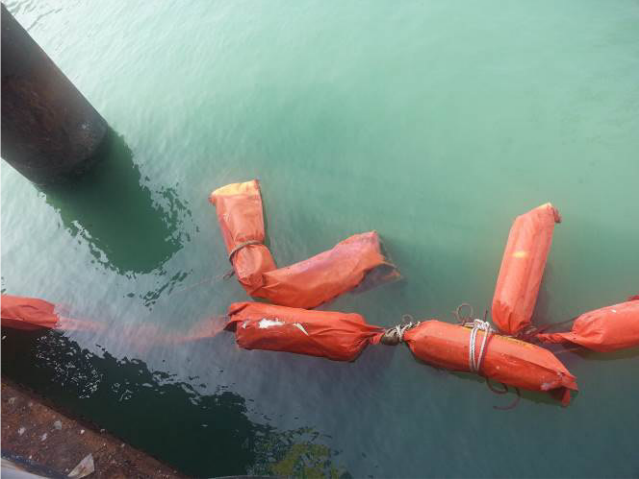
<p><b>Ref No:</b> 160301-R01</p> <p><b>Impact:</b> Water Quality (B25)</p> <p><b>Details:</b> Properly repair the damage silt curtain or replace with the new silt curtain to surround the works at P68.</p>

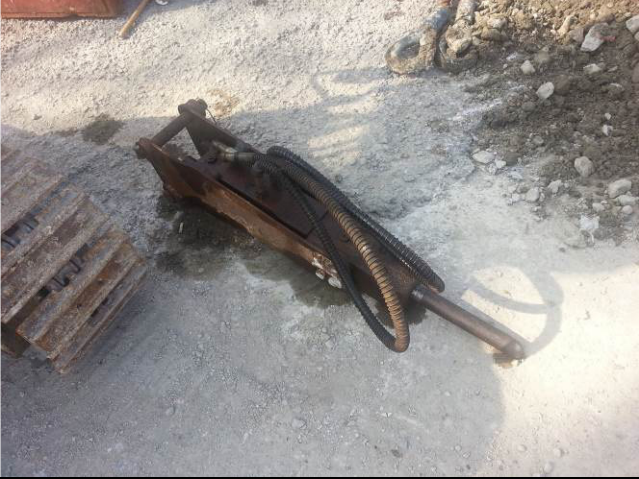
<p><b>Ref No:</b> 160301-R02</p> <p><b>Impact:</b> Waste / Chemical Management (F8)</p> <p><b>Details:</b> Provide tarpaulin sheet at underneath of the parts of breaker and clear the oil leakage at P68.</p>

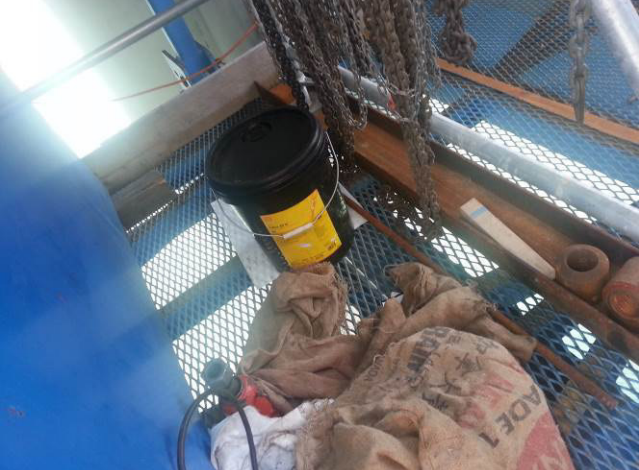
<p><b>Ref No:</b> 160301-R03</p> <p><b>Impact:</b> Waste / Chemical Management (F9)</p> <p><b>Details:</b> Provide drip tray for the oil containers at P76.</p>

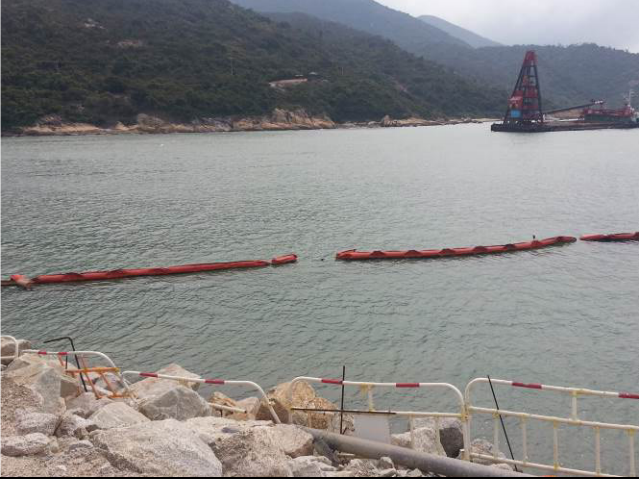
<p><b>Ref No:</b> 160308-R02</p> <p><b>Impact:</b> Water Quality (B25)</p> <p><b>Details:</b> Properly repair the silt curtain to avoid the gap at P83.</p>

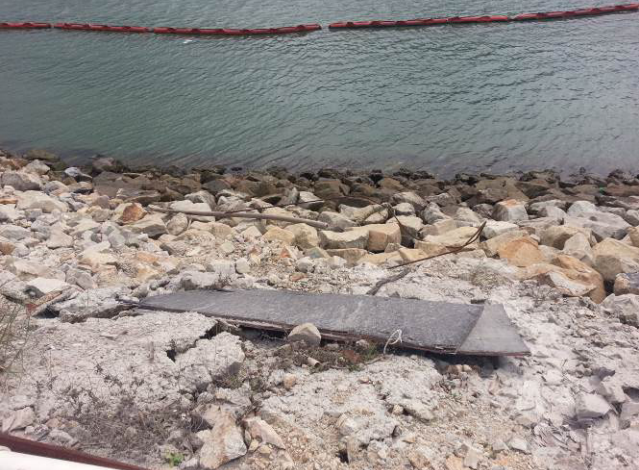
<p><b>Ref No:</b> 160308-R03</p> <p><b>Impact:</b> Water Quality (B21)</p> <p><b>Details:</b> Clear the wooden board at the seawall area at P88.</p>

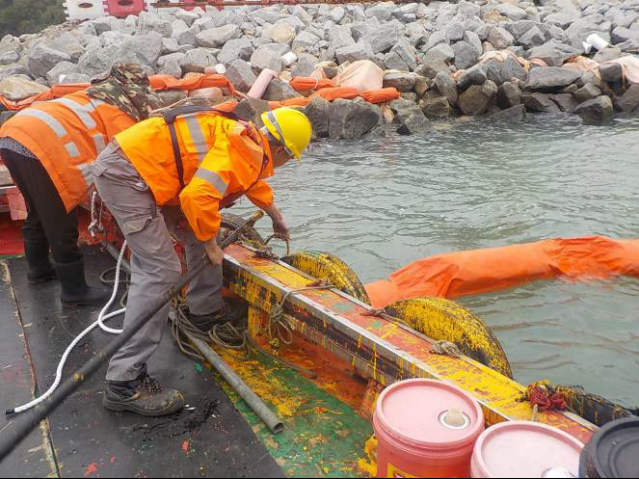
<p><b>Ref No:</b> 160301-R01</p> <p><b>Impact:</b> Water Quality (B25)</p> <p><b>Details:</b> Properly repair the damage silt curtain or replace with the new silt curtain to surround the works at P68.</p> <p><b>Follow Up:</b> The damage silt curtain was repaired by the workers.</p>

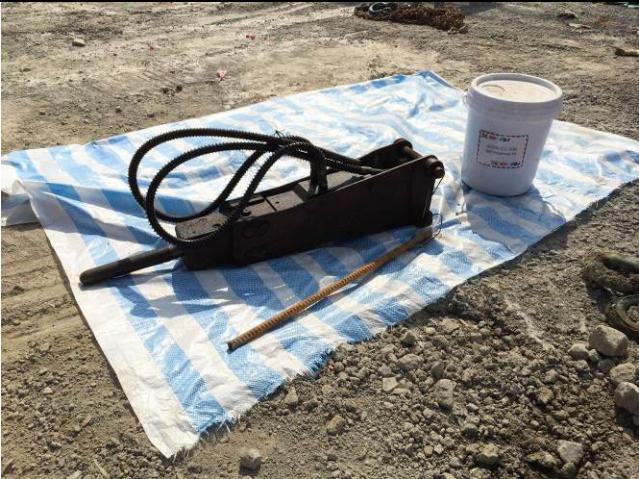
<p><b>Ref No:</b> 160301-R02</p> <p><b>Impact:</b> Waste / Chemical Management (F8)</p> <p><b>Details:</b> Provide tarpaulin sheet at underneath of the parts of breaker and clear the oil leakage at P68.</p> <p><b>Follow Up:</b> Tarpaulin sheet and spill kit were provided.</p>

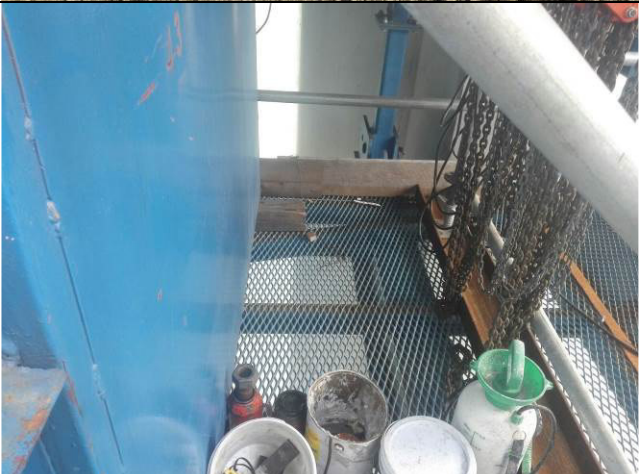
<p><b>Ref No:</b> 160301-R03</p> <p><b>Impact:</b> Waste / Chemical Management (F9)</p> <p><b>Details:</b> Provide drip tray for the oil containers at P76.</p> <p><b>Follow Up:</b> The oil container without drip tray was removed.</p>

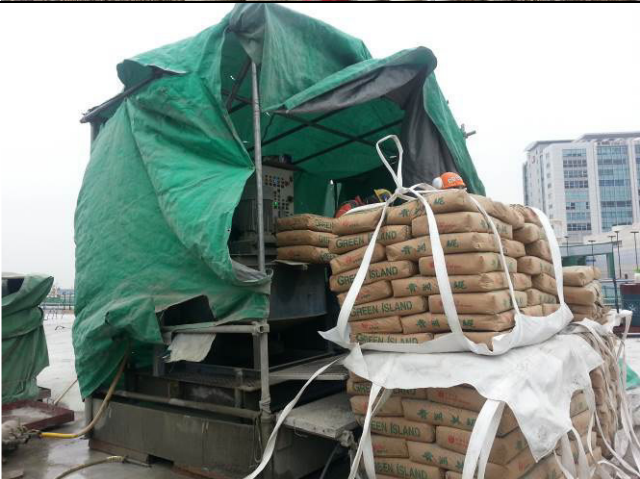
<p><b>Ref No:</b> 160315-R06</p> <p><b>Impact:</b> Air Quality (D13 &amp; D20)</p> <p><b>Details:</b> Properly repair the enclosure for the grouting works and cover the cement bags at the bridge surface at P98.</p>

15/03/2016	To remove the oil drum at near the trees at Portion C (P111).	Rectification/improvement was observed during the follow-up audit session on 22 March 2016.
<i>Air Quality</i>	08/03/2016	Properly repair the enclosure for the grouting works at bridge surface (P98).	Rectification/improvement was observed during the follow-up audit session on 22 March 2016.
	15/03/2016	Properly repair the enclosure for the grouting works and cover the cement bags at the bridge surface at P98.	Rectification/improvement was observed during the follow-up audit session on 22 March 2016.
